# 6 CIRCUMSTANCES RELATED TO THE TAKEOFF AND CRASH OF FLIGHT 1363

## The Takeoff Roll – Condition of Aircraft

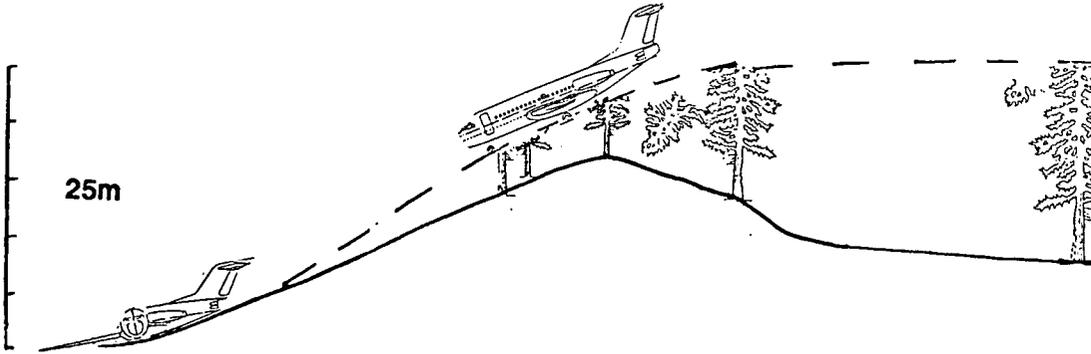
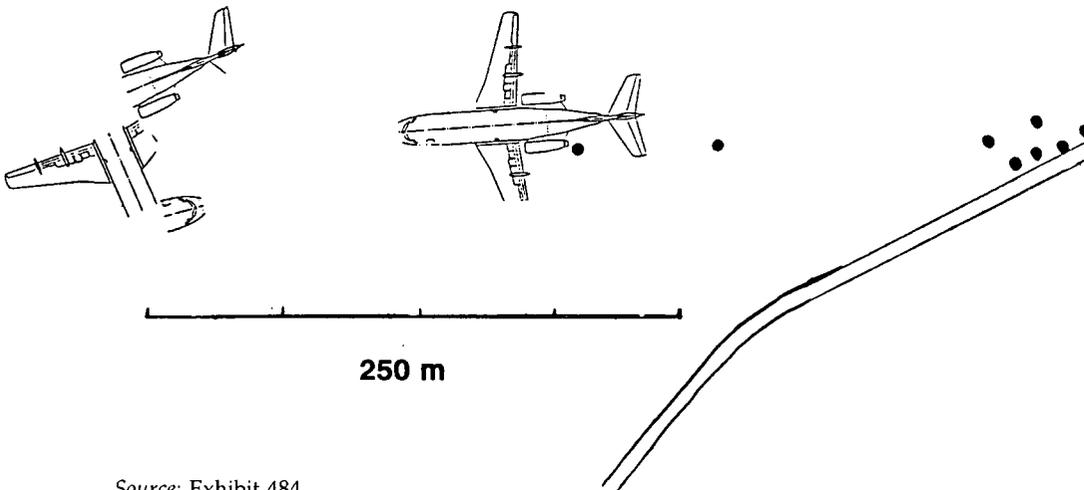
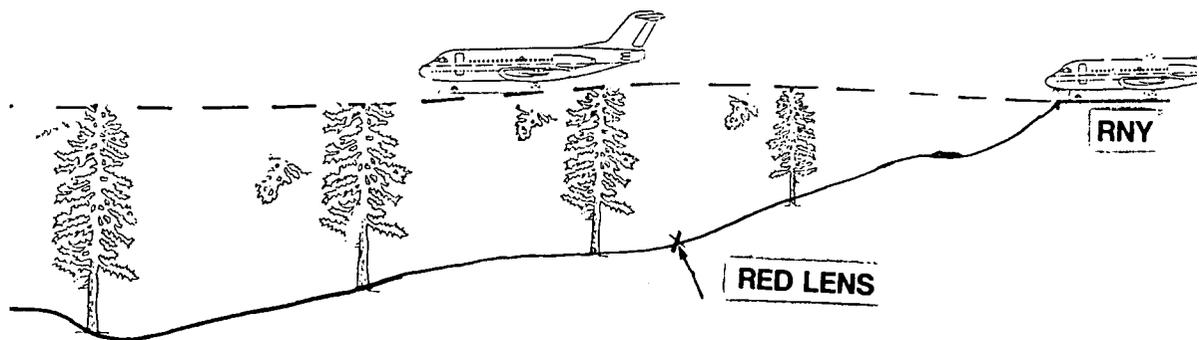
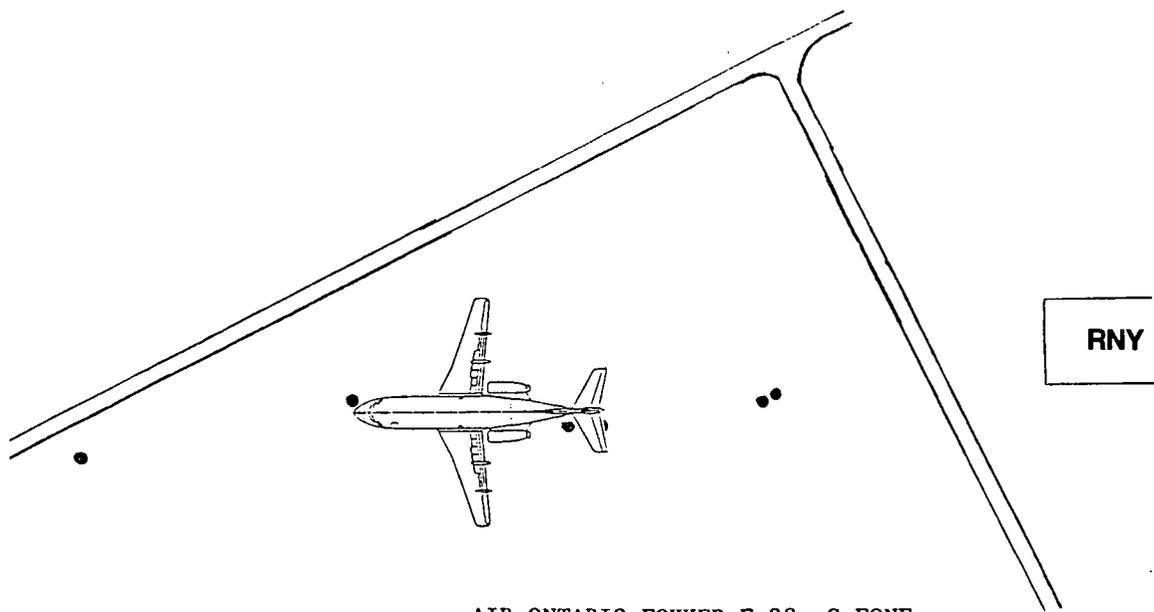
Figure 6-1 Aircraft Flight Plan Profile

AIR ONTARIO FOKKER F-28, C-FONF  
DRYDEN MUNICIPAL AIRPORT  
DRYDEN, ONTARIO  
CASB ENGINEERING  
PRELIMINARY PLOTS

- The takeoff roll then continued and the aircraft was rotated a second time, finally lifting off at approximately the 5700 mark of the 6000 foot runway. It flew over the end of the runway approximately 15 feet above the ground. It thereafter failed to gain altitude and mushed through the air in a nose-high attitude, before commencing to strike trees.

- The F-28 aircraft failed to gain altitude after takeoff, maintaining a flat, nose-high flight path until it began impacting trees 127 metres from the runway end. It barely cleared a treed rocky bluff 700 metres west of the runway before going down into a wooded area where it broke up into three sections, coming to rest 962 metres from the end of the runway.
