**PART FOUR**

**AIRCRAFT INVESTIGATION  
PROCESS AND ANALYSIS**

# TECHNICAL INVESTIGATION

## The Aircraft and Its Systems

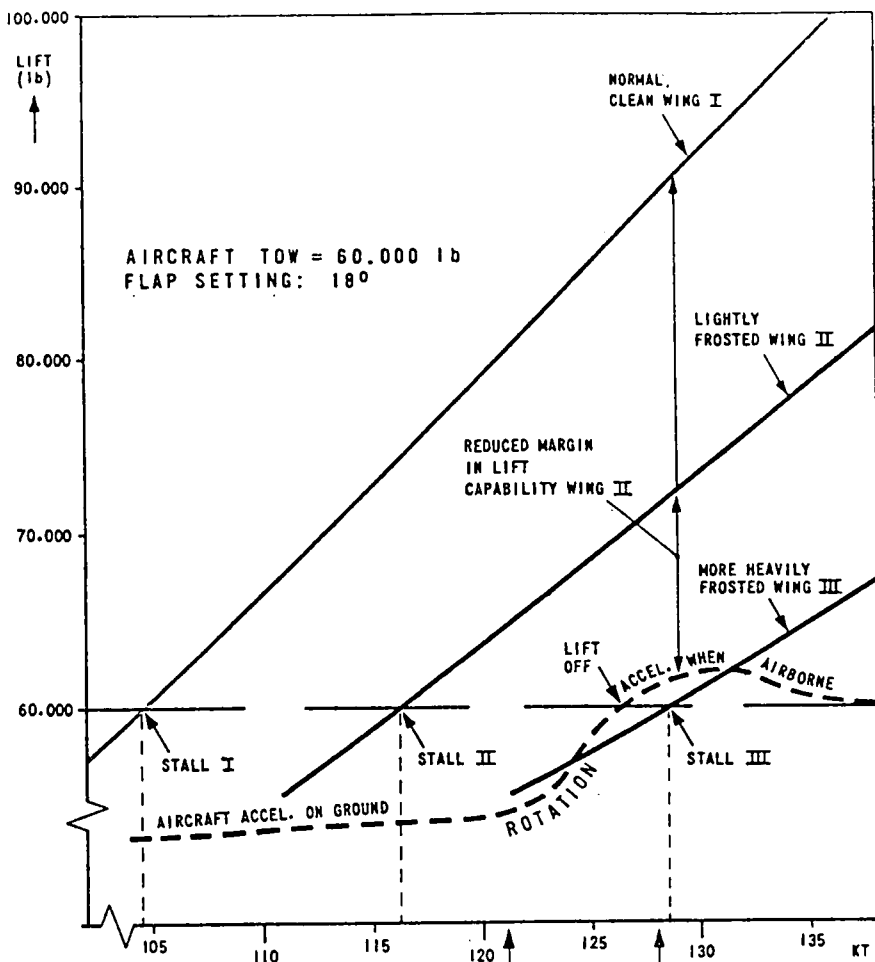
Figure 12-3 Comparative Margins for Two Arbitrarily Chosen Frost-Contaminated Wings and the Normal Clean Wing

SPEED MARGIN TO STALL AT	$V_R$	$V_2$
WING I	16.5 KT	24 KT
WING II	5 KT	12 KT
WING III	-	-

with more heavily frosted wings is unable to sustain flight because the wing is in a stall condition at rotation.

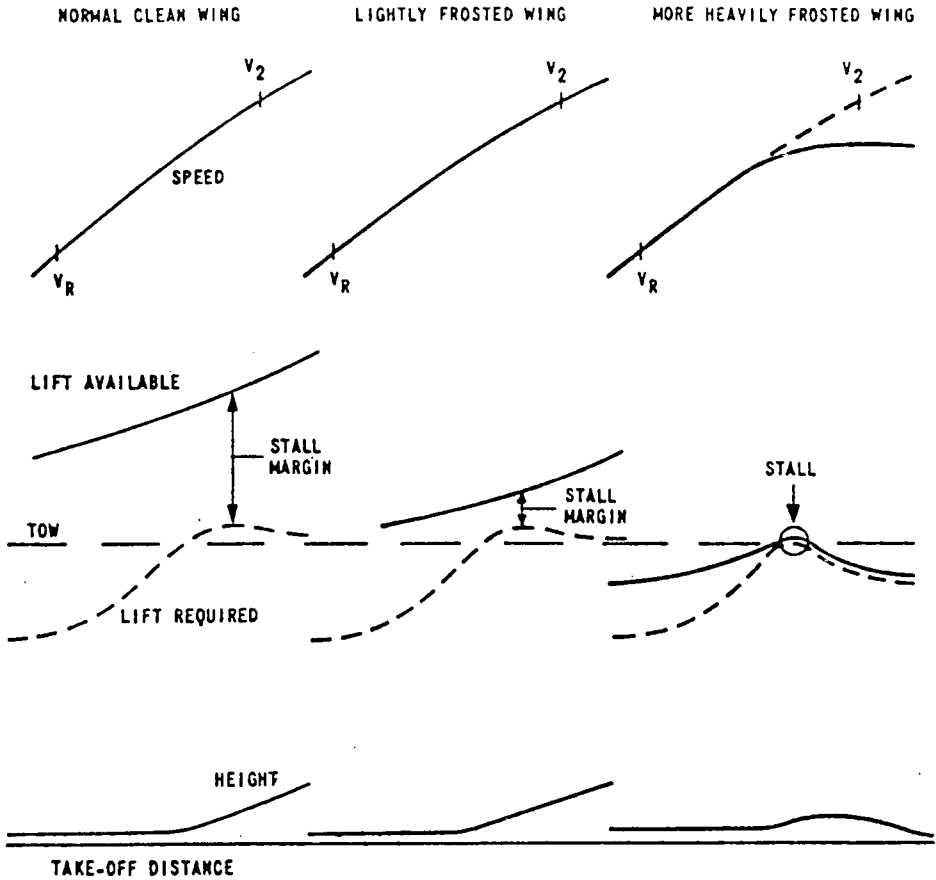
Figure 12-4 Comparative Stall Margins<sup>1</sup>

<sup>1</sup> Illustrates differently the comparative stall margins for the same (figure 12-3) two arbitrarily chosen frost-contaminated wings and the normal clean wing.

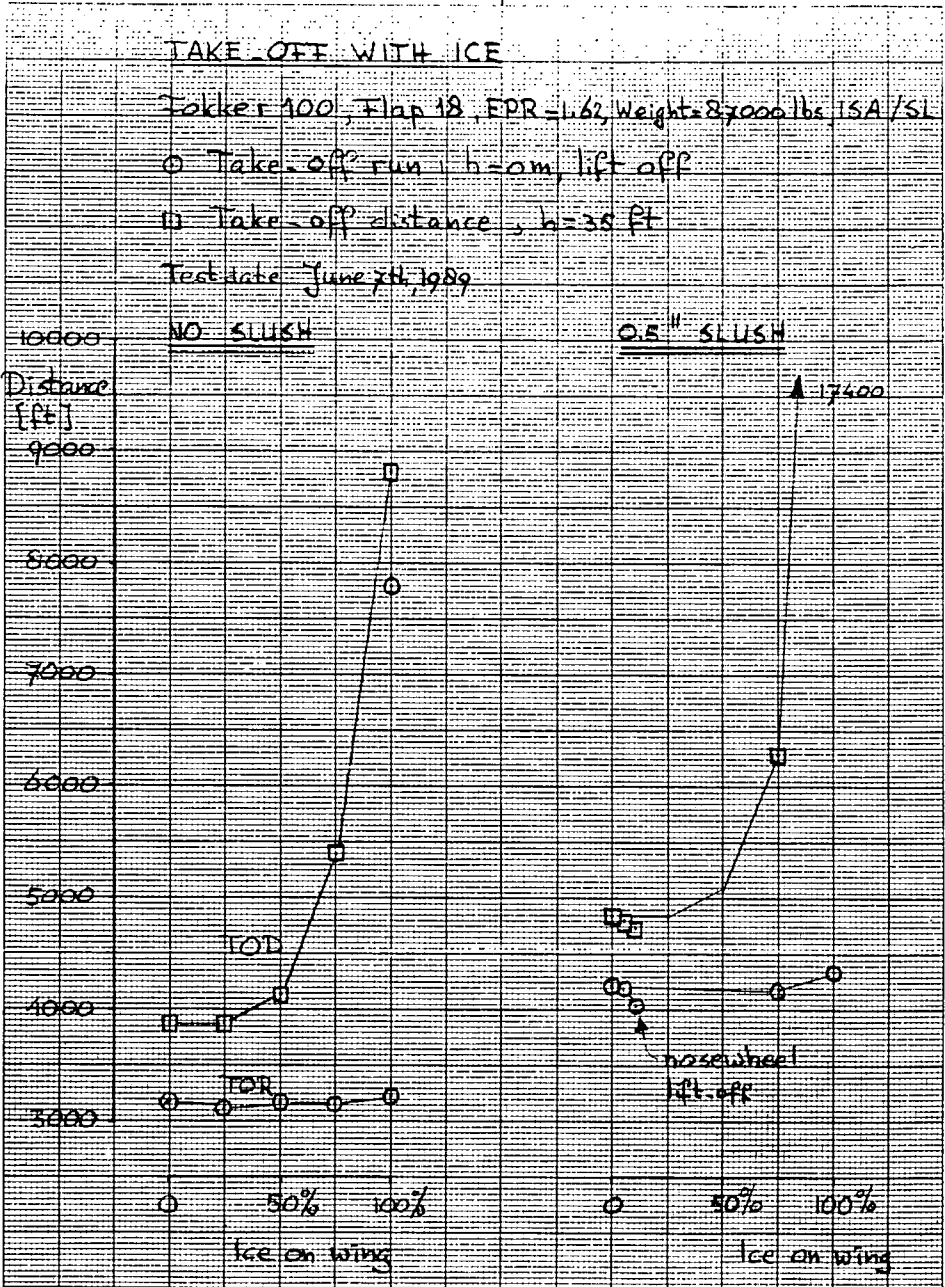
Figure 12-5 Fokker 100 Simulation of Takeoff with Ice, Flaps 18°

Figure 12-5 describes the Fokker 100 simulator with 18° of flap at sea level taking off with power and weight equal to full power on an F-28 at 63,500 pounds. By loading up the wing with contamination from 0, representing a clean wing, to 1.00, representing contamination in an amount equal to 1–2 mm diameter particles per square cm of wing surface, but with no runway slush, the takeoff run of the F-28 ranged between 3100 and 3250 feet. However, as contamination on the wing increased from 0.5 to 1.00, the takeoff distance increased from approximately 4150 to 8800 feet.

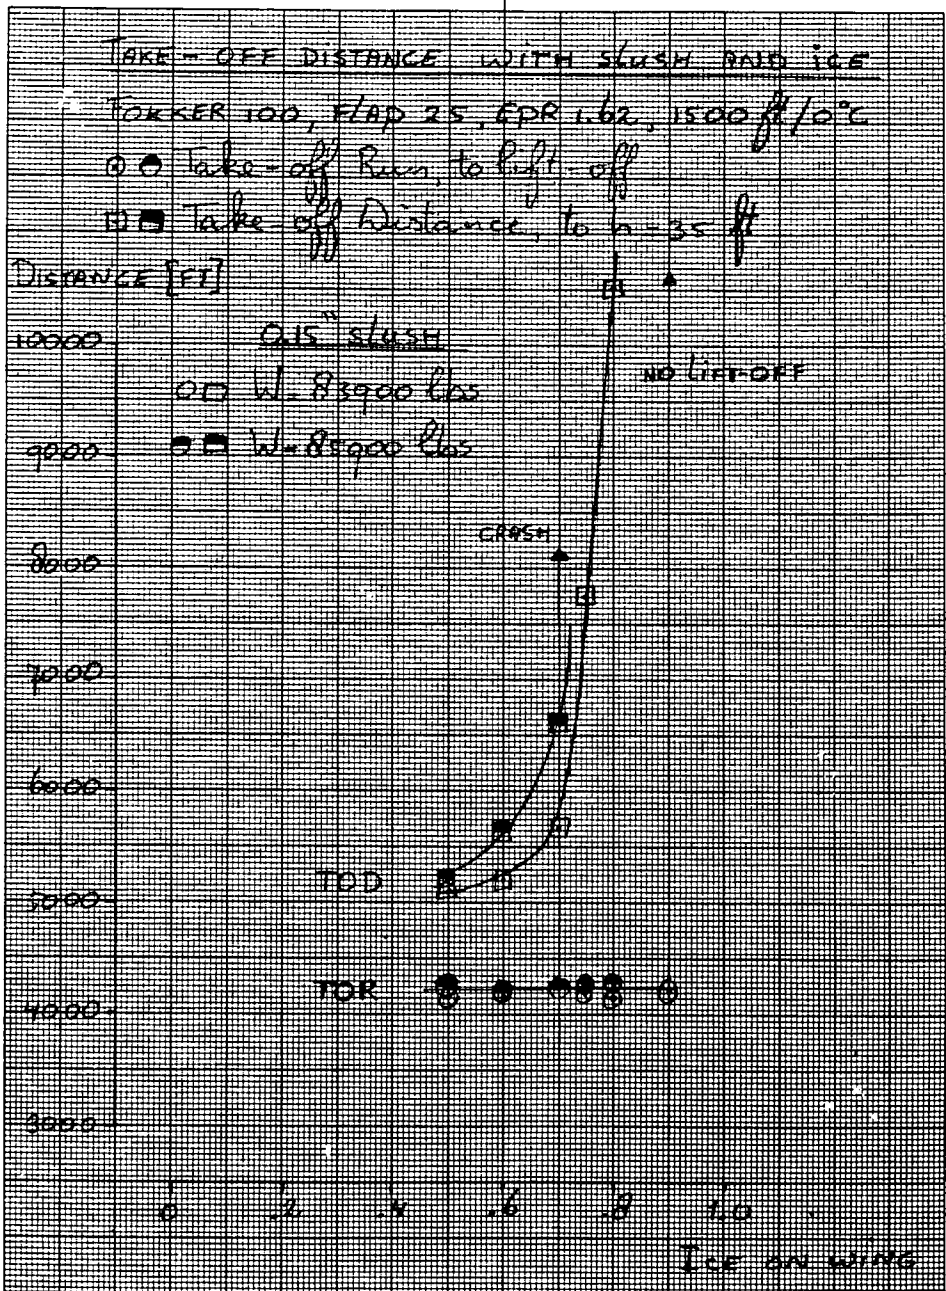
Figure 12-6 Fokker 100 Simulation of Takeoff with Slush and Ice, Flaps 18°

of slush and wing contamination, with a slow rotation the takeoff run increased by 10 m (32.8 feet) from 1545 m (5070 feet) to 1555 m (5100 feet) while the takeoff distance actually decreased 435 m (1427 feet) from 2285 m (7495 feet) to 1850 m (6070 feet).

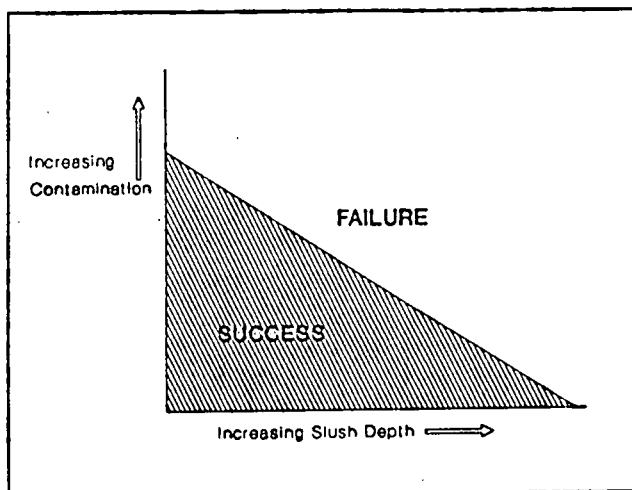
Figure 12-8 A Boundary Condition Plot for Successful Takeoff

Figures 8a-10b of the "Flight Dynamics" report illustrate in detail the various test runs. A review of the figures reveals that there are well-defined boundaries of slush depth and contamination level that either allow or prevent the aircraft from flying successfully. For example, with a rotation speed ( $V_R$ ) of 122.5 knots, a slush depth of 0.25 inches, and a wing-contamination level of 0.65, the aircraft flies away. At 0.68 wing contamination, the aircraft gets airborne, but, 500 feet beyond the end of the runway, it is only at 10 feet. At 0.69 contamination, the aircraft returns to the runway and runs off the end. In another example, with a rotation speed of 127.5 knots, a slush depth of 0.10 inches, and a wing-contamination level of 0.823, the aircraft flies away despite two bursts of stick-shaker. At 0.824 wing contamination, the aircraft height never exceeds 5 feet, and it eventually returns to the surface 1100 feet beyond

the end of the runway. The figures also demonstrate that pilot technique can have a marked effect on the success or failure of a takeoff.

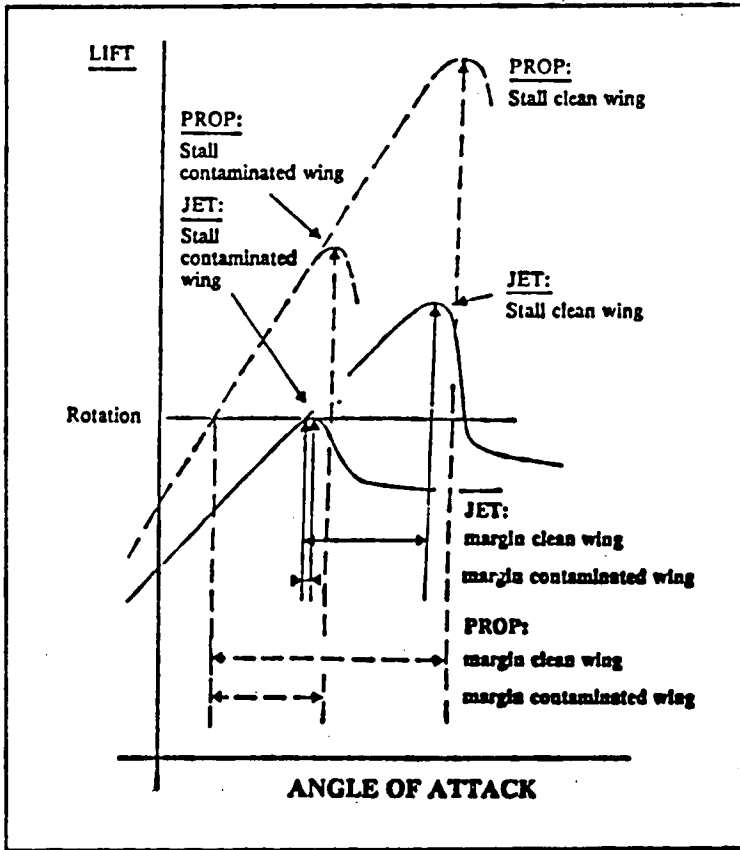
Figure 12-9 Jet- and Propeller-Driven Aircraft Comparison

It was determined that a clean wing with the benefit of high-energy propeller-driven airflow would achieve about 25 per cent additional maximum coefficient of lift ( $C_{LMAX}$ ) at takeoff speeds compared with the same wing without the benefit of propeller airflow. For a contaminated wing with propeller airflow, the  $C_{LMAX}$  would be similar to that of the

same clean wing without propeller airflow. For a contaminated wing of a propeller-driven aircraft where the propeller airflow is lost (engine stoppage), the  $C_{LMAX}$  would be approximately the same as that of a contaminated wing of an aircraft that does not have the benefit of propeller airflow (jet aircraft).
