## AVIATION INVESTIGATION REPORT

A08P0125

### LOSS OF ENGINE POWER AND COLLISION WITH TERRAIN

**BIGHORN HELICOPTERS INC.  
BELL 206B JET RANGER (HELICOPTER) C-GCHE  
CRANBROOK, BRITISH COLUMBIA  
13 MAY 2008**

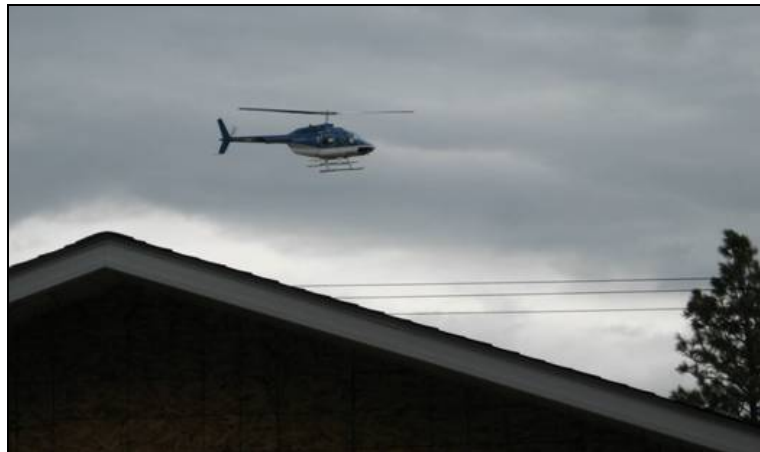
**Photo 1.** C-GCHE moments before the power loss

later, in the vicinity of 10th Street and 14th Avenue, the helicopter carried out several low-altitude manoeuvres (see Photo 1 and Appendix B – Cranbrook City Map), apparently examining the power lines in that area. It was flying south-southwest over 14th Avenue (midway between 7th and 10th Streets) at about 120 feet above ground level (agl) and 25 knots when the engine lost power (see Photo 2). The helicopter descended rapidly; the final few seconds of flight were uncontrollable and in free-fall from about 85 feet above the ground.

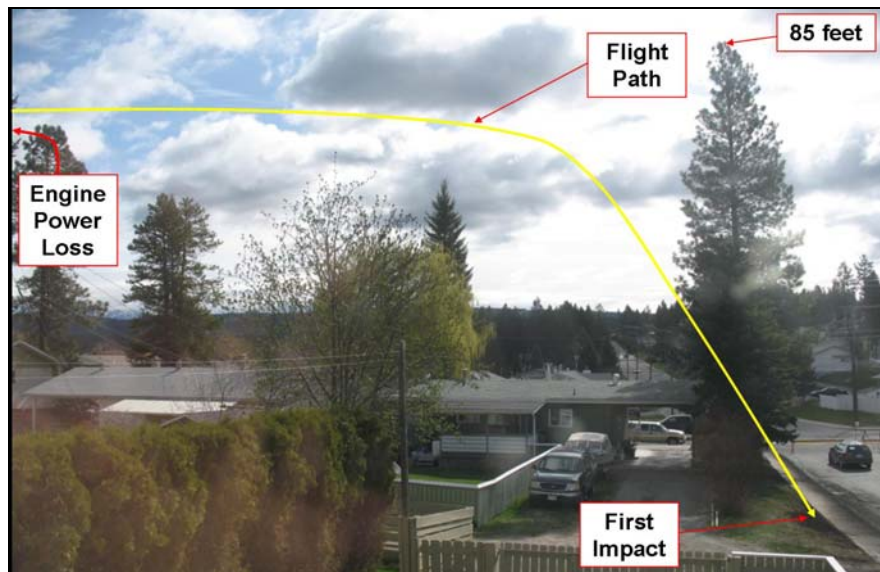
Photo 2. Final flight path

At the accident site, the direction of the final seconds of flight was essentially into the prevailing wind. The helicopter struck the gently rising ground on 10th Street South, about 300 feet west of 14th Avenue South. It was generally an open area but had several obstructions that the pilot may have tried to avoid during descent. On the east side of the crash site, there were two tall evergreen trees, with the higher being about 85 feet tall. As well, there was a set of residential power lines running north-south, and a residence below (see Photo 2). Given the relative positions and motions of the car, the helicopter, the pedestrian, and the trees, it is unlikely that the pilot saw either the pedestrian or the car before impact.

During the last two seconds of flight, the helicopter descended almost vertically to the street in a nose-up, left-side-down attitude. The tail boom stinger and tail rotor blades struck the ground first, causing the tail rotor gearbox section to break off. The main fuselage then struck the street with such force that the landing skids broke up and the cabin, engine and transmission platform, and airframe structure collapsed, bursting the fuel cell. The helicopter slid forward about 20 feet, rotated about 200°, and came to rest heading opposite to its flight path. Both rotor blades were intact and street-impact damage to one blade was confined to the outboard three-foot section. Seconds after impact, a fire began and, within a minute, it had intensified into a fierce fuel-fed fire, with a large stream of burning fuel flowing down the street gutter. The Cranbrook Fire Department arrived within four minutes of the crash and extinguished the fire; about 60 per cent of the helicopter was consumed. The engine, main transmission, and rotor head survived the fire. Some components thrown free during breakup were unaffected by the fire.

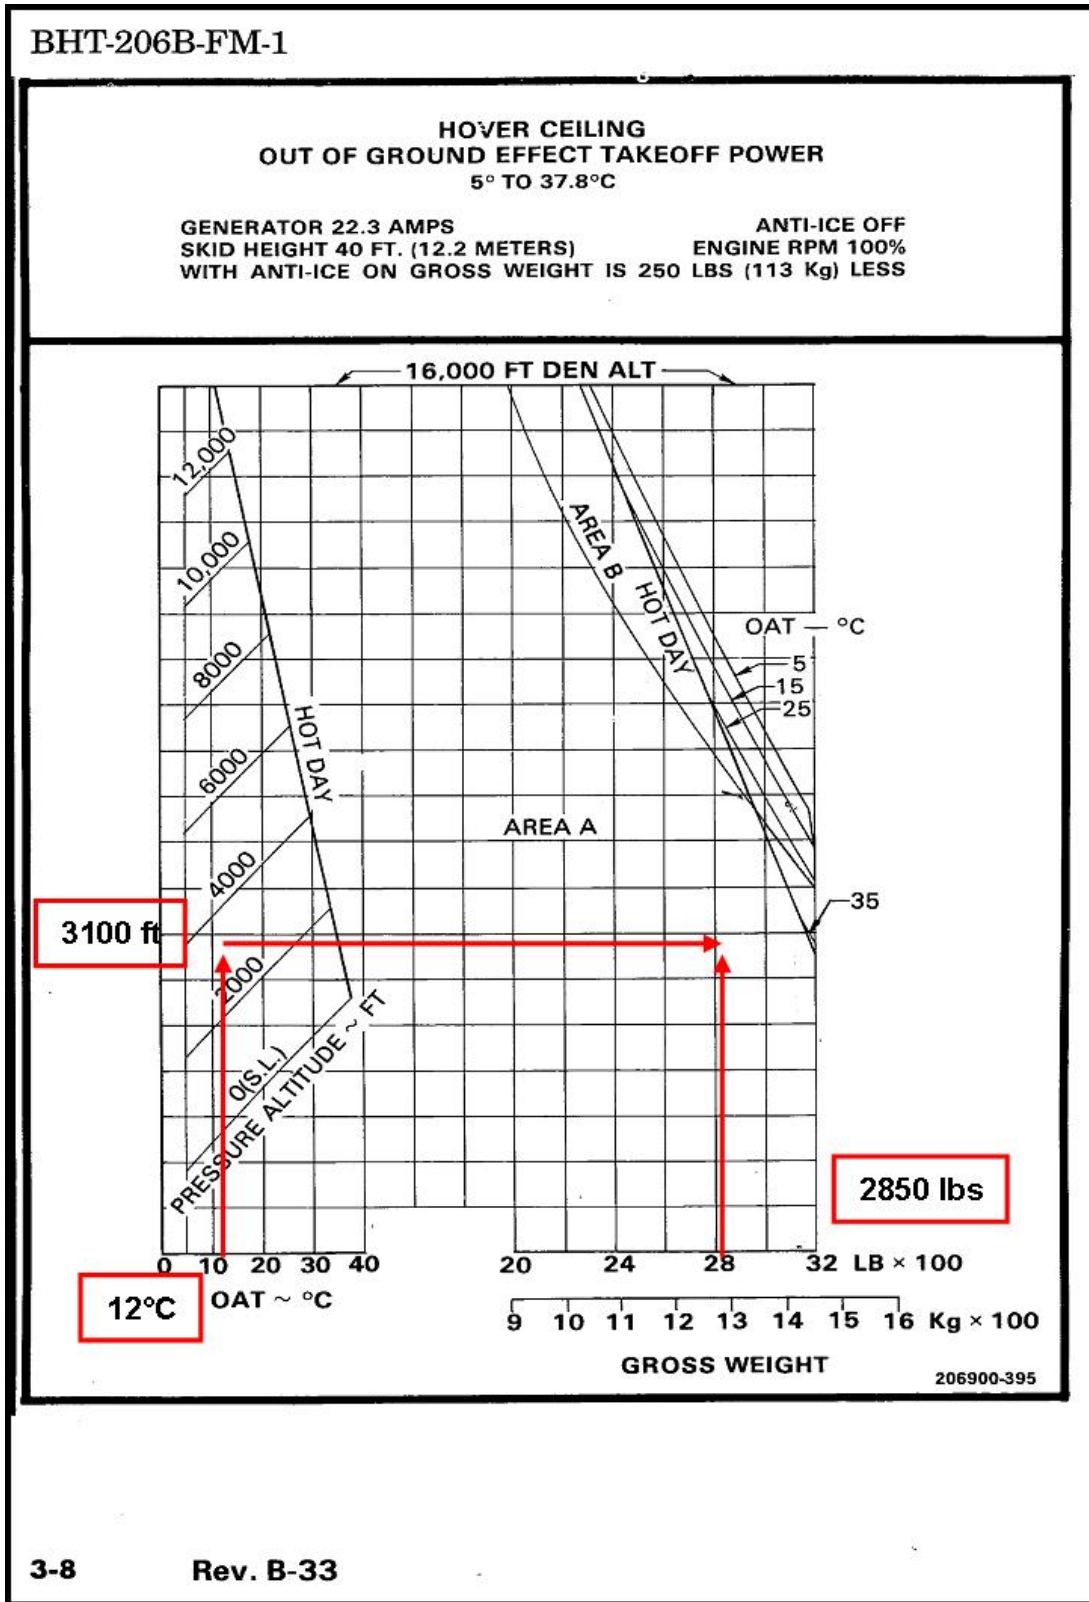
# Appendix C - Hover Ceiling Out of Ground Effect (HOGE)

The crash site was about 3100 feet above sea level (asl) and, with an air temperature of 12°C, the density altitude would have been in the order of 3400 feet asl. With reference to the Bell 206B RFM, the hover ceiling out of ground effect (HOGE) chart ensures that the helicopter can hover without the performance benefit of ground effect, by providing a maximum allowable gross weight for varying conditions of pressure altitude and outside air temperature. For the environmental conditions at the time of the accident, the HOGE chart showed that the weight of the helicopter with the three occupants on board would have been within the HOGE performance capability of the helicopter (see Appendix C - Hover Ceiling Out of Ground Effect).

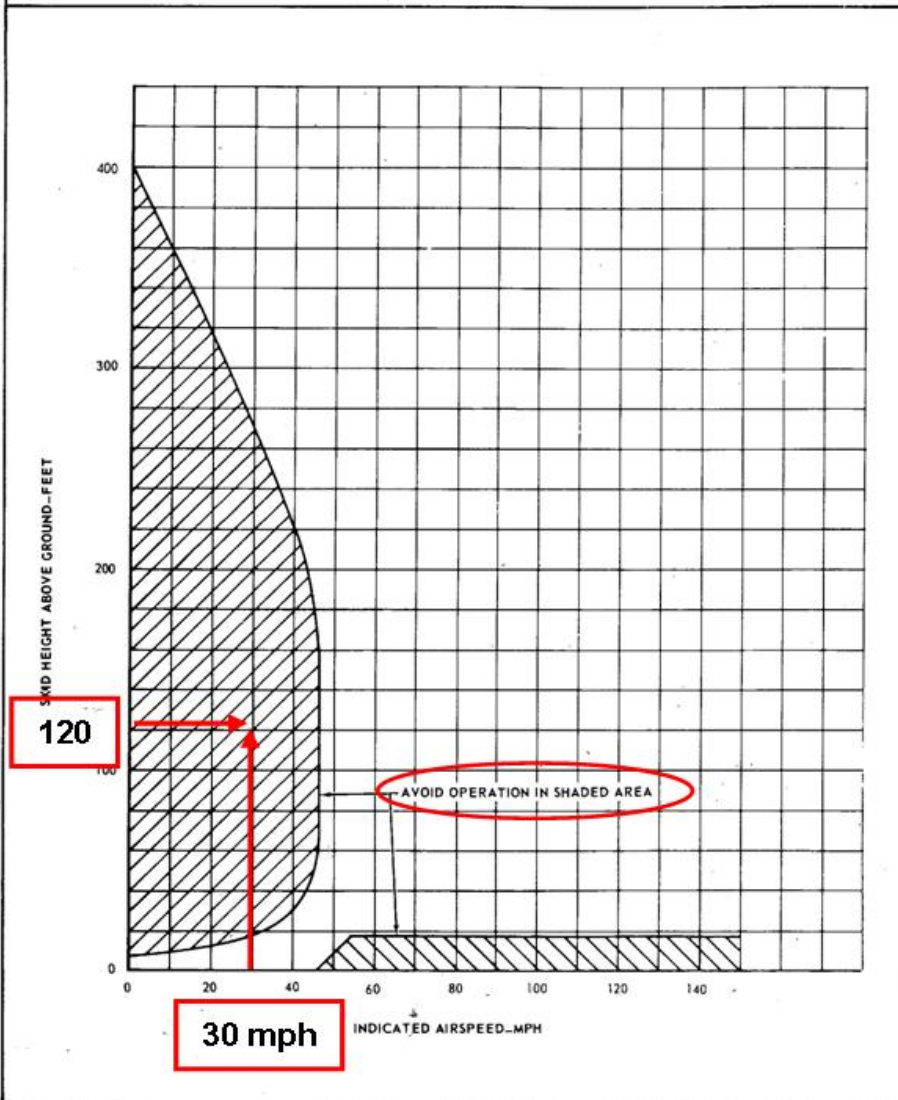
# Appendix D – Height Velocity Diagram

The two-part HVD for the Bell 206B is contained in Section 3 – Performance of the RFM and is shown in Appendices D and E of this report. Note that the airspeed is referenced in miles per hour (mph). The HVD shows that a pilot should not expect to establish full autorotation from heights between 40 and 200 feet above the ground, unless the airspeed is above 45 mph. In the case of C-GCHE, the helicopter was at about 120 feet agl and travelling at about 30 mph; with such height and speed, the helicopter could not have achieved full autorotation before it struck the ground.

In reviewing the accident flight path, it can be seen that the helicopter was frequently exposed to the higher-risk avoid zones of the HVD during its passage over the built-up areas of Cranbrook. Under these conditions, the helicopter would not have had sufficient altitude or time to develop autorotative flight following a sudden loss of engine power. As a result, the pilot would have had no opportunity to conserve rotor rpm and a high rate of descent would have developed rapidly. Any manoeuvring by the pilot to avoid obstacles would have exacerbated this deteriorating condition.
