**AVIATION INVESTIGATION REPORT
A08O0189**

BOUNCED LANDING/GO-AROUND AFTER TOUCHDOWN

KELOWNA FLIGHTCRAFT AIR CHARTER LTD.

BOEING 727-227 C-GLKF

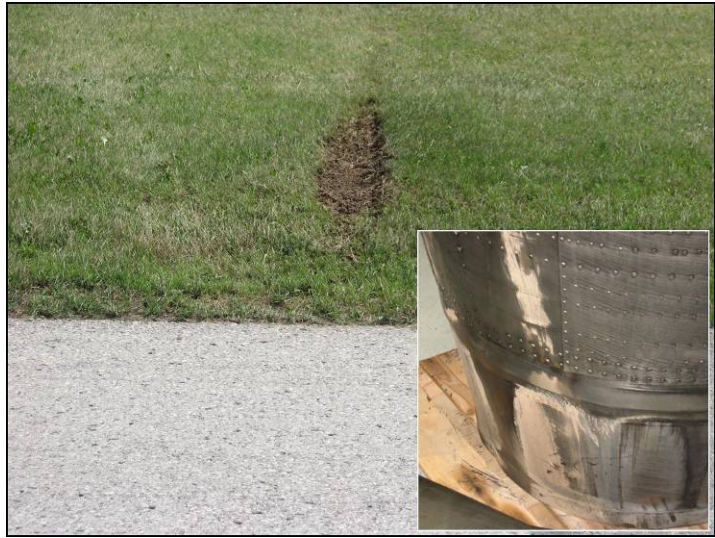
After the occurrence, airport personnel inspected Runway 06. They found a 12-foot-long ground scar in the turf off the end of the runway, starting approximately 44 inches from the hard surface and parallel to the runway heading. The scar was up to 9 inches wide and 2 inches deep (see Photo 2), and was caused by the number 2 engine thrust reverser actuator fairing and tailpipe.

There was some dirt and grass found in the number 2 engine cascade vane openings.

Photo 2. Ground scar from number 2 engine tailpipe (inset)

However, in this occurrence, the go-around was initiated with the spoilers deployed. This resulted in added drag that precluded a safe lift-off and caused the tail and the number 2 engine to strike the ground. While the manufacturer's manual contains guidance on how to respond to a bounced landing event, during simulator training, crews are not required to conduct the bounced landing recovery procedure. Furthermore, this crew had not practiced the go-around after touchdown manoeuvre during simulator training. Therefore, they were never exposed to either scenario and never had the opportunity to learn to retract the spoilers when conducting a go-around.
