Transportation Safety Board
of Canada

**AVIATION INVESTIGATION REPORT
A13O0049**

RISK OF COLLISION

**BETWEEN
KELOWNA FLIGHTCRAFT AIR CHARTER LTD.
BOEING 727-281, C-GKFJ
AND
AIRPORT MAINTENANCE VEHICLES (SNOW SWEEPERS)
HAMILTON AIRPORT, ONTARIO
19 MARCH 2013**

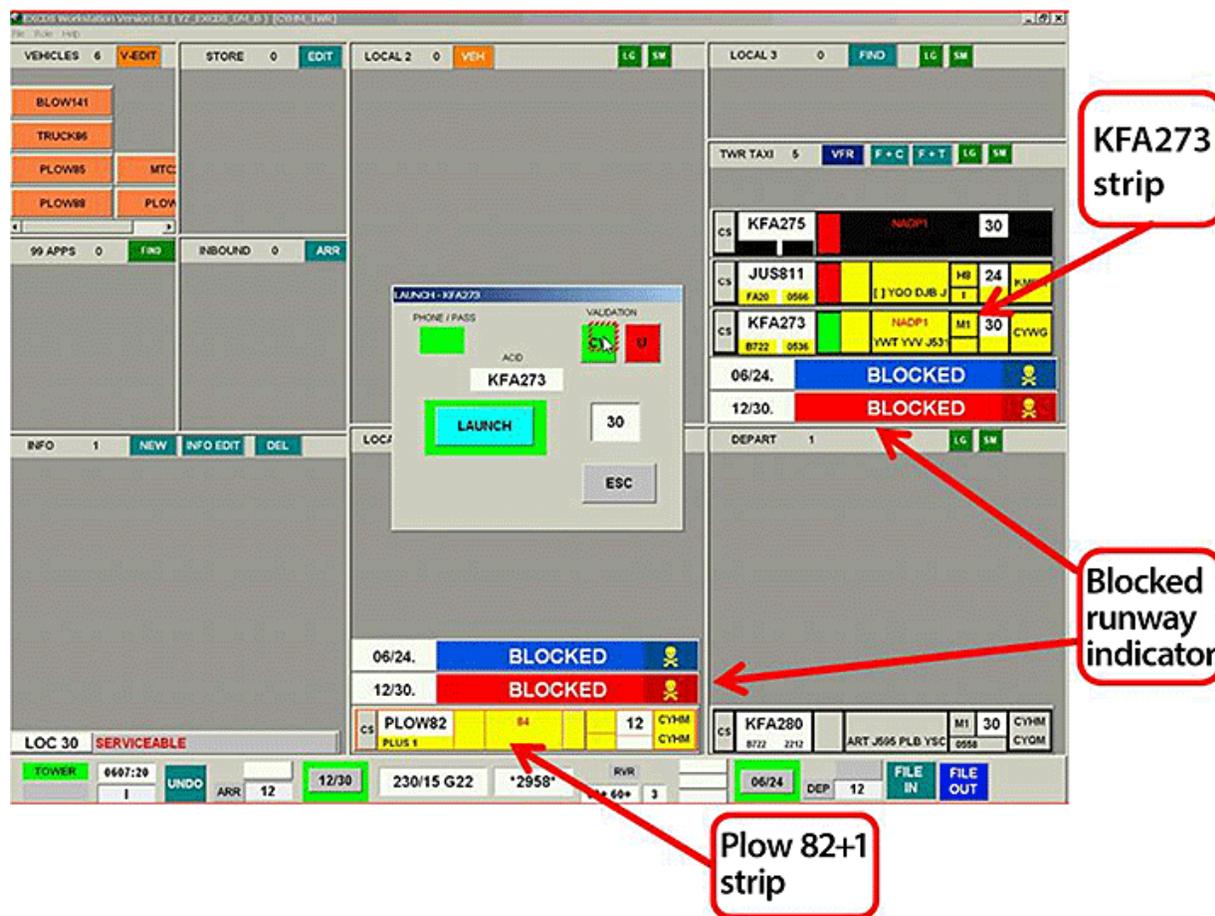
Figure 1. The display on the extended computer display system (EXCDS) at the time of take-off clearance of KFA273

As the controller began issuing the take-off clearance to KFA273 (Appendix A), the EXCDS display was scanned; however, the blocked-runway indicator was overlooked. As the controller was uttering the words “cleared for take-off Runway 30”, a visual scan of the runway surface was completed, and the snow sweepers were noticed. The controller paused for a second without releasing the push-to-talk button (PTT), and then used the non-standard phrase “actually standby”. When the PTT was released, the controller heard the aircraft respond “273”.

The NAV CANADA *Hamilton Air Traffic Control Tower Unit Operations Manual* requires⁷ that a blocked-runway indicator (Figure 1) be placed by a controller over the appropriate runway header on the EXCDS display, to serve as a visual reminder when the runway is occupied or unavailable. Aircraft are not to be cleared for take-off or landing on a particular runway when a blocked-runway indicator occupies that position on the display, and this display in addition to the entire runway surface is to be viewed as part of the controller's scan before such a clearance is issued. EXCDS recordings for 4 hours surrounding the occurrence showed that aircraft

departed on runways that had a “blocked runway” depiction at least 3 other times, although in all 3 cases, the runway was not in fact physically occupied.

Repeated exposure to a warning or reminder can result in the user becoming habituated to the warning, in turn resulting in the failure of the reminder to attract the attention of the operator.⁸ More specifically, the practice of authorizing aircraft to arrive or depart on a runway for which a blocked-runway indicator is showing serves to desensitize the controller to the importance of the blocked-runway indicator. This desensitization reduces the effectiveness of the indicator as a defence and increases the risk of aircraft being authorized to use a runway that is unavailable.

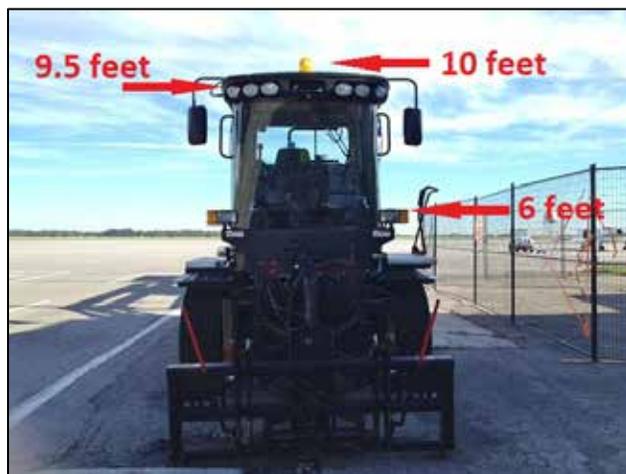
Figure 2. A CYHM snow sweeper

As required by Transport Canada's *Aerodromes Standards and Recommended Practices*, snow sweepers must have a beacon light installed. The snow sweepers have a beacon installed 10 feet above the ground on the top of the cab. Additionally, the snow sweepers are equipped with 6 white floodlights situated at 9.5 feet above the ground, and 2 headlights at 6 feet above the ground (Figure 2).

The snow sweepers were operating as designed, with no mechanical failures.

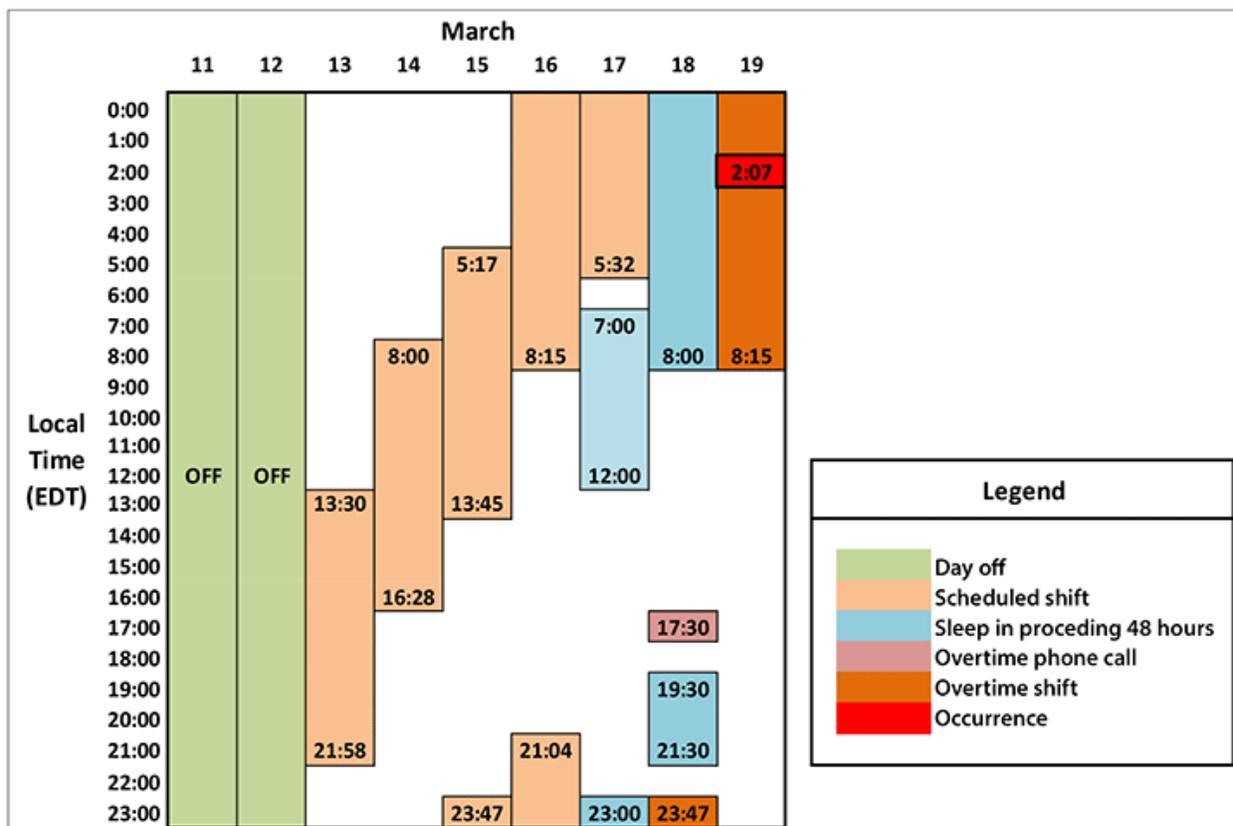
Figure 3. The controller’s schedule

CYHM tower is a 24-hour facility. During the week prior to the occurrence shift, the controller had worked 5 regularly scheduled shifts, with start times that varied from early morning to late night (Figure 3). On the controller’s first scheduled day off, 18 March 2013, an unscheduled overtime shift arose, and the controller was called at 1730 and given the option to work that shift. The controller initially declined; however, in response to a second phone call, once informed that no one else had volunteered, the controller accepted. The overtime shift was to begin at 2347. In an effort to be rested, the controller obtained 2 hours of sleep before the shift began.

The controller reported feeling fatigued at the time of the occurrence, and occasionally had difficulty getting adequate sleep during this type of shift rotation.

- The shift rotation was counter-clockwise, meaning that the controller would be sleeping and waking at progressively earlier times.
- The controller had 10 hours off between finishing the early day shift at 1345 and starting the first midnight shift at 2347. Assuming a 45-minute commute each way to work, plus time for meals, personal hygiene, and any family and social responsibilities, the controller does not have an 8-hour opportunity for sleep between these 2 shifts. This shift pattern was observed 6 times during the 70 days preceding the occurrence.

Based on known fatigue risk factors and the predicted sleep, the quantitative analysis showed low predicted effectiveness occurred during a large proportion of the night shifts. The following risk factors were noted:

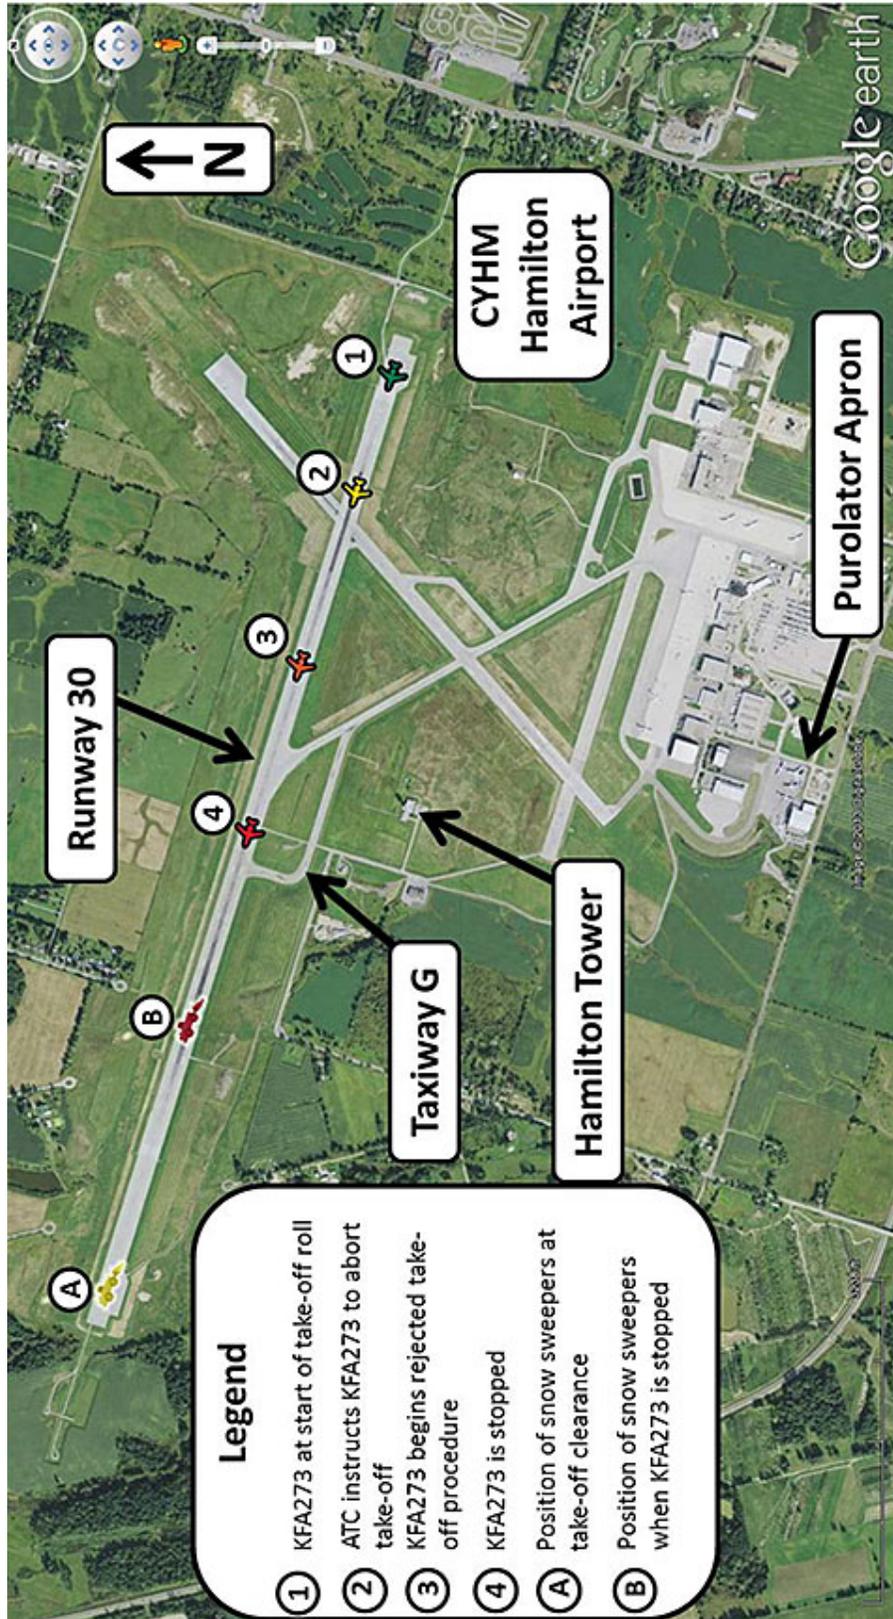
Appendix B – Visual depiction of event

When viewing the airport environment (Appendix B) from the tower cab, the Purolator Apron is approximately 90° to the right of the Runway 30 threshold. As the controller was issuing taxi instructions to KFA271 and viewing the Purolator Apron, KFA273 began its take-off roll and, as the runway was out of the controller’s direct view, this movement went unnoticed for 22 seconds.

The aircraft was brought to a stop approximately 1700 feet following initiation of the RTO, at a position 4800 feet from the threshold and approximately 1200 feet short of the snow sweepers (Appendix B).
