REPORT OF THE MISSISSAUGA RAILWAY ACCIDENT INQUIRY

THE HONOURABLE MR. JUSTICE SAMUEL G.M. GRANGE
SUPREME COURT OF ONTARIO
COMMISSIONER

December 1980

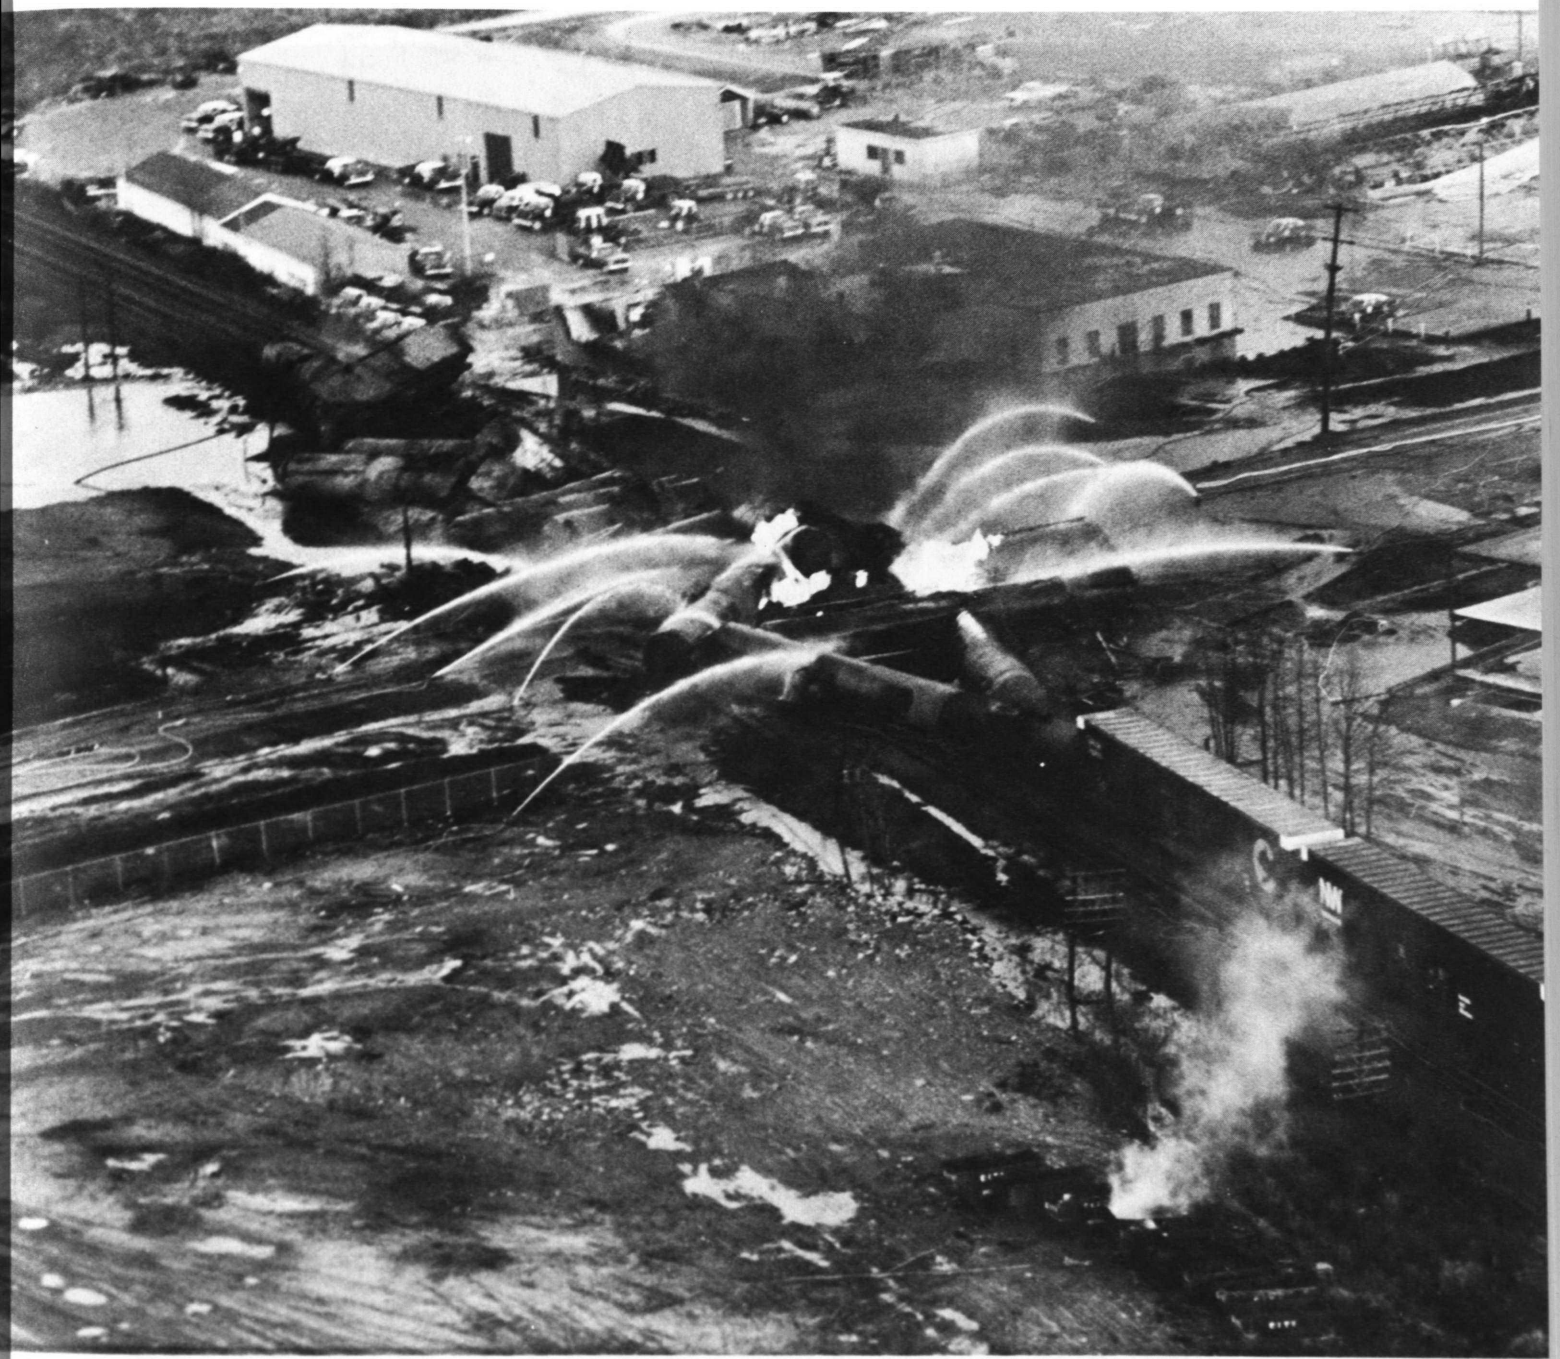
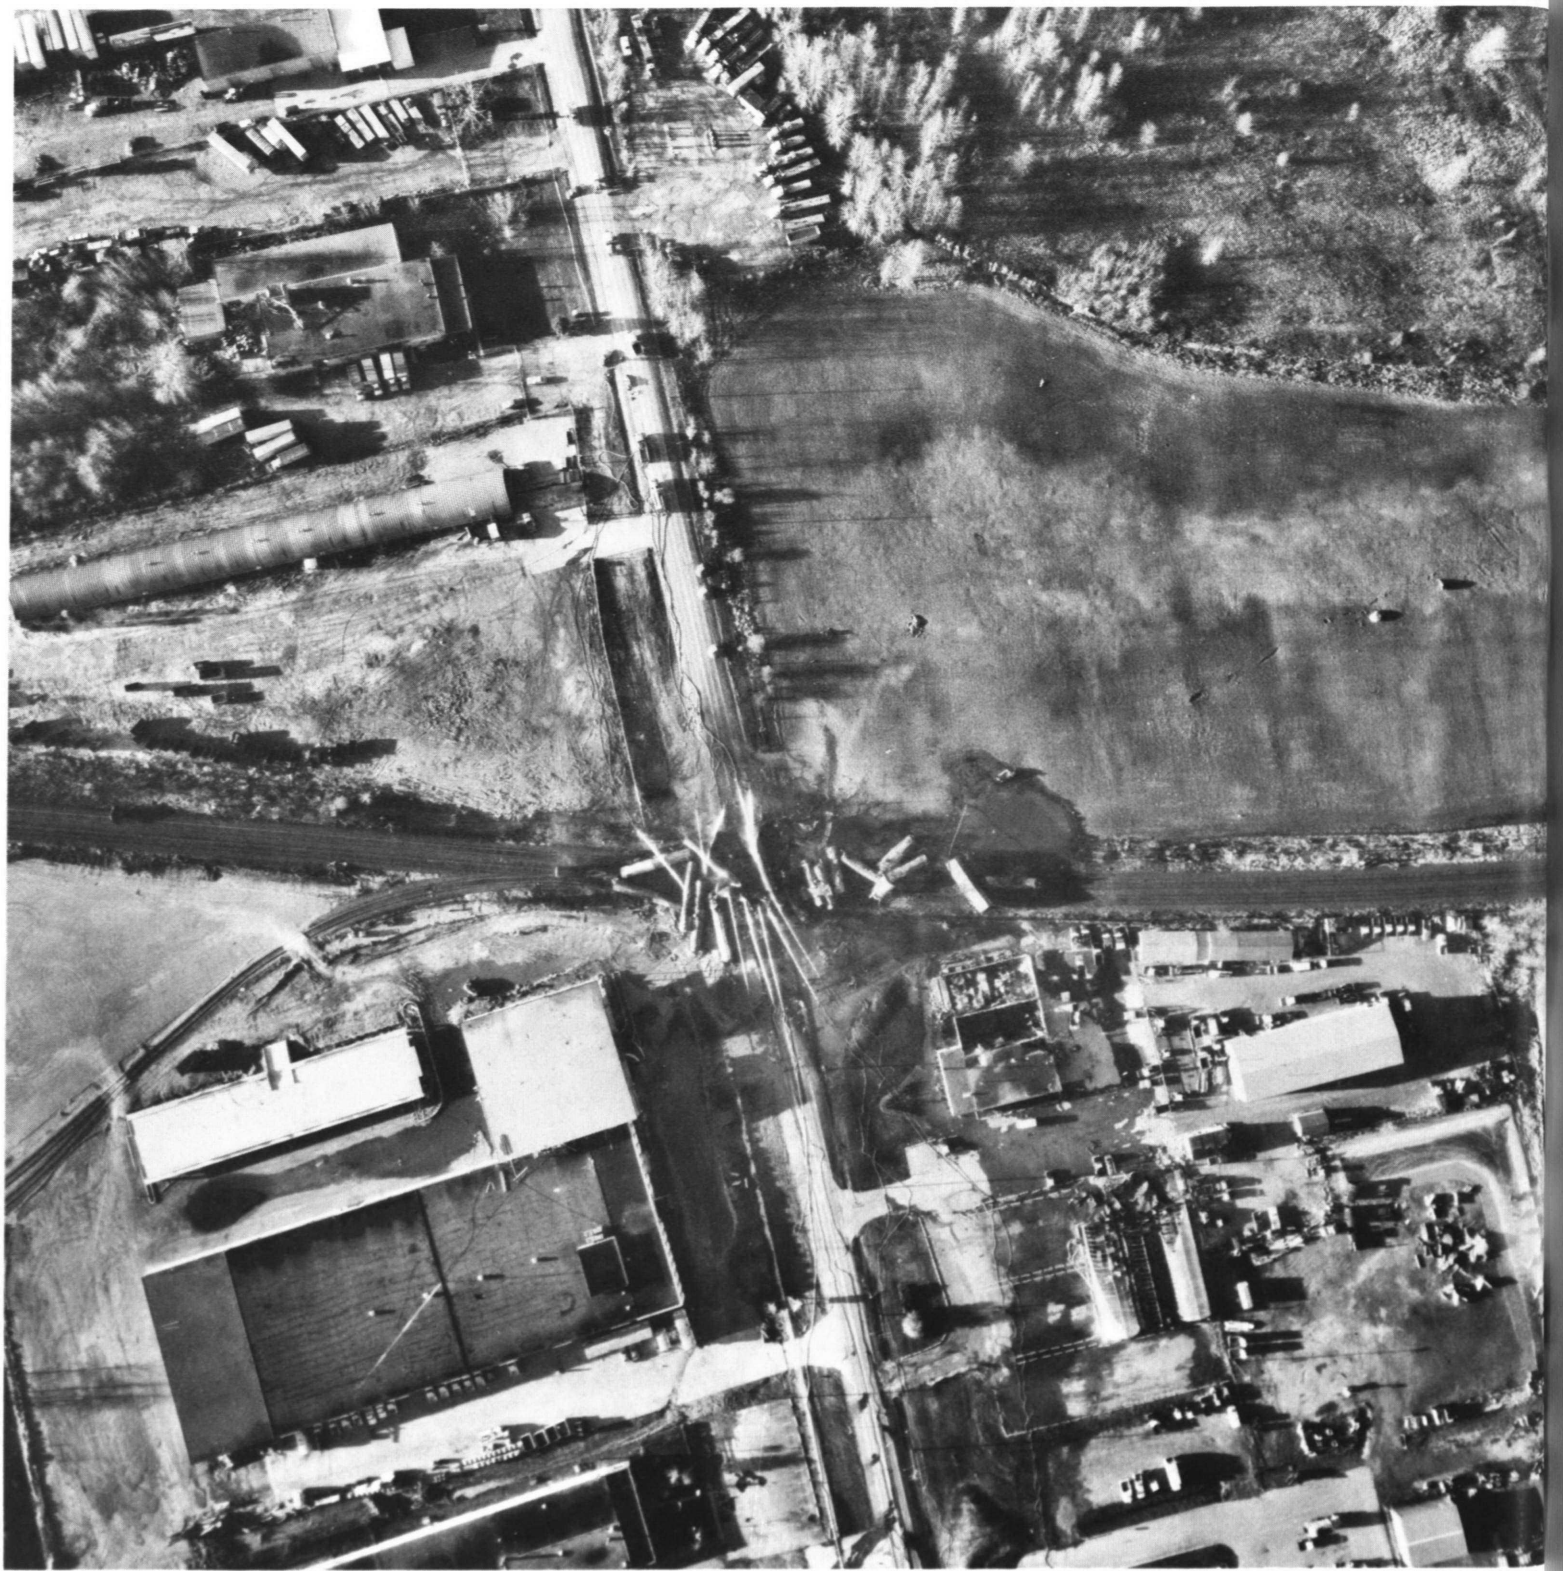
There is really no problem about the cause of the derailment. The Toluene car suffered a "hot box" in its right-rear journal box. Almost all railway cars have eight wheels upon four axles which are numbered one to four from the "B" end of the car. The cars can go in either direction, but for reference purposes one end is labelled "A" and the other "B"; the "B" end is the end where the hand brake is to be found. The axles and wheels are lettered "L" for left and "R" for right looking from B to A. The hot box therefore was in the R1 position. The axles at their extremities are called journals. These journals bear the weight of the car and are housed in journal boxes. The two forward and two rear axles are connected by side frames of which the journal boxes are a part and the whole assembly in front is called the leading truck and the whole assembly behind is called the trailing truck. Inside the journal boxes are bearings resting upon the constantly revolving journals. Some of these bearings—the modern ones—are roller bearings, but the majority and the ones in the Toluene

car (Car 1) were of the friction or plain bearing type. In the plain bearing arrangement a wedge rests upon a brass (the actual bearing) which rests upon the journal with a lubricator pad (soaked in oil) beneath the journal supplying the lubrication which is so sorely needed between the brass and the journal. If for any reason the lubricator pad ceases to perform its task, the bearing and journal will be in direct contact and the journal will start to overheat. Eventually and inevitably if unattended, the journal will burn off and the tank car will collapse. With Car 1 the rear axle, together of course with its two wheels, separated from its truck and the car over a mile short of the derailment site. The car proceeded on its six wheels to and past Erindale Station Road where apparently the front wheels of the trailing truck, i.e. R2 and L2 derailed. The wheels however did not then detach and the car proceeded on its 6 wheels, 4 on the rails and 2 off, almost to Mavis Road where the remaining wheels hit a switch and the whole car derailed. The other 23 cars then followed it off the track.
