THE OCEAN RANGER

CHAPTER TWO THE OCEAN RANGER

CHAPTER THREE MANNING

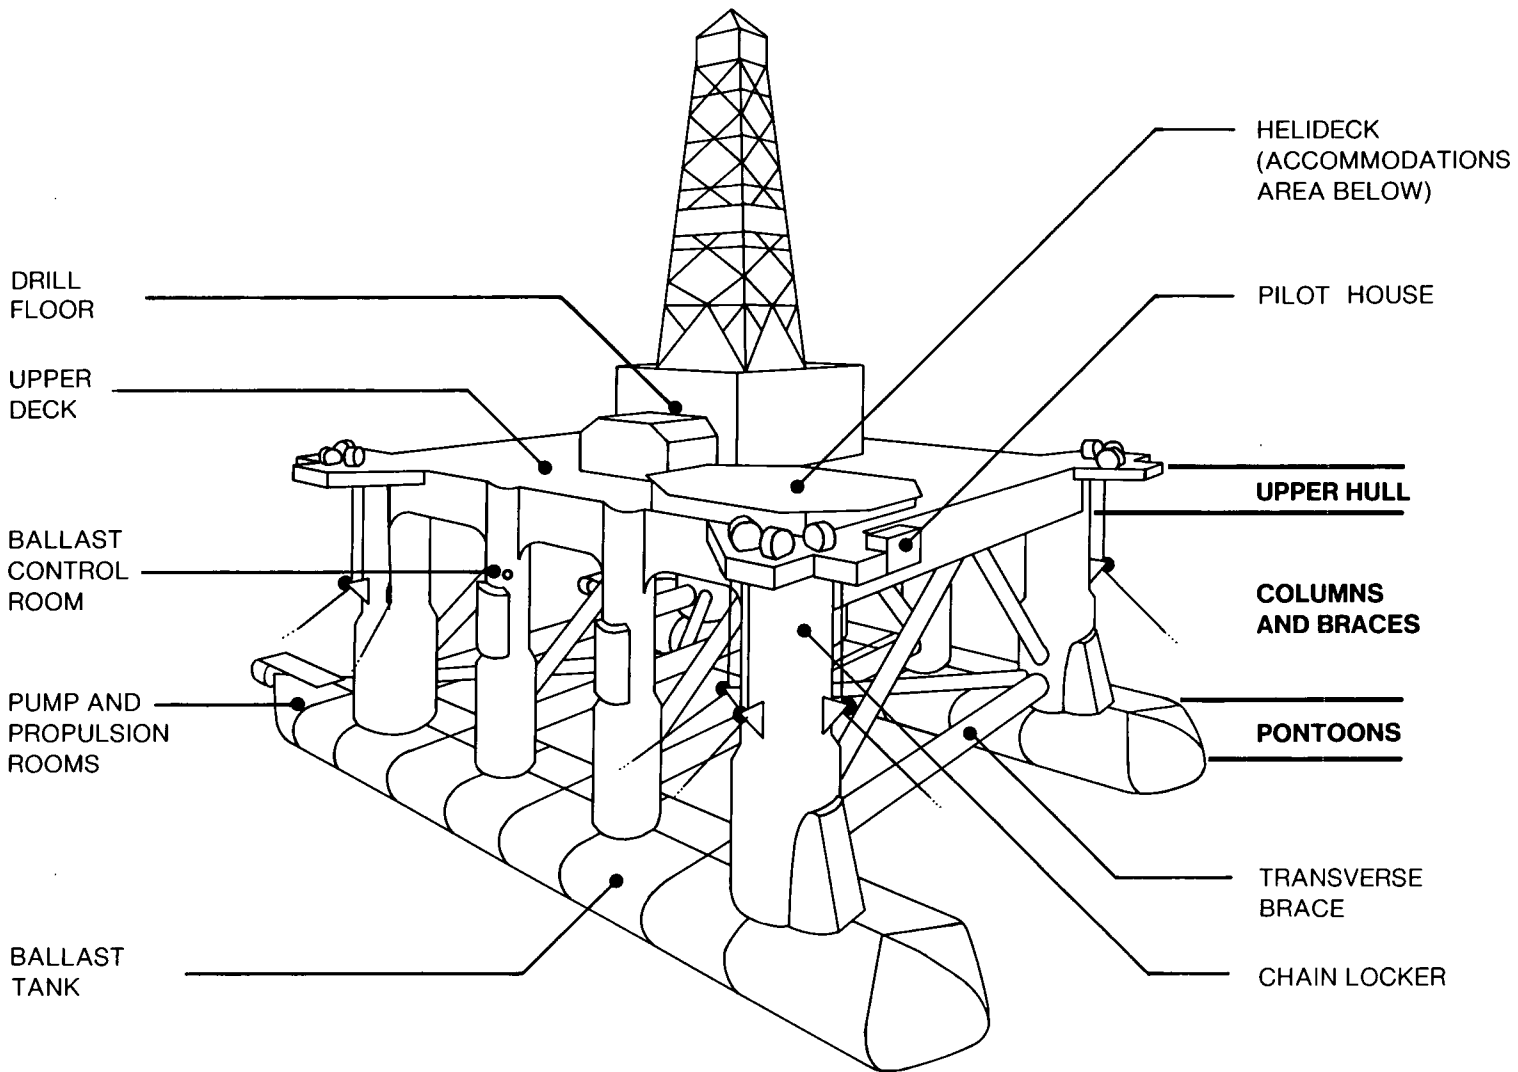
2.1 This illustration outlines the major structural components and working areas of the *Ocean Ranger*. The pontoons, 406 feet long, lay 80 feet below the surface when the rig was drilling.

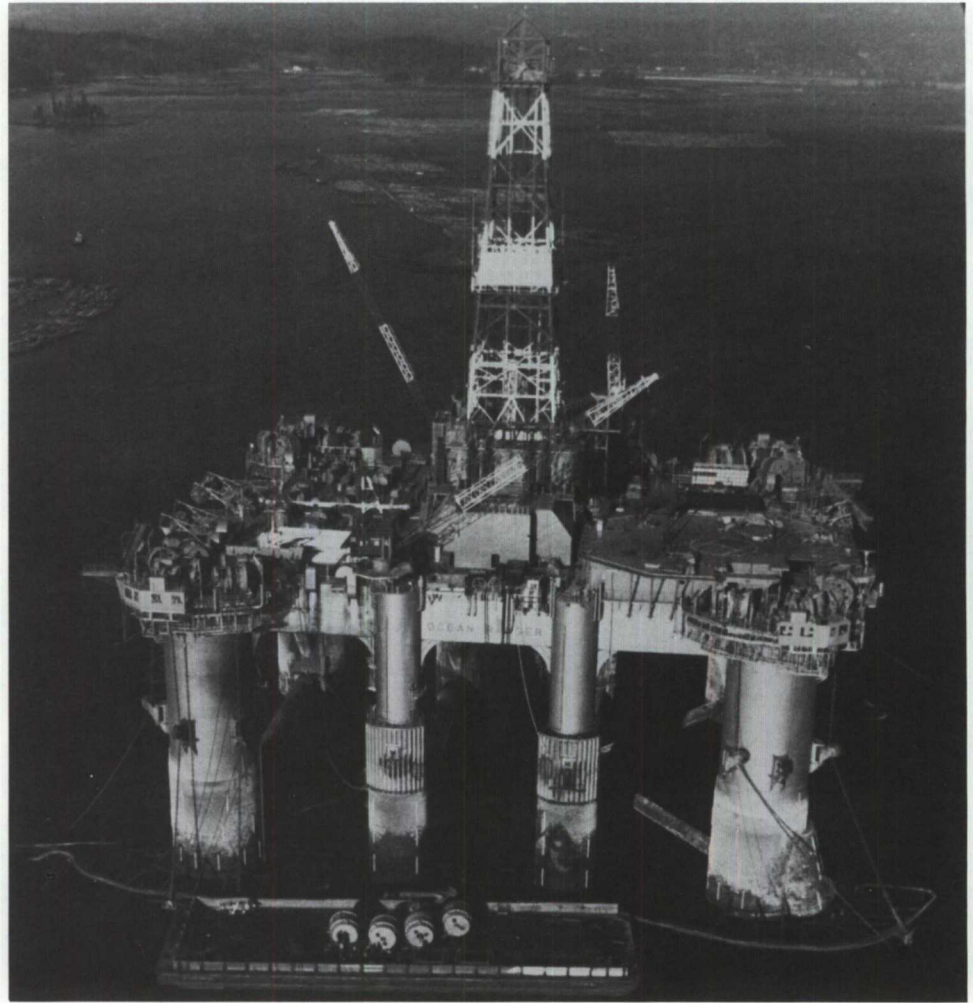
2.2 The *Ocean Ranger's* 12 anchor windlasses were replaced at the shipyard in Port Alberni, British Columbia, during 1979.

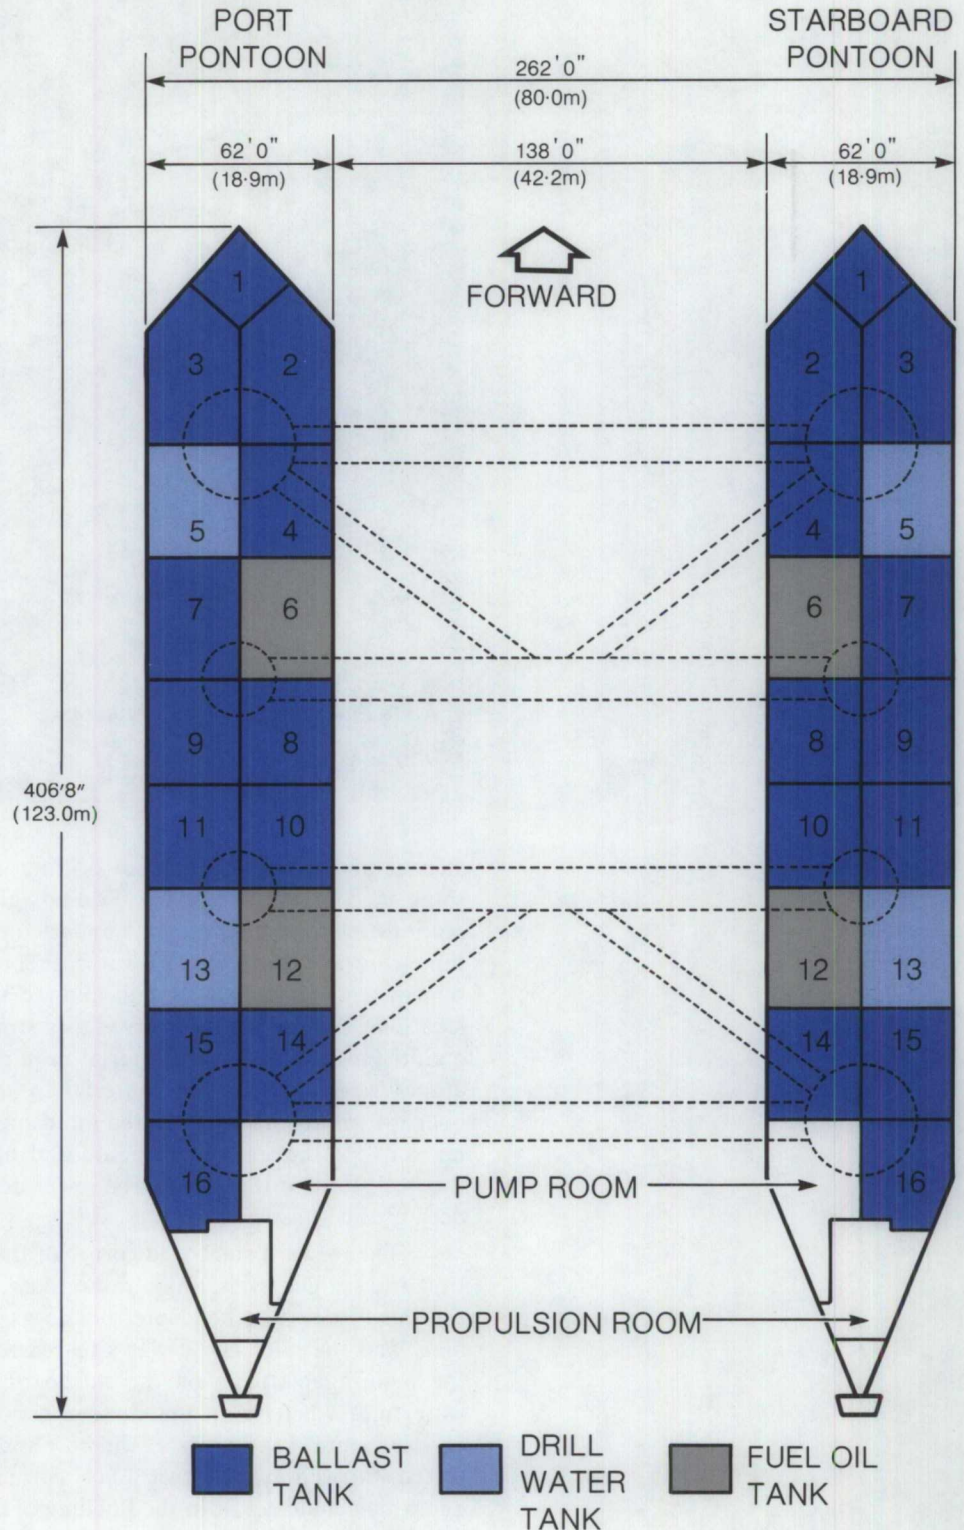
2.3 Of the 32 pontoon tanks, 24 were used to store ballast water, with the remainder used to store drill water and fuel oil. The ballast control room was located in the column above starboard tanks 10-13.

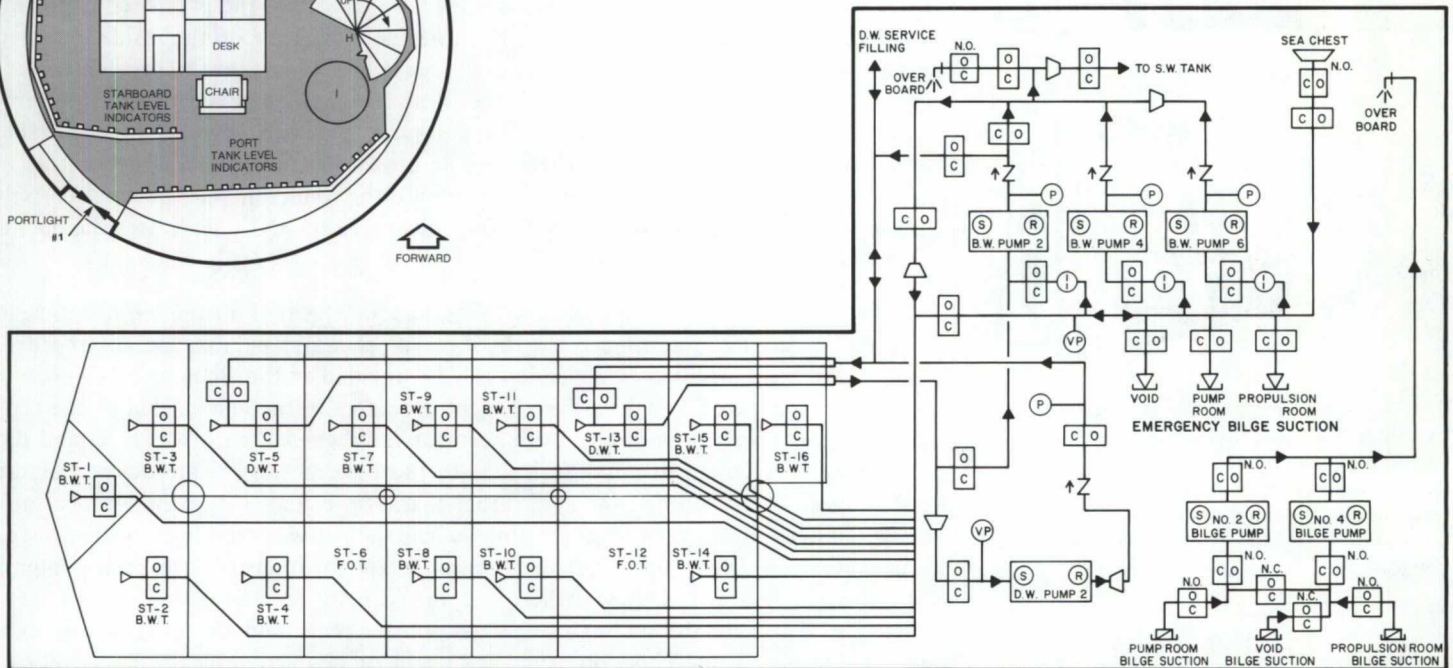
2.4 The ballast control room, 18 feet in diameter, was approximately 28 feet above the mean water level at the 80-foot drilling draft. The valves and pumps in the ballast system were controlled from the mimic panel, which provided a clearly labelled schematic representation of the system's components. The starboard section of the mimic panel is illustrated.

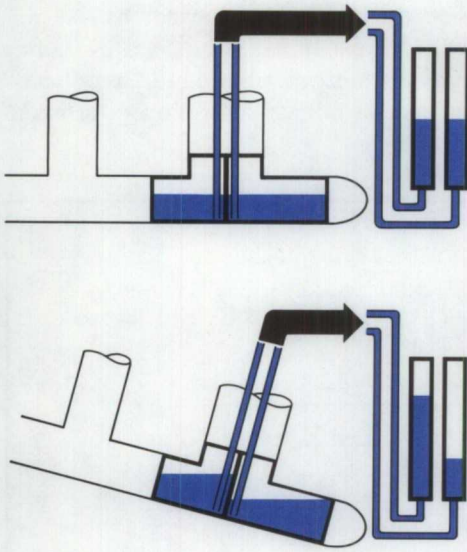
2.5 An accurate assessment of the weight carried in each pontoon tank was critical for the stability calculation. Substantial errors would be encountered if the rig was trimmed, as the conversion tables made no allowance for the position of the gauge's sensor tube.

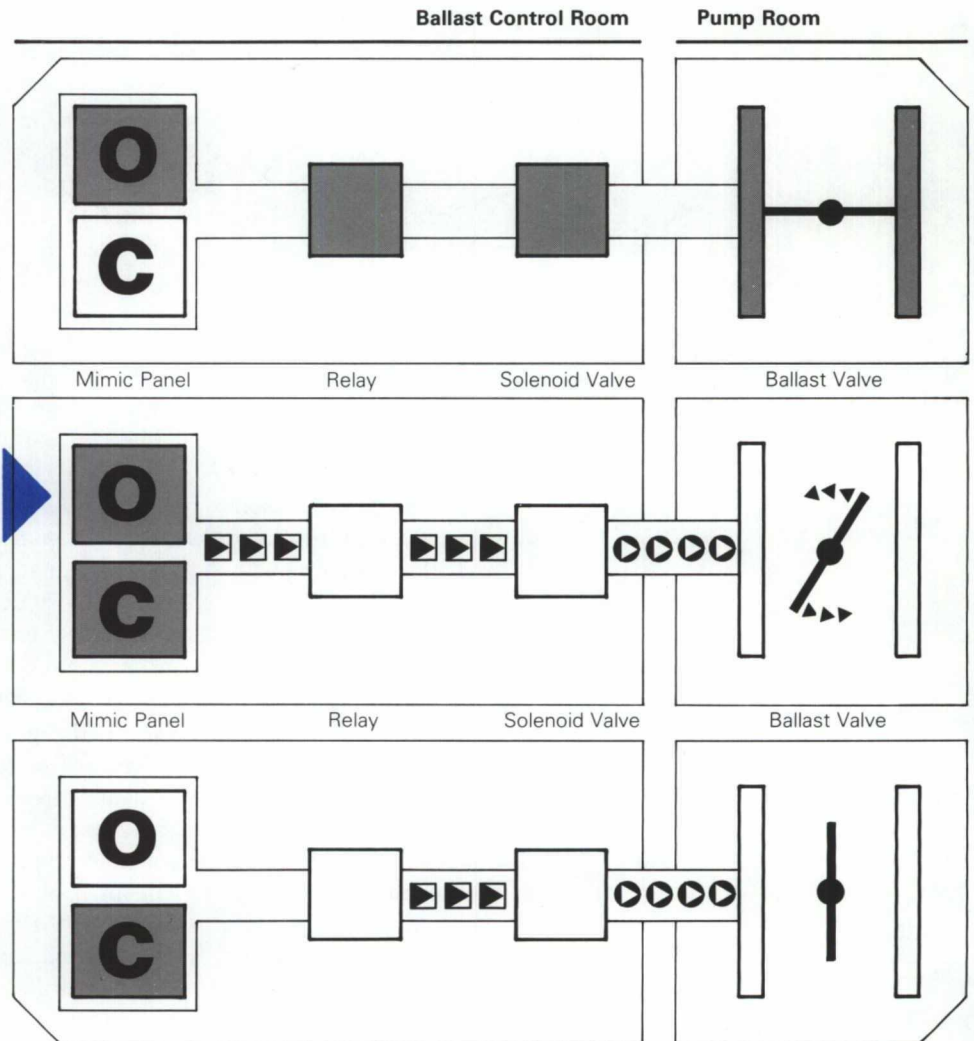
2.6 Ballast control operation using the mimic panel.

VALVE CLOSED. The relay and solenoid valve are both in the unactivated position. A limit switch on the ballast valve actuator, connected to the indicator light through the relay, has illuminated the "closed" light.

OPEN SWITCH PRESSED. The "close" light is immediately extinguished as soon as the relay is activated. The ballast valve is in transit for 20-40 seconds. The failure of the valve to open, or to open completely, results in both indicator lights remaining extinguished.

VALVE OPEN. When the ballast valve is completely open a second limit switch on the valve actuator illuminates the "open" light.

The mimic panel provided very limited information regarding the valves, and no information about the mechanical condition of the equipment. In the event of a mechanical failure in the valve control system, the operator could be presented with confusing or conflicting information. There was no method of ascertaining the direction of travel of the valves from the ballast control room. ODECO's original specifications did require a feature of this type but it was not included in the installed console.

ODECO ought to have realized the importance of providing a method of manually controlling the ballast valves from the ballast control room and incorporated this requirement in its contract specifications. It so happened that the resident electrician, representing the owners during the construction of the rig, knew that this could be done using the solenoid valves. The solenoid valves could be opened by inserting any device, the size of a pencil. By withdrawing the device the solenoid valve would close. He arranged for Mitsubishi to fabricate brass rods for this purpose which he used to test the pneumatic system before the electric control panel was installed. He also arranged for the brass rods to be stored in a box behind one of the panels of the control console. But there were no diagrams or instructions regarding the use of this method of manually controlling the valves from the ballast control room.

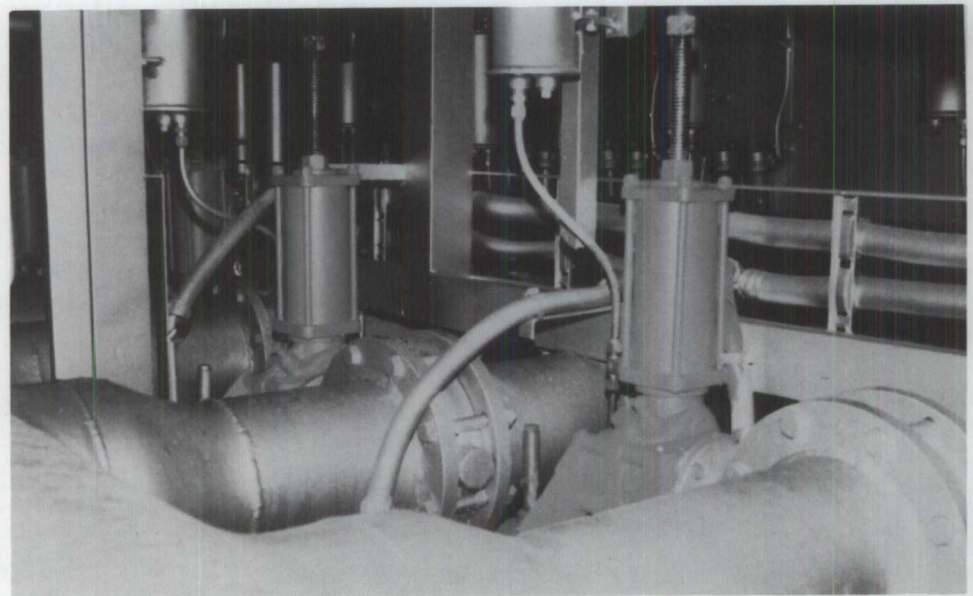
2.7 This photograph shows two of the remotely operated 18-inch butterfly valves in the pump room, which connected each ballast tank to the common manifold. Two other valves can be seen in the background, and the manifold is visible in the lower left-hand corner. These valves could be operated manually by using the threaded jackscrew at the top of the actuator.

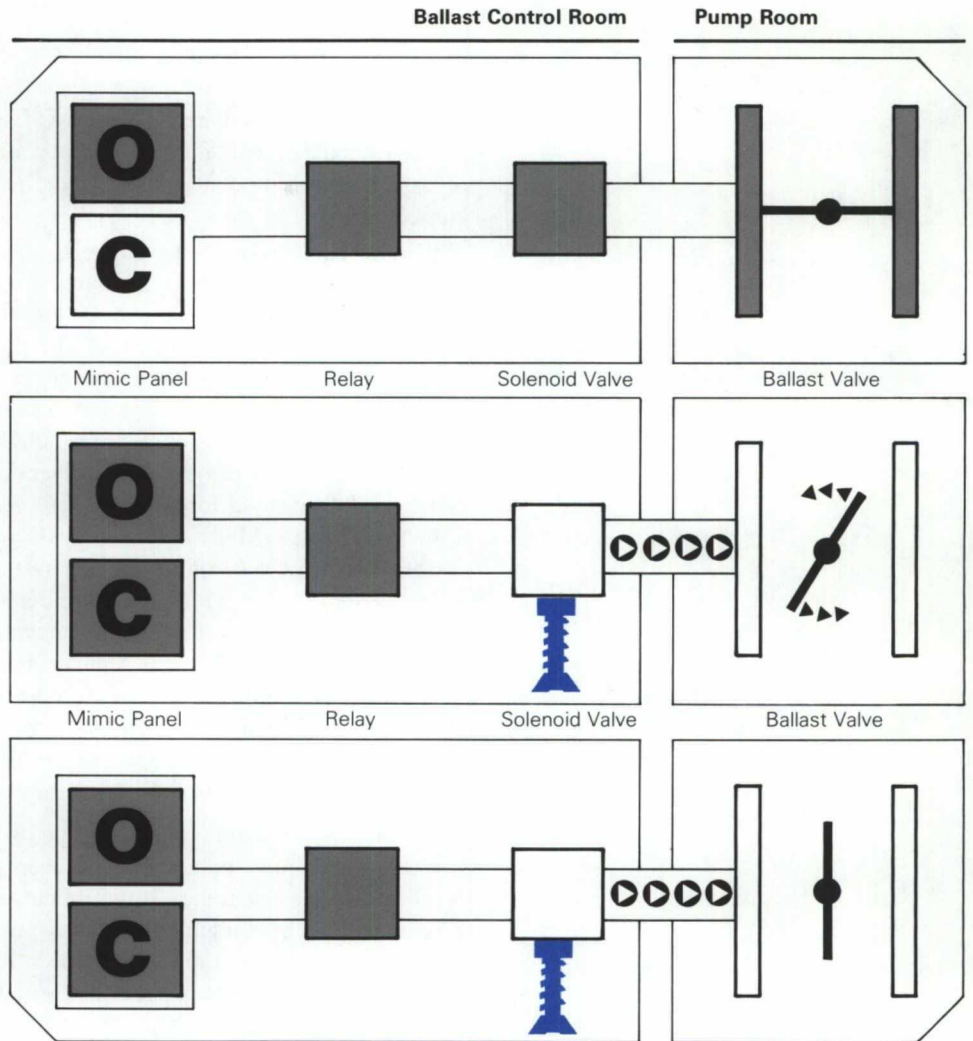
2.8 Ballast control operation using the brass rods.

VALVE CLOSED. The relay and solenoid valve are both in the unactivated position. A limit switch on the ballast valve actuator, connected to the indicator light through the relay, has illuminated the "closed" light.

BRASS ROD INSERTED. The solenoid valve is manually activated, causing the ballast valve to open within 20-40 seconds. As the valve starts to move and releases the limit switch, the "close" light is extinguished.

VALVE OPEN. With the ballast valve fully opened, the 'open' light remains extinguished because the relay is in the unactivated position. Opening the ballast valve in this manner does not require electrical power to the mimic panel.

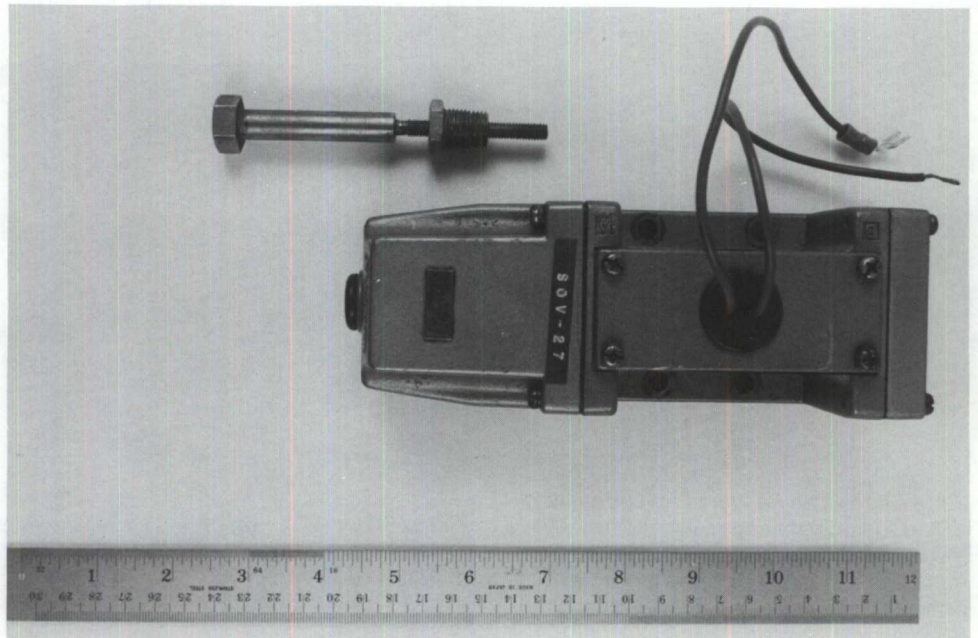
2.9 The solenoid valve on the right is one of the 64 recovered from the wreck. The black protrusion at the front of the valve is a plastic dust cover inserted in a threaded opening. Although the valve was normally opened electrically using the switches on the mimic panel, it could also be opened manually by pushing the solenoid core with a tool inserted through this hole. The brass rod at the top is one of at least eighteen that were placed in the ballast control room, during construction, for this purpose.

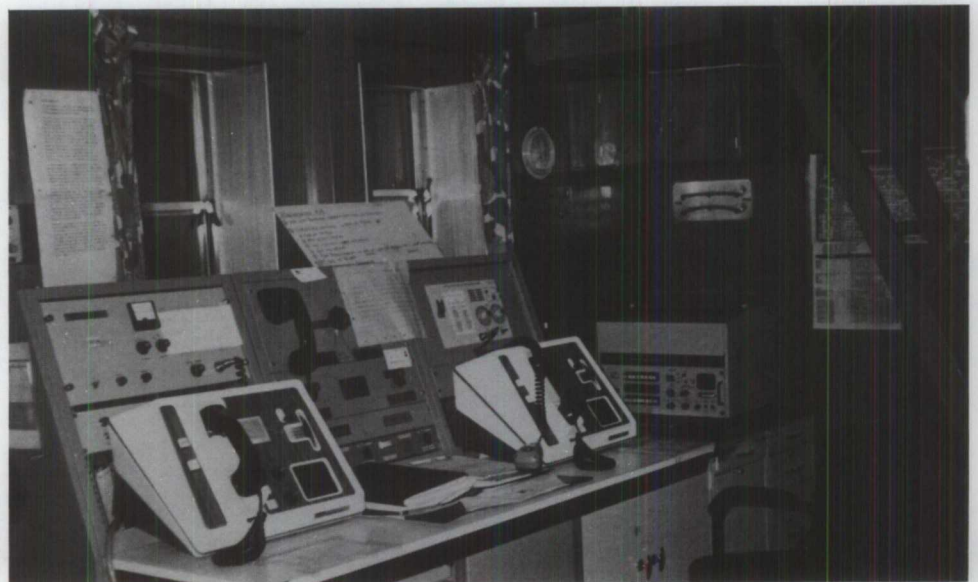
2.10 The *Ocean Ranger's* radio room contained the primary communications equipment, installed in this console. The two inclinometers in the corner of the room were similar to those installed in the ballast control room and several other locations.

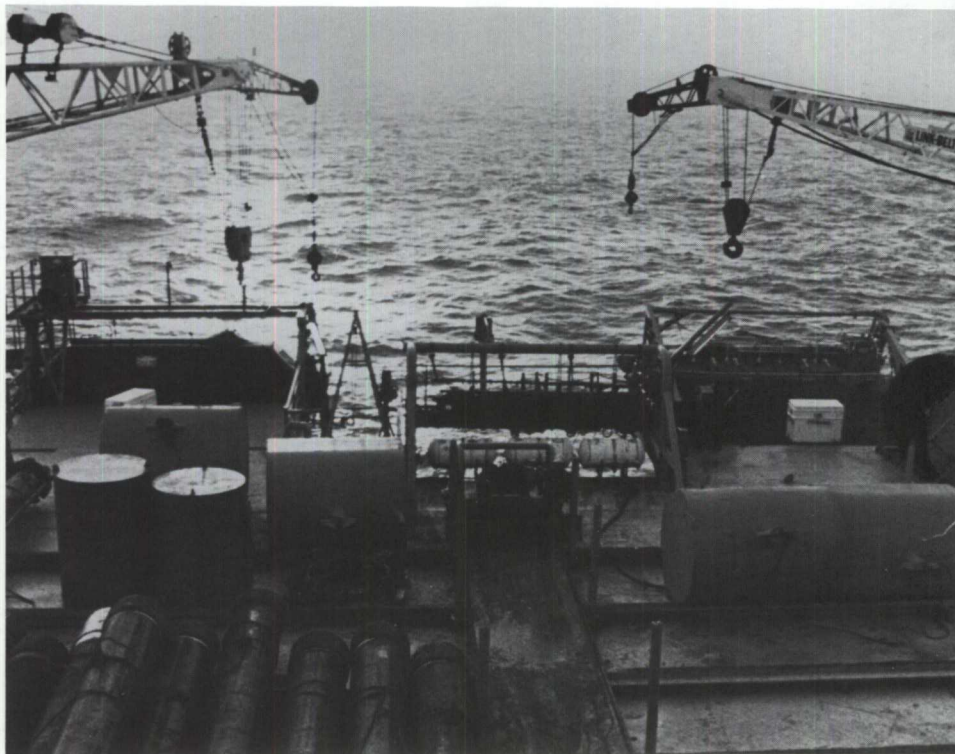
2.11 The stern of the *Ocean Ranger* showing the Harding (right) and Watercraft (left) lifeboats. A life raft station with three raft cannisters and a scramble net is located between the two boats. The white boxes beside each boat contained life preservers.

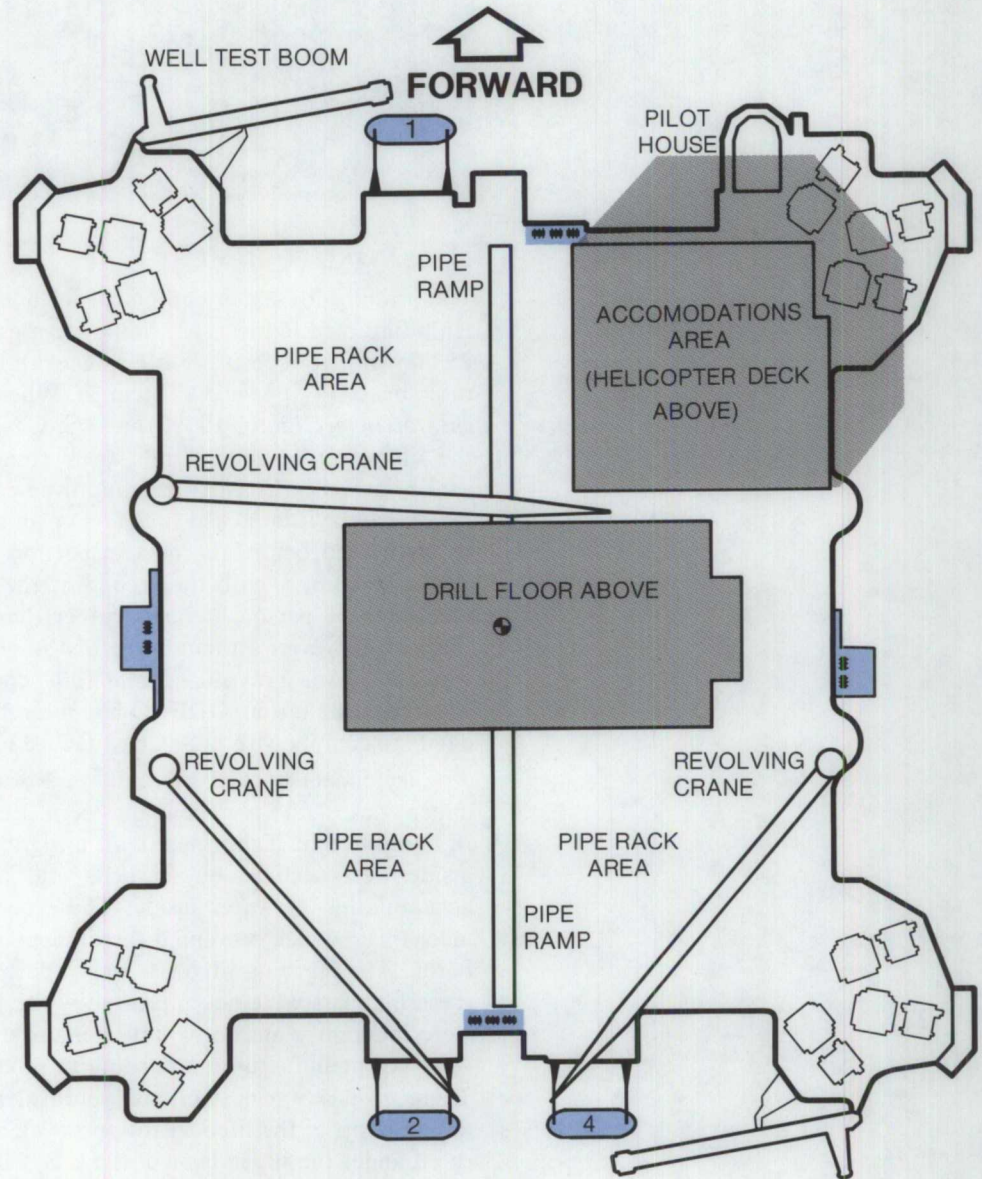
2.12 The upper deck was the main working area. Drill pipe and casing were loaded by crane from supply vessels, and stored in racks at the bow and stern. As drilling progressed, this material was moved to the drill floor along the pipe ramps and subsequently lowered into the well. The well test booms located at the port bow and starboard stern were used to flare gas and burn oil from the well during testing. At the time of the loss three lifeboats and ten life rafts were installed on this level; a fourth lifeboat was stowed on deck awaiting installation. Lifeboats #1 and #2 were 50-person Harding boats, while #4 was a 58-person Watercraft.

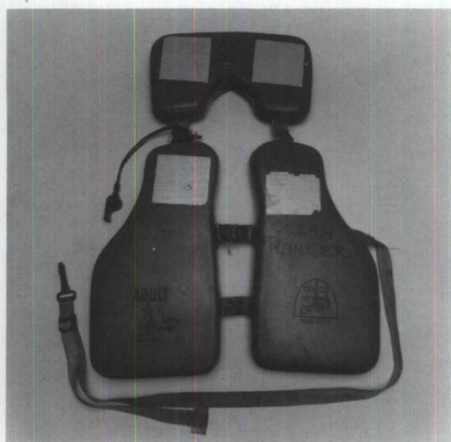
2.13 One of the Billy Pugh Model #200 life preservers recovered. The sea water-activated light that was attached to each life preserver is missing from the photograph.

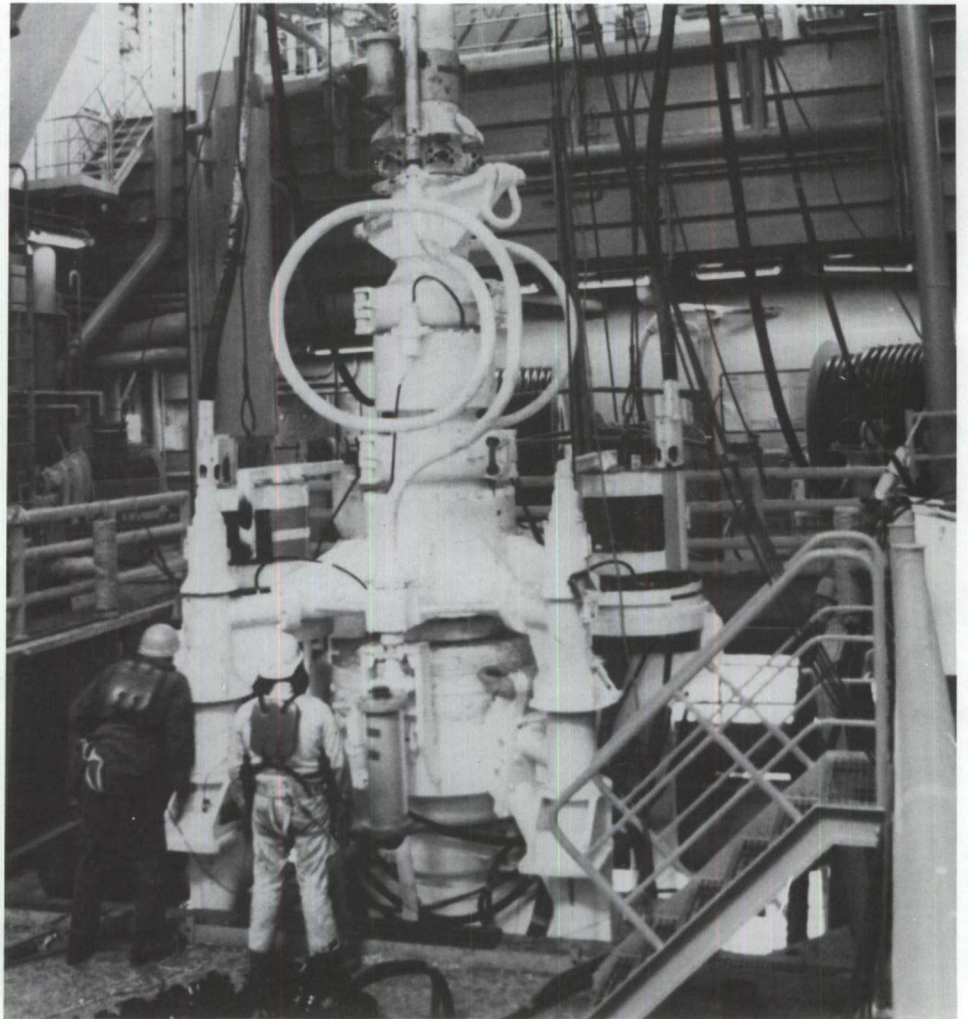
3.1 This photograph shows the blowout preventer and marine riser being lowered to the seabed through the moonpool in the cellar deck. The blowout preventer is below the level of the deck, and the lower marine riser package and the riser connector are at the level of the two crew members in the foreground.

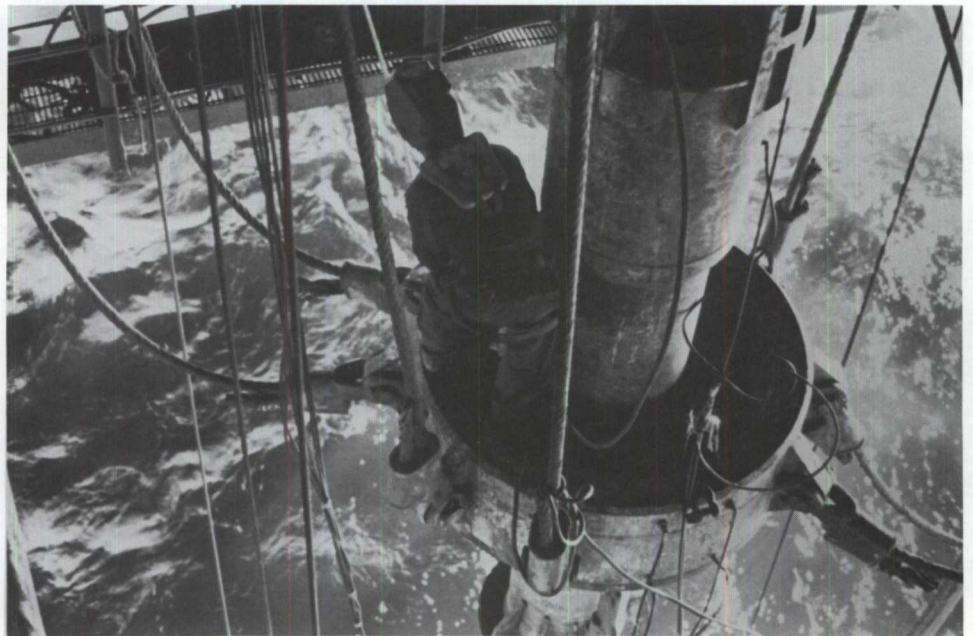
3.2 A welder at work on the slip joint, which is the primary element of the heave compensation system, and the point at which the marine riser connects to the rig. The worker is wearing a work vest and is secured by a safety belt and line.

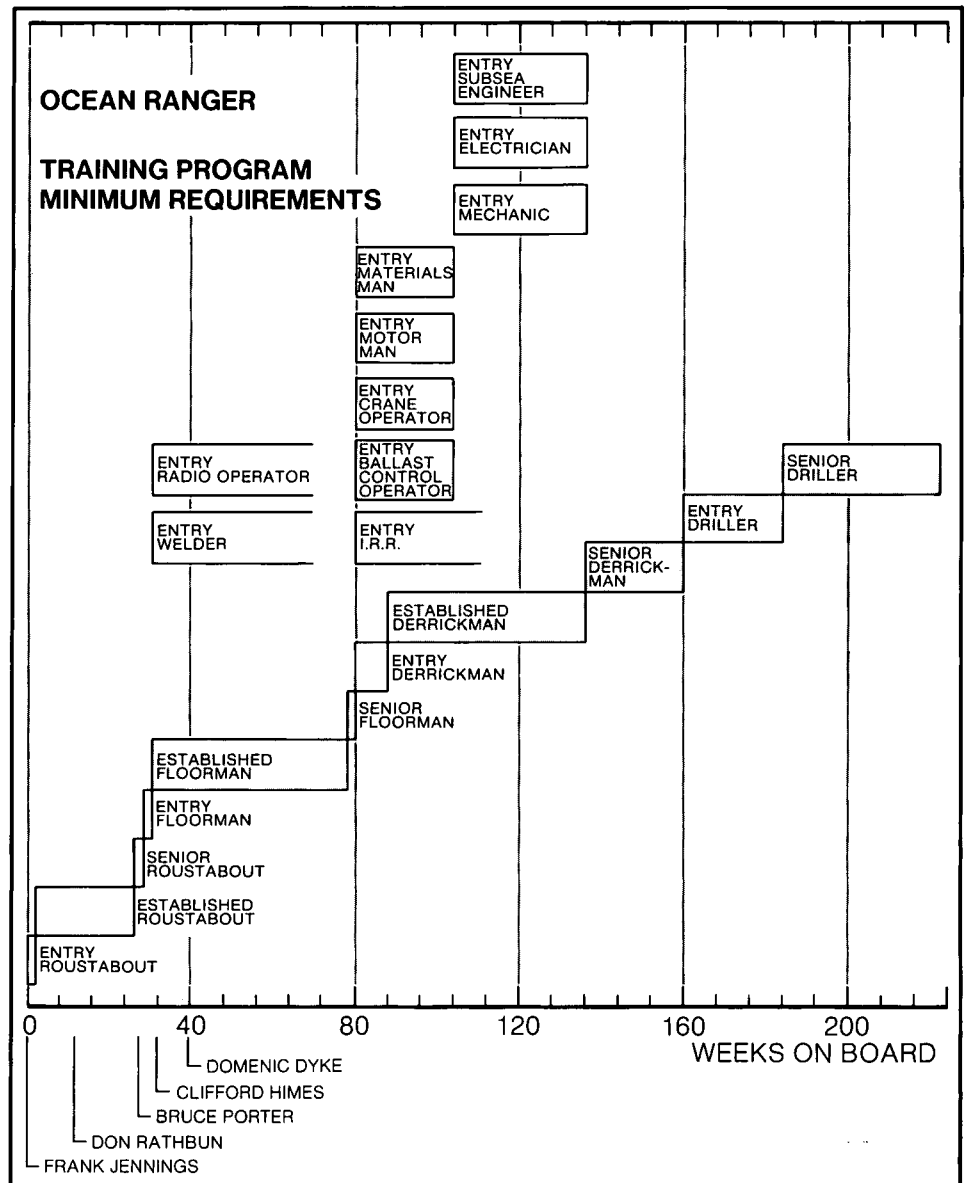
3.3 The ODECO training policy for the industrial crew required 80 weeks of experience before a crew member was recruited to train as a ballast control operator. This policy was not followed on the *Ocean Ranger*.

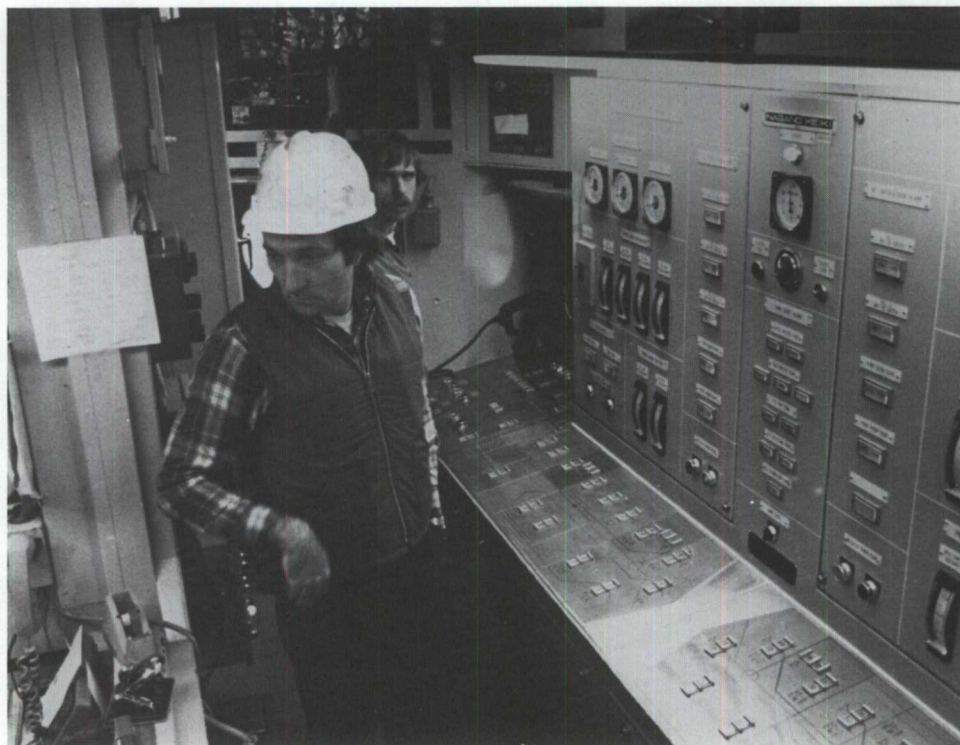
3.4 Ballast control operators at work in the ballast control room. The photograph shows the confined working area in the room; an Aldis lamp, used for illuminating the draft marks at night, can be seen on the port section of the mimic panel in front of porthole #3. The handset for the rig-wide public address system is visible at the extreme left.

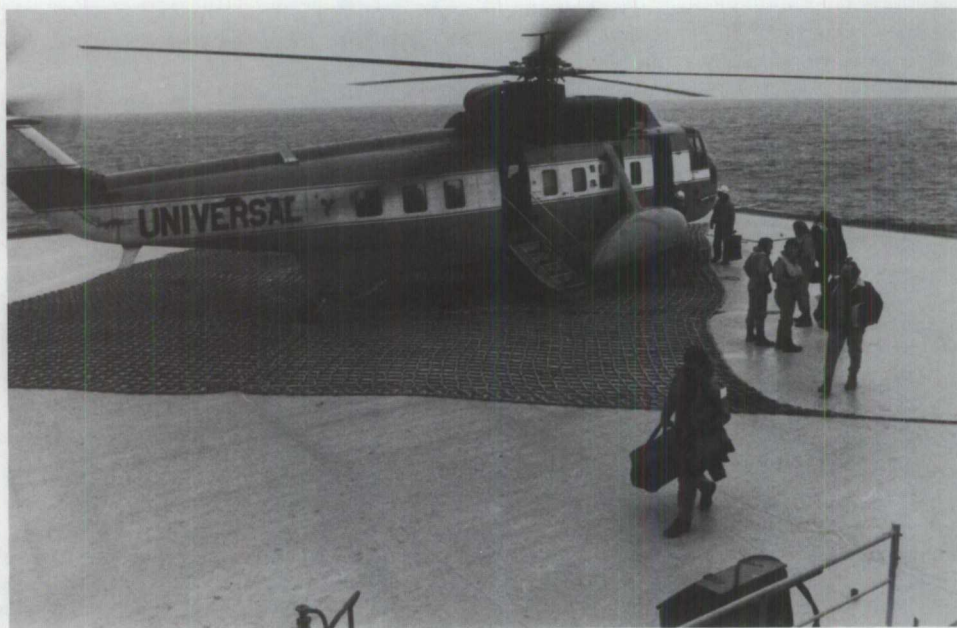
3.5 A Sikorsky S-61 on the *Ocean Ranger's* helideck during a crew change. This type of helicopter was used to transfer personnel and light cargo from St. John's to the Hibernia Field. During these flights all passengers wore immersion suits and inflatable life preservers.
