APPENDIX F

| Report A, EP 266/82 – Portholes Examination | 271 |
| Report B, EP 90/83 – Porthole Glass Pressure Tests | 278 |
| Report C, EP 265/82 – Analysis of Solenoid Control Valves | 286 |

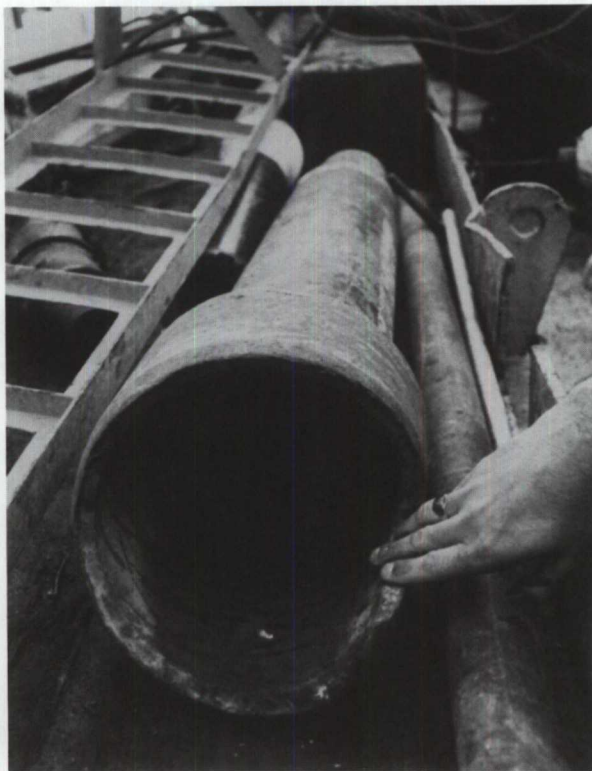
By 1500 hrs. the mill had been turning for about one half hour without progress. It was decided to pull it out of the hole to examine it. When it was brought out it was found to have a piece of drill pipe wedged in its throat together with the top of a hang-off tool.

Therefore, when the clockwise rotating mill engaged the top of the sheared pipe it had unscrewed the left-handed thread of the hang-off tool, disengaging it from the bottom half of the tool. Further rotation only damaged the threads of the tool. When the mill was removed the top of the sheared pipe was recovered.

FIGURE 6 Mill pulled from hole with sheared pipe wedged in its throat. Note top of hang-off tool.

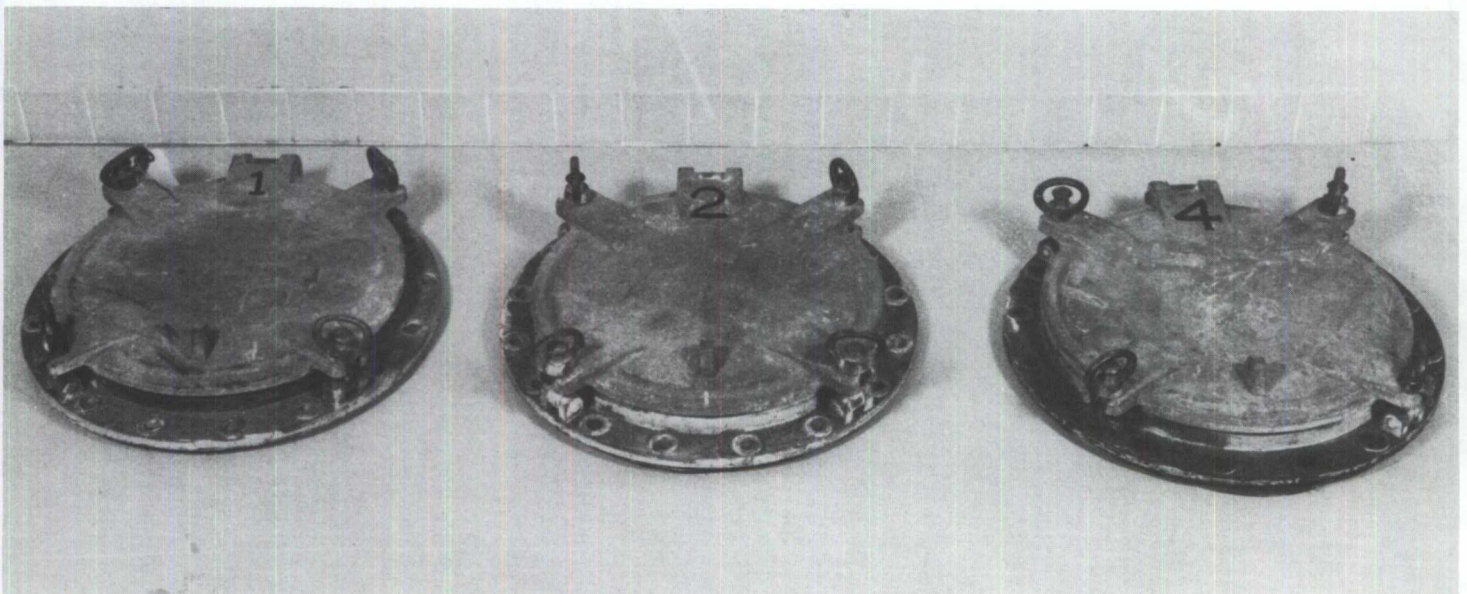
2.1 The three portholes received are shown in Photo 1 numbered 1, 2 and 4. The deadlight bolts on portholes 1 and 4 were only "hand-tight" and were easily removed (no torque reading). The deadlight bolts on porthole No. 2 were "frozen" on their threads, likely due to salt-water immersion. When these bolts were "unfrozen", they were also determined to be hand-tight and subsequently moved freely. The force required to loosen the frozen bolts was not directly related to the actual clamping force on the deadlight. Photo 2 shows the three portholes with deadlights open.

PHOTO 1 Portholes as received with deadlights closed. Identified by the numbers 1, 2 and 4.

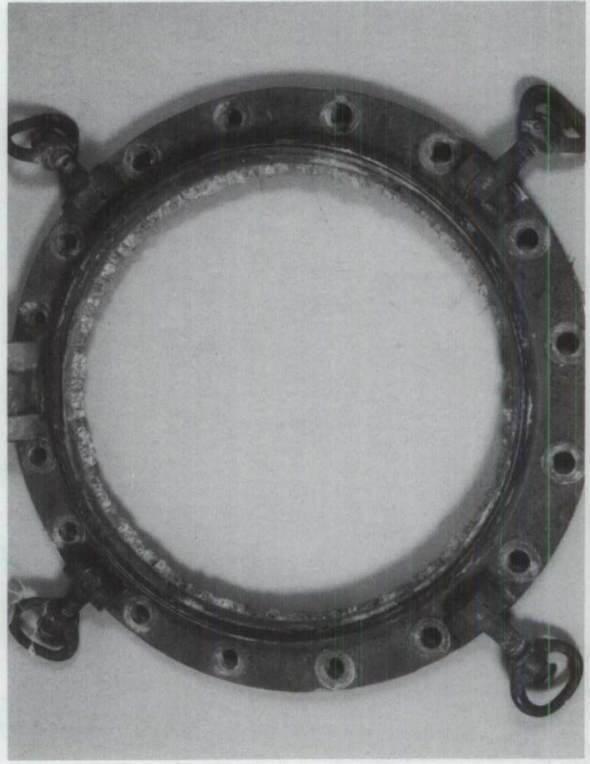
PHOTO 2 Portholes with deadlights open show the glass condition in each case.

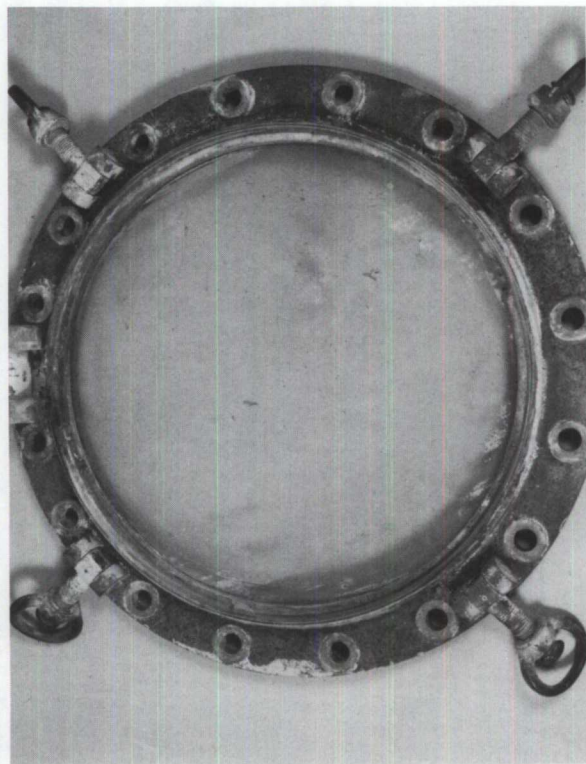
The porthole glass was broken, leaving glass fragments in a continuous pattern around the porthole circumference. The glass fragments were held in place by the locking ring. The glass thickness was measured at different locations around the circumference and was found to average 14.95 mm (0.59 inches). The inside diameter of the glass locking ring was measured across three diameters at 120° to each other and found to be 459 mm (18.09 inches) in each direction, indicating no out-of-round. The outside diameter of the locking ring was similarly measured and found to be 476 mm (18.74 inches) in each direction. This measurement was also assumed to be approximately equal to the diameter of the porthole glass (after accounting for clearance to allow for glass expansion).

4.6 Analysis indicates that the glass in porthole No. 1 probably failed under uniform pressure loads resulting from sinking to the sea floor, but assisted by a blow to the glass while submerged. It is also concluded that the deadlight was probably closed at the time of glass failure.

PHOTO 4 Porthole No. 1 with deadlight open, view looking outboard. Note glass fragments in continuous pattern around circumference.

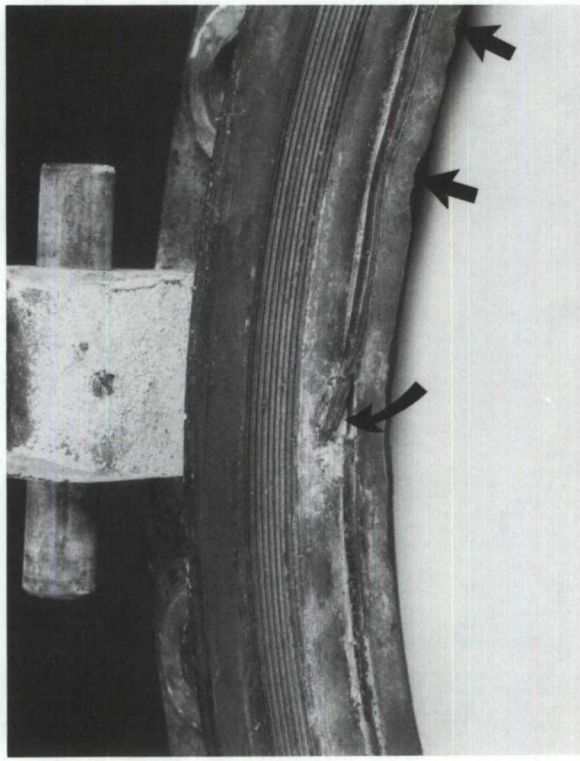
4.7 The glass in porthole No. 4 failed due to loads of an impact nature, likely resulting from surface waves. It was also determined that the deadlight was probably open at the time of failure.

PHOTO 8 Porthole No. 4 with deadlight open, view looking outboard. Note glass completely removed, no fragments.

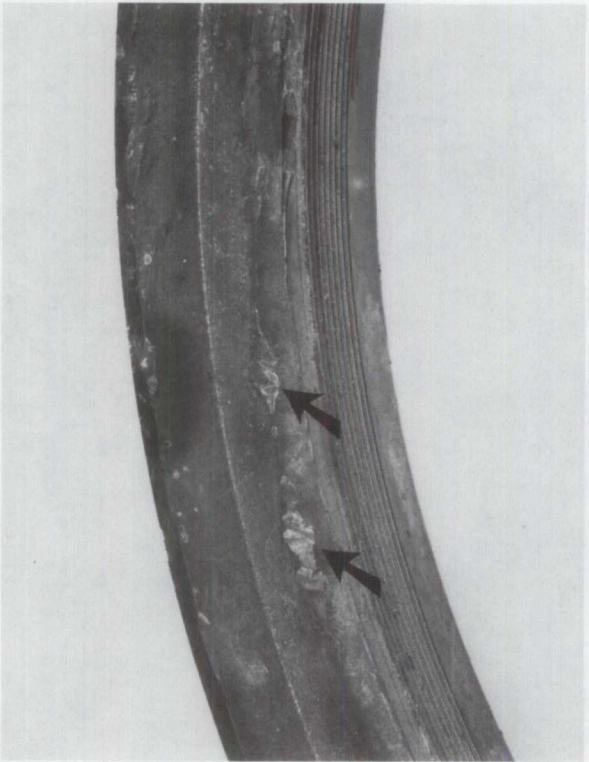
There was no glass in porthole No. 4. The rubber glass seal was in place in the seal groove of the glass support flange. The seal was broken at one location adjacent to the deadlight hinge, Photo 9, but none of the seal was missing. On the outboard edges of the glass support flange and porthole, numerous impact marks and gouges were observed, Photo 10. These marks were bright in colour and appeared to be randomly located around the full circumference of the porthole. The marks appeared to be the result of concentrated and repeated impacts. Testing showed that the orientation and severity of the impact marks could only have been made by blows from outside the porthole. They were bright in colour (indicating them to be recent in nature) and it was determined, most likely, that they occurred during removal of the porthole from the rig structure. The glass locking ring was still in place and the width of the groove which held the glass was measured. The groove width measured from the top of the seal was 14.5 mm (0.59 inches) and without

PHOTO 9 Porthole No. 4 showing broken seal (arrows) adjacent to the deadlight hinge. Also note profile of impact marks on outer edge of porthole (arrows) compare with photo 10.

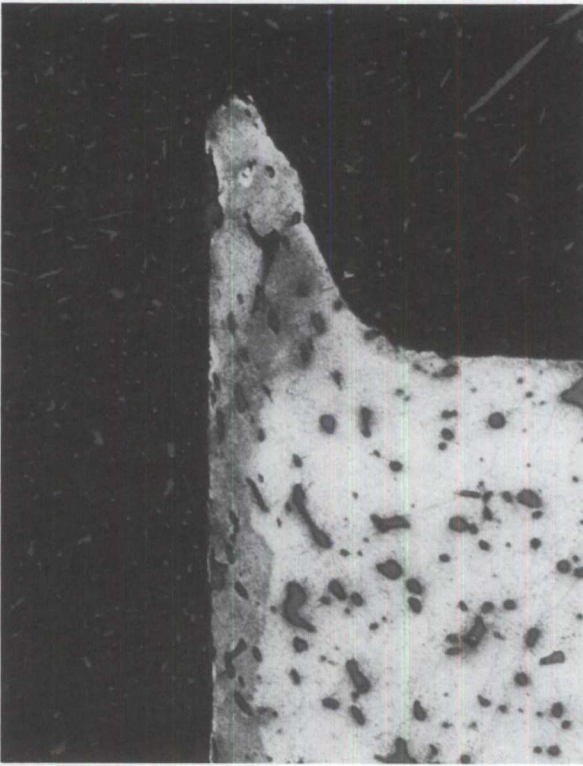
3.1 The metallurgical analysis of the locking rings indicates that the loads on the glass of porthole No. 4 were of higher magnitude and more of an impact nature than the loads on the glass of porthole No. 1. It is considered most probable that the glass in porthole No. 4 burst due to a dynamic surface ocean wave impact. On the other hand, the lack of any significant material deformation in the locking ring from porthole No. 1 suggests more of a static loading condition. Static pressure loads would be applied as a result of sinking to the sea floor if a pressure differential exists across the glass. This would require the deadlight to be closed and sealed, trapping an air pocket on the inboard side of the glass. The static pressure loads alone would not have been sufficient to burst the porthole glass. However, a concentrated blow by a sharp object might easily shatter tempered glass,

PHOTO 13 Glass locking ring from porthole No. 4 shows protruding lip of material along the inside edge (arrows).

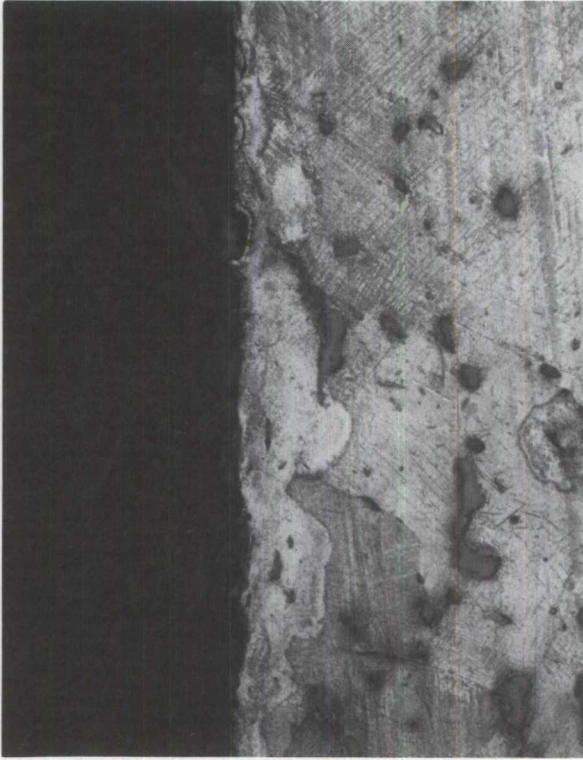
PHOTO 14 Cross section of locking ring shows protruding lip of material. Note the pattern of flow near the base of the lip indicating smearing deformation of the material.

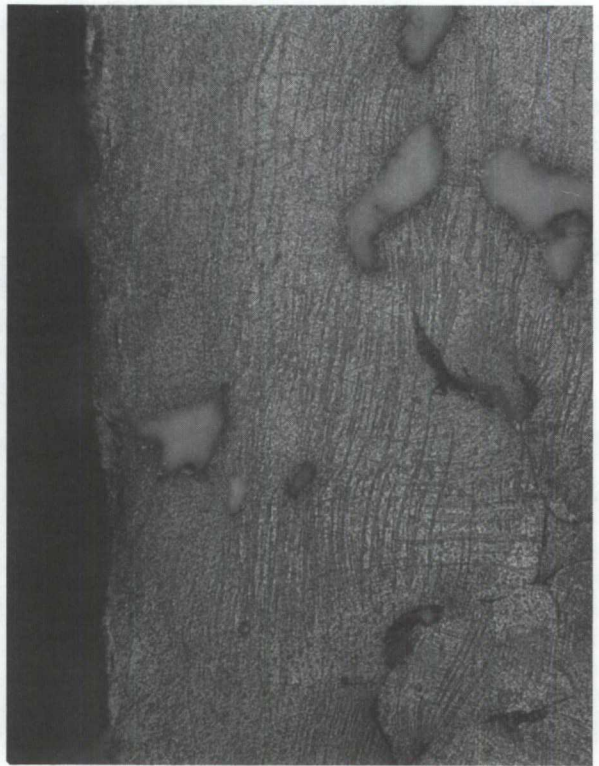
2.5 Metallurgical examination of the material microstructure of the locking rings revealed a narrow band of deformation slip lines (characterized by a crosshatch pattern) just below the ring surface which mates with the glass, Photo 15 and 16. The slip line pattern extended further below the surface in the ring from porthole No. 4 and was much more prevalent in the area of the protruding lip, Photo 17. Slip lines are formed as a result of deformation in the material and are characterized by a cross-hatch pattern.

PHOTO 15 Deformation slip lines (crosshatch pattern) adjacent to the glass mating surface of porthole No. 4 locking ring.

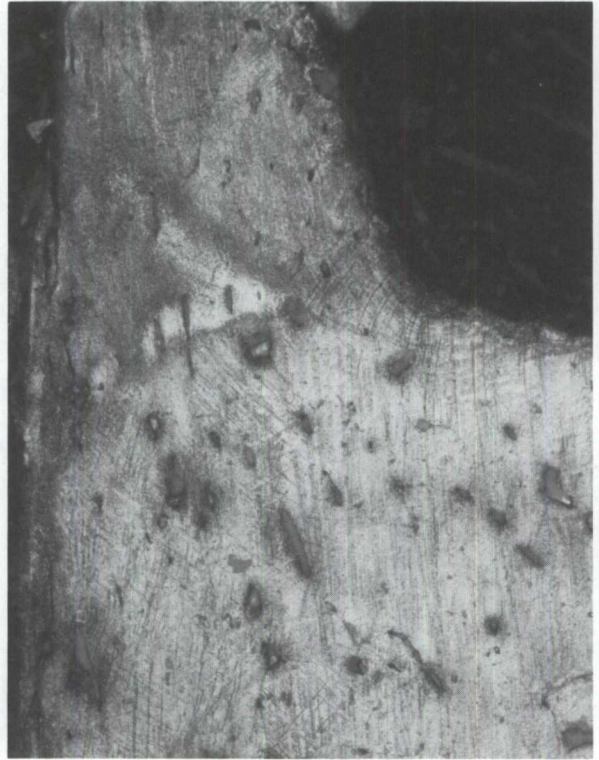
PHOTO 16 Deformation slip lines as in photo 15.

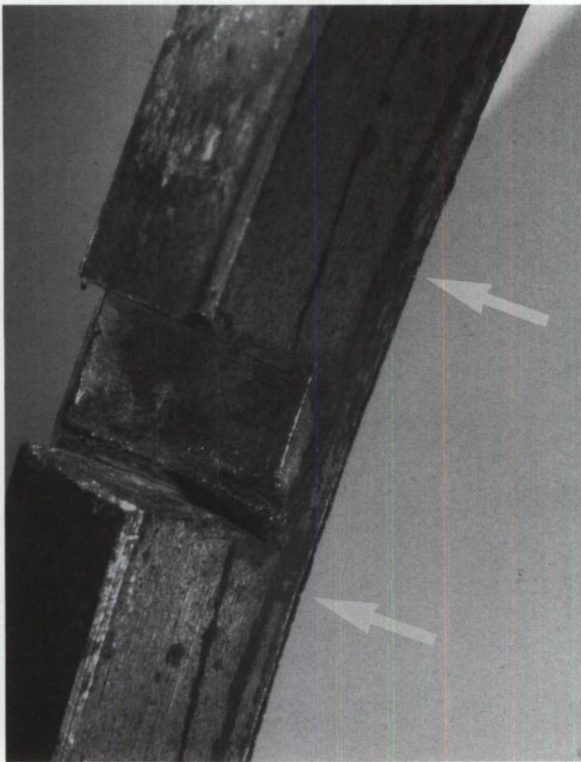
3.5 The *Ocean Ranger* No. 2 porthole glass failed at a pressure of 4.8 kg/cm² (68 psi) causing deformation to the locking ring very similar to that found on the No. 4 porthole locking ring.

PHOTO 7 Glass retaining ring removed from porthole No. 2 shows protruding lip of deformed material (arrows).

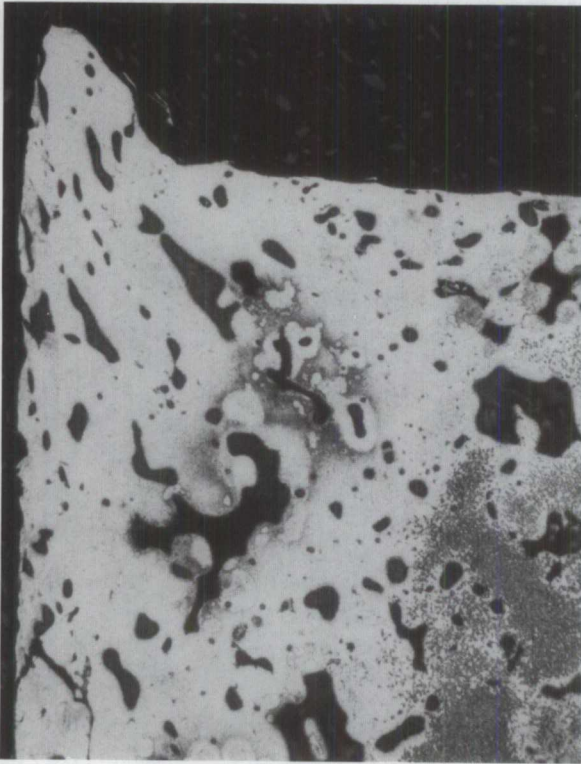
PHOTO 10 Cross section of retaining ring from porthole No. 2 shows distinct protruding lip. Note the pattern of flow at the lip indicating smearing deformation of the material.

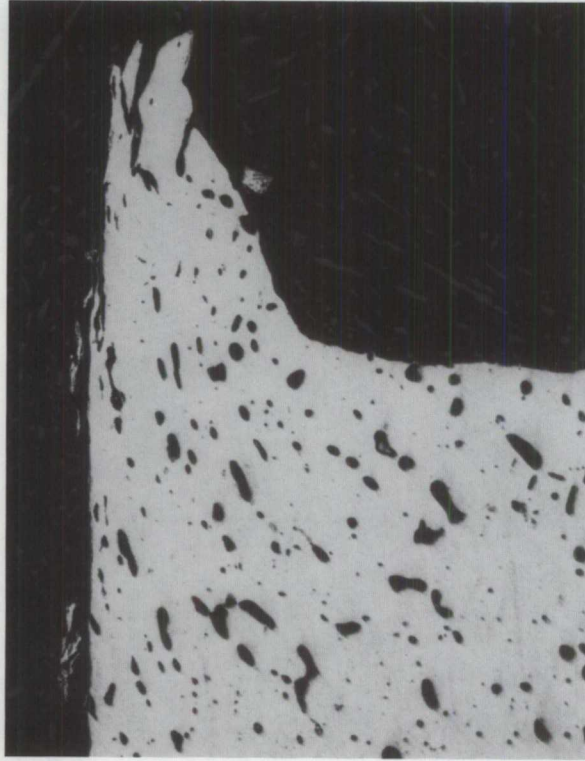
PHOTO 11 Cross section of retaining ring from porthole No. 4 shows similar protruding lip.

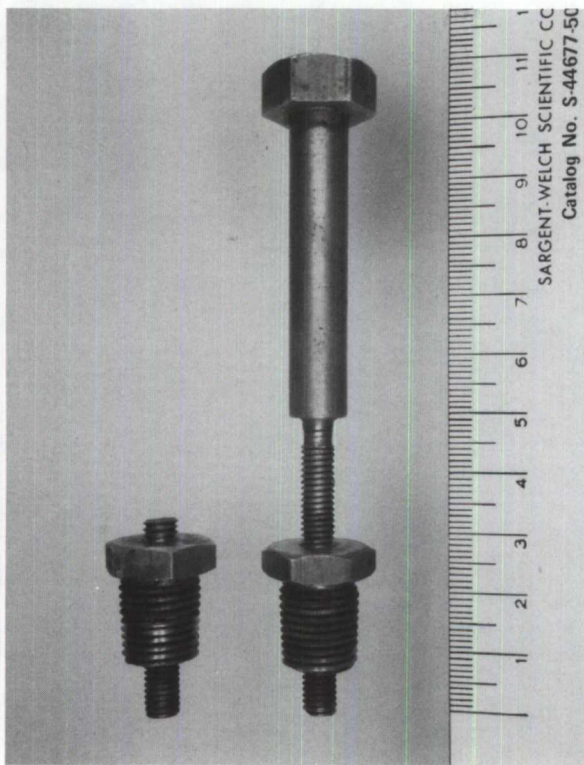
i) the broken actuator rods all failed through bending overload, and were considered most likely to have all been broken when the solenoid valve banks were being retrieved from the wreckage, and not prior to or during the accident.

PHOTO 5 A broken and intact actuator rod, inserted into a brass plug.

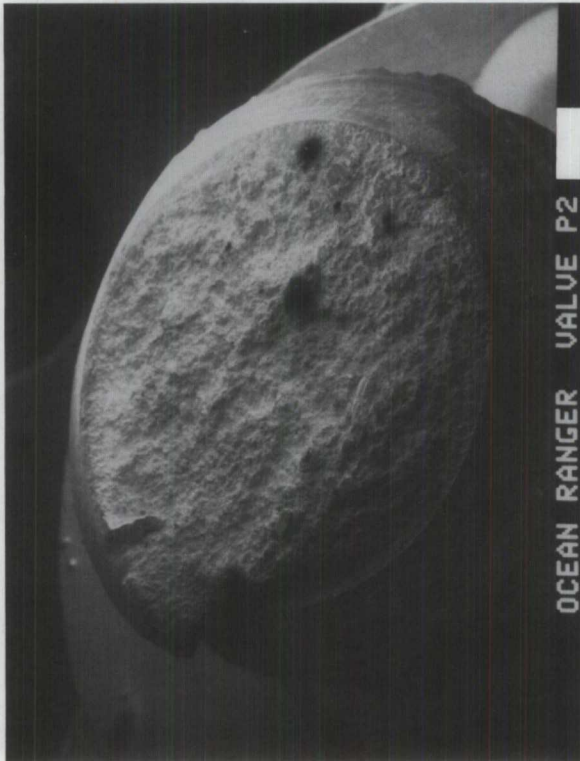
OCEAN RANGER VALVE P2

PHOTO 16 SEM photograph showing a typical fracture surface observed in all of the 14 broken actuator rods.

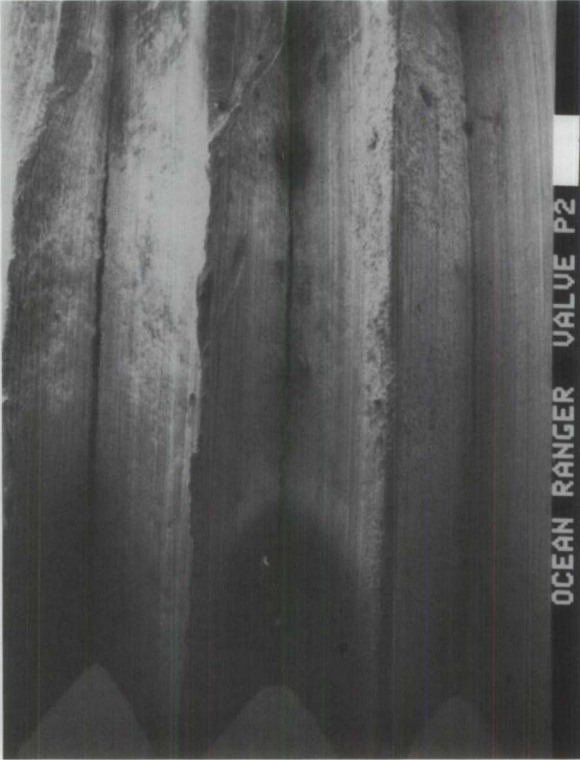
OCEAN RANGER VALVE P2

PHOTO 17 SEM photograph showing cracks observed in the thread roots of a failed actuator rod. This was typical for all 14 broken actuator rods examined.

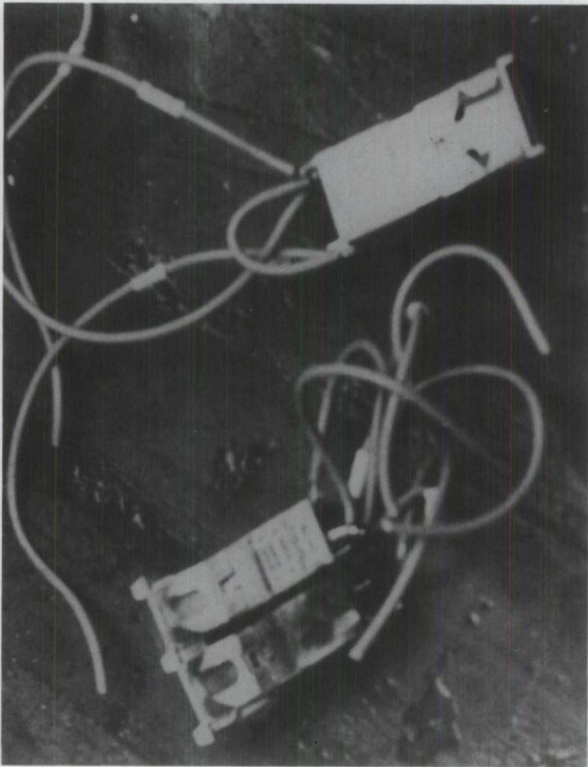
PHOTO 5 Switch P-19 showing sparking damage.

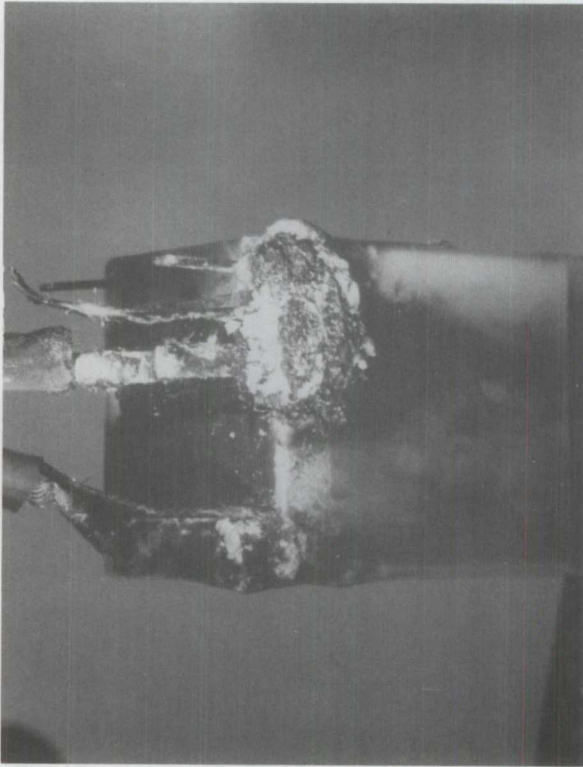
PHOTO 14 Detail of burned area on switch P-19.

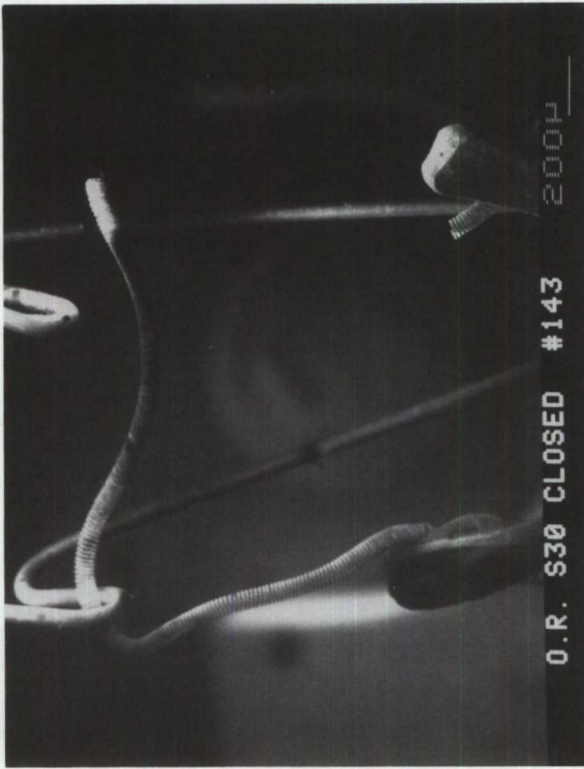
PHOTO 1 Starboard #30 closed. Filament broken near contact post.

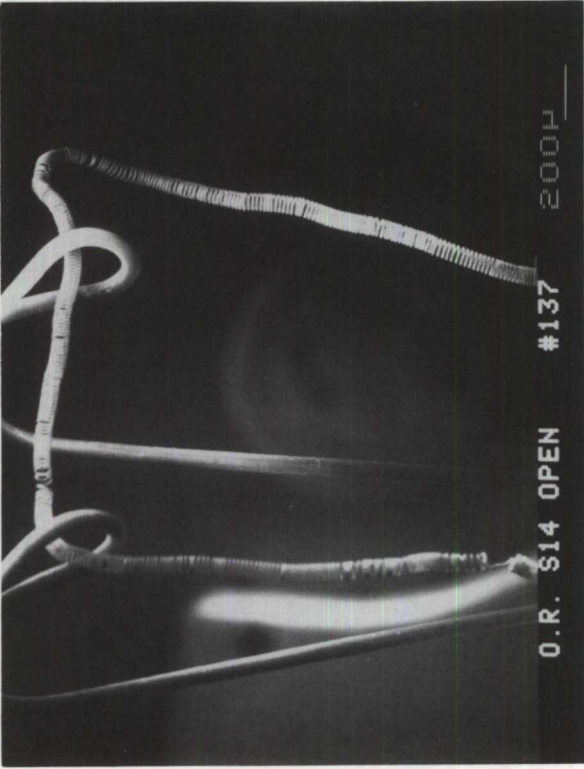
PHOTO 2 Stretched filament damage probably due to high voltage.

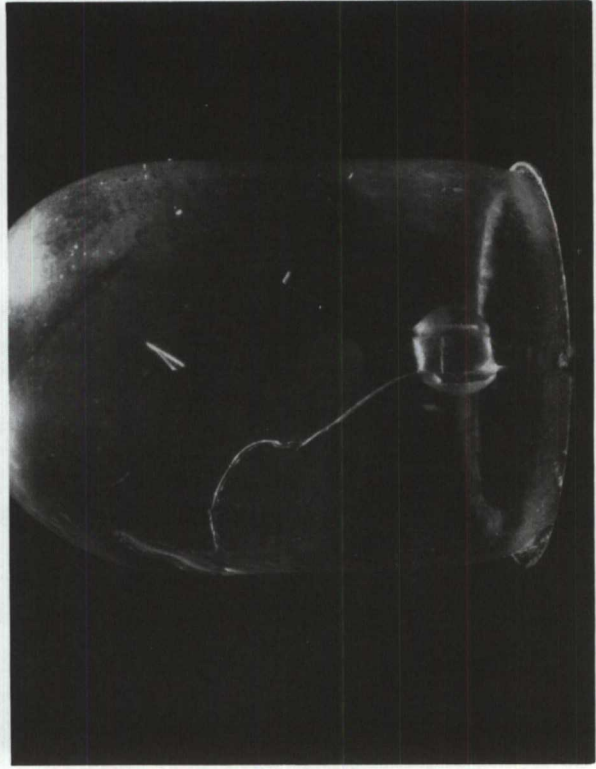
PHOTO 3 Filament fused to glass from #2 bilge water starboard stop pumplight.

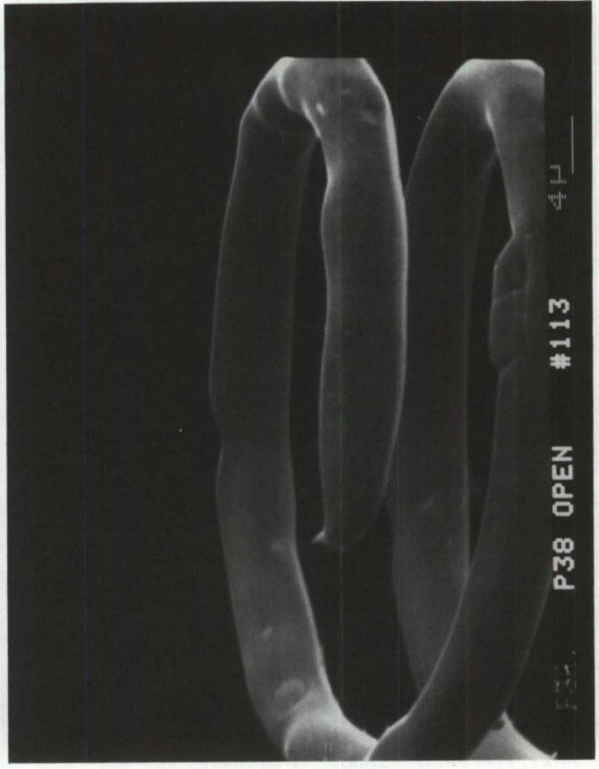
PHOTO 4 Hot fracture of port #38 open bulb.

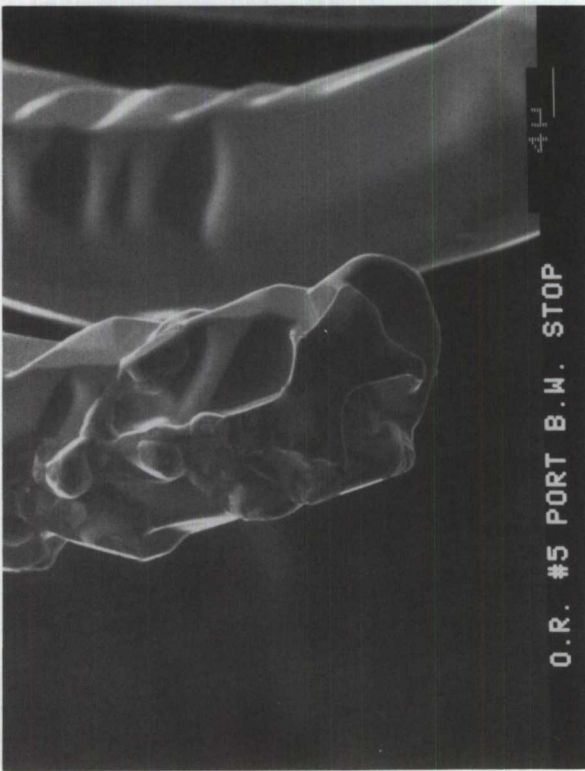
PHOTO 5 Smooth fracture surface of port ballast water stop bulb.

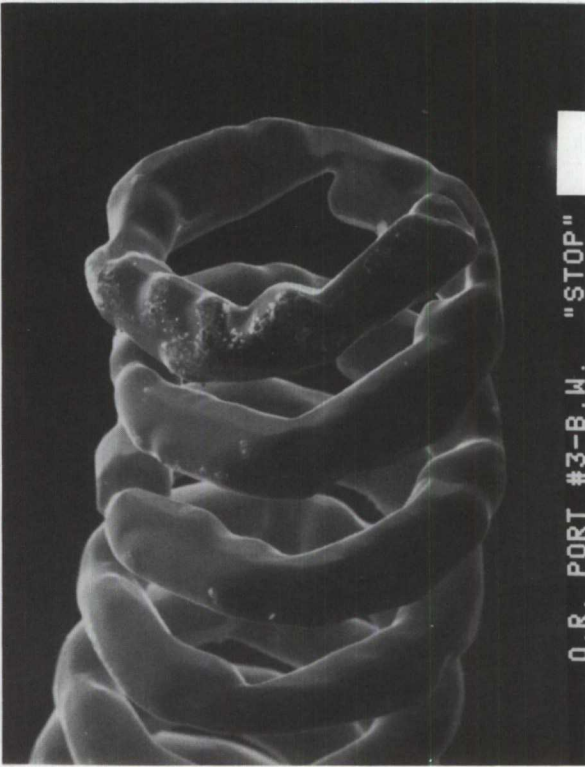
PHOTO 6 Smooth fracture surface of port #3 ballast water stop.
