Marine Transportation Safety Investigation Report M17C0061

CAPSIZING

Small fishing vessel *Emma Joan*
Grosse-Île, Îles-de-la-Madeleine, Quebec
20 May 2017

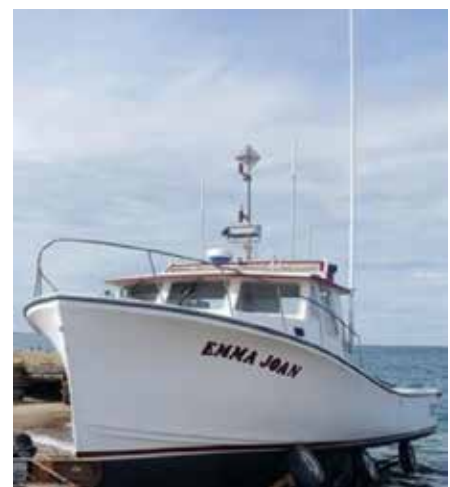
Figure 1. Fishing vessel *Emma Joan*
(Source: owner/master)

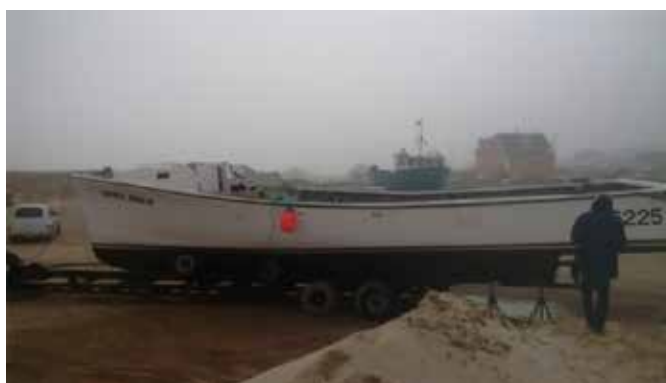
The 2 fishing vessels arrived just before the master surfaced. A lifebuoy was thrown from one of the fishing vessels to them; both grabbed onto the lifebuoy and were pulled on board. Both crew members were taken to the wharf at Grosse-Île, where first responders treated them for hypothermia before transporting them to hospital. They received medical attention and were released later that day. The damaged vessel was recovered the following day (Figure 2). No pollution was reported.

Figure 2. Damaged *Emma Joan* after being salvaged

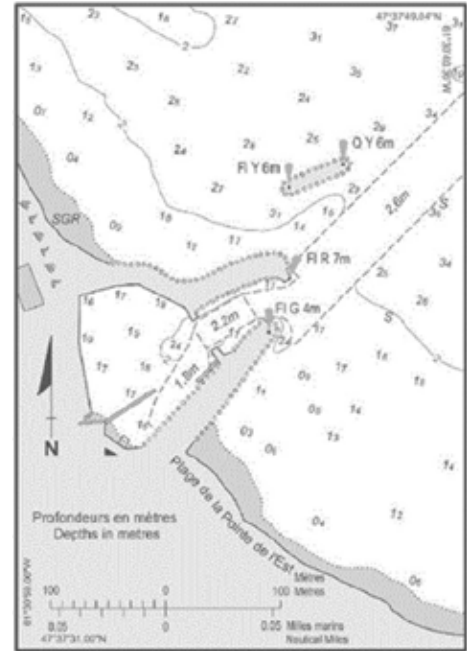
Approximately 45 fishing vessels operate out of Grosse-Île harbour. Navigation between the harbour and the sea is through an unmarked dredged channel that is 50 m wide and 415 m long. No buoys or other aids to navigation are used to mark the channel. In 2012, an offshore island breakwater was installed (Figure 3) and an extension was added in the fall of 2016. This extension required shifting the unmarked channel south of and parallel to its original location prior to the opening of the 2017 fishery (Figure 4).

Sailing directions³ issued by Fisheries and Oceans Canada (DFO) indicate that channel depths (figures 3 and 4) are obtained by routine dredging, and that, due to continual silting, mariners are cautioned that they may find less water than expected.

Figure 3. Grosse-Île harbour and unmarked channel prior to 2017 (Source: Canadian Hydrographic Service Sailing Directions ALT 108, issued July 2013)

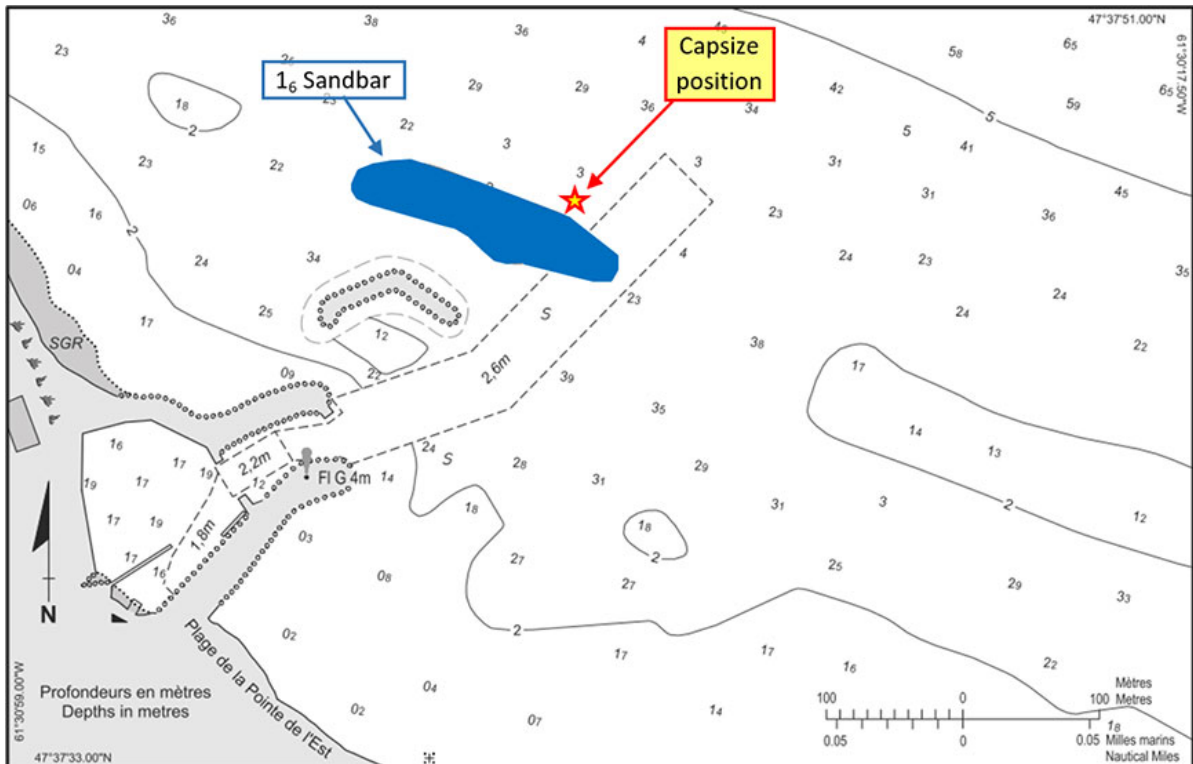
Figure 4. Grosse-Île harbour and new unmarked channel in 2017, with TSB annotations (Source: Canadian Hydrographic Service Sailing Directions ALT 108, issued June 2017, after the occurrence)

DFO manages and maintains harbours, including Grosse-Île harbour, to ensure they are safe and accessible to fishermen and other users through the Small Craft Harbours program.⁴ Due to varying weather and sea conditions, the amount of silting and the prevalence of the sandbar in and around the channel fluctuate significantly from year to year. Therefore, DFO conducts annual depth surveys and dredging operations at Grosse-Île. Surveys conducted on behalf of DFO before the 2017 lobster season indicated that the sandbar ran across the new channel, reducing the water depth to only 1.6 m at the sandbar's highest point.⁵

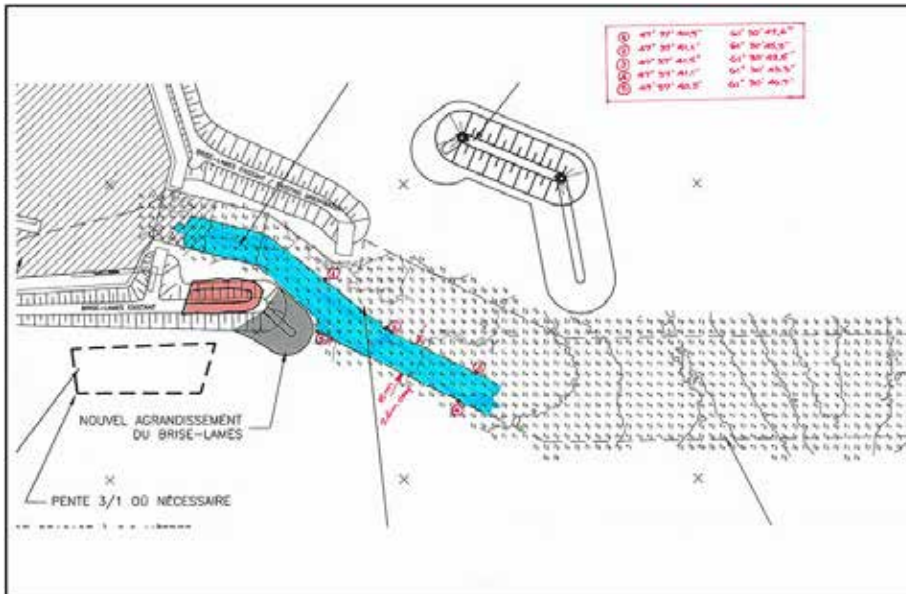
Figure 5. Safety passage diagram issued to the Harbour Authority of Grosse-Île for 2017 lobster season opening (Source: Small Craft Harbours program, Fisheries and Oceans Canada)

To provide information on the safety passage, on 02 May 2017, DFO issued a survey diagram (Figure 5) to the Harbour Authority of Grosse-Île for distribution to fishermen. The master of the *Emma Joan* received a copy of this diagram, which highlighted the safety passage and included 5 latitude and longitude coordinates marking the passage's extremities. The diagram indicated that the water depth in the new channel was 1.6 m at the sandbar's highest point, but its position was not highlighted and coordinates for its position were not given.

At Grosse-Île, considerable work was done to survey the unmarked channel and dredge a safety passage in the vicinity of the wharf before the start of the fishing season. Although the diagram provided to fishermen indicated the height of the sandbar, it did not highlight its location or provide

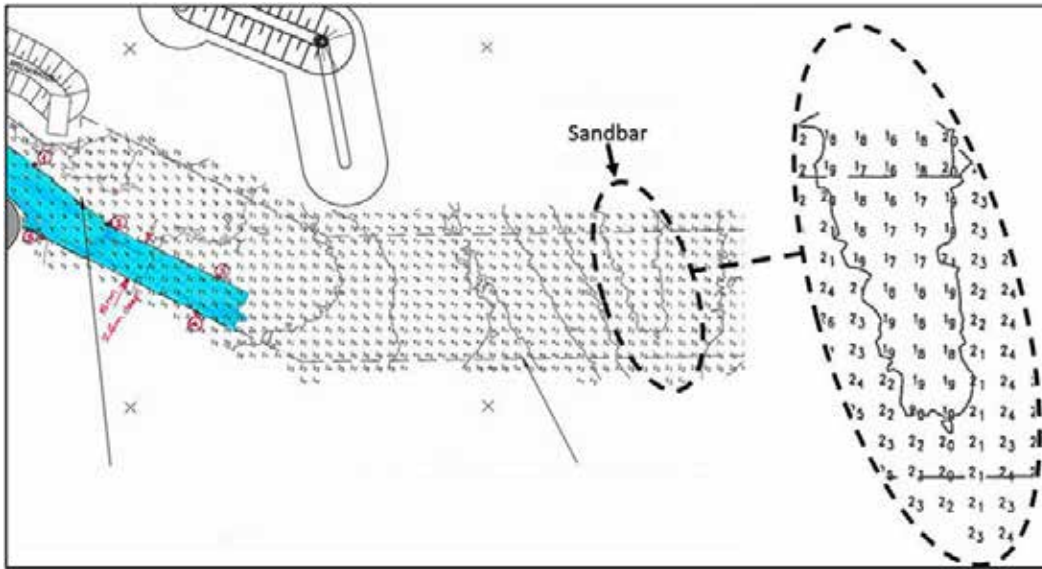
Figure 6. Safety passage diagram with TSB annotations highlighting the sandbar location
(Source: Small Craft Harbours program, Fisheries and Oceans Canada, with TSB annotations)
