**HABITAT COMPENSATION, RESTORATION  
AND CREATION IN THE FRASER RIVER  
ESTUARY.**

***Are We Achieving a No-Net Loss of Fish  
Habitat ?***

**Canadian Manuscript Report of  
Fisheries and Aquatic Sciences No. 2349**

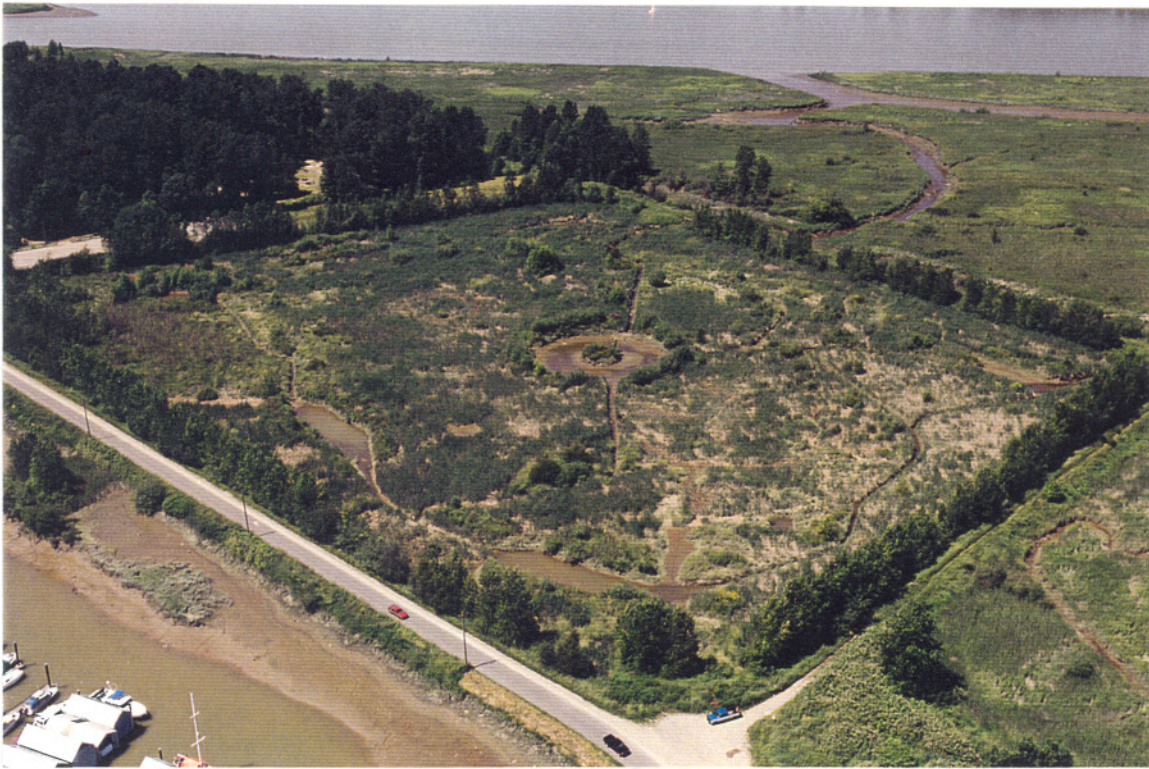
**Site # 09-003, CPR # 09-003 Ladner Lagoon.**

The dyke of this sewage lagoon was breached to restore tidal channels, marsh habitat and riparian vegetation.

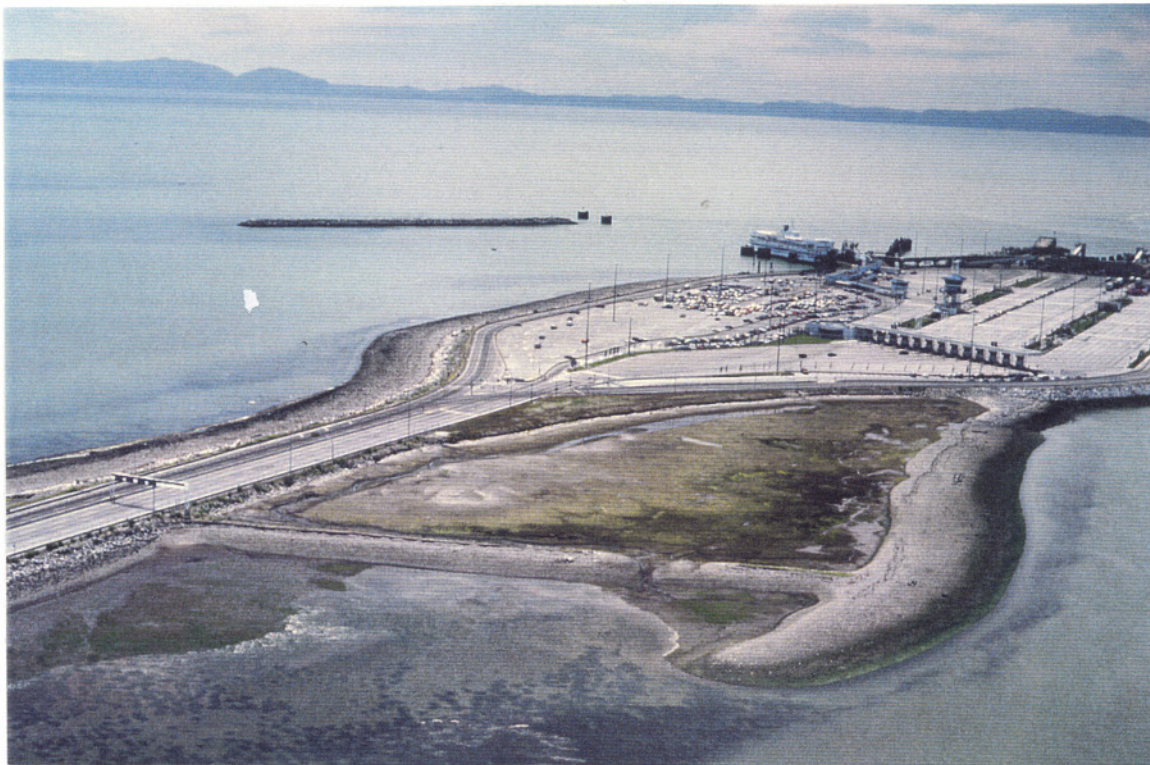
**Site # 07-003, CPR # 9012-0107. Tsawwassen Terminal - Phase 1 Expansion.**

As of 1993, attempts to create a saltmarsh basin as compensation at this site has produced mixed results.

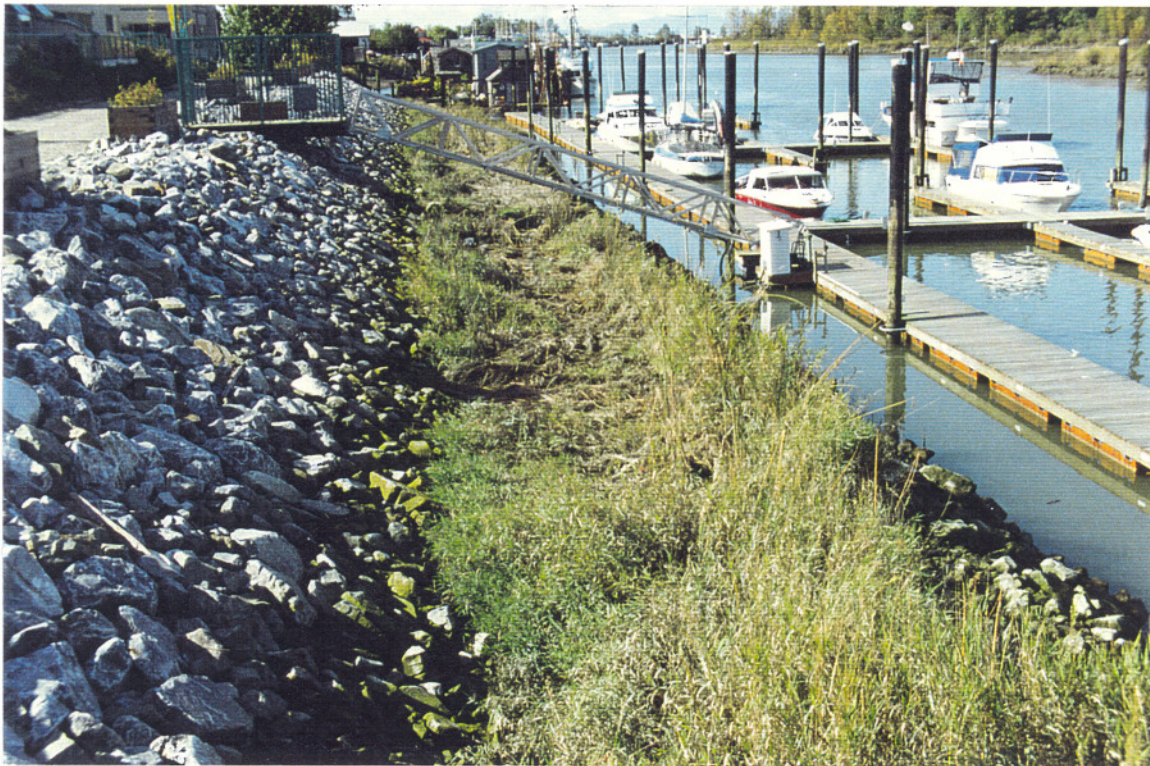
**Site # 09-004, CPR # 8902-0010. Riverwest Condominiums.**

This is an example of a mid-elevation marsh bench that was incorporated into a dyke structure.

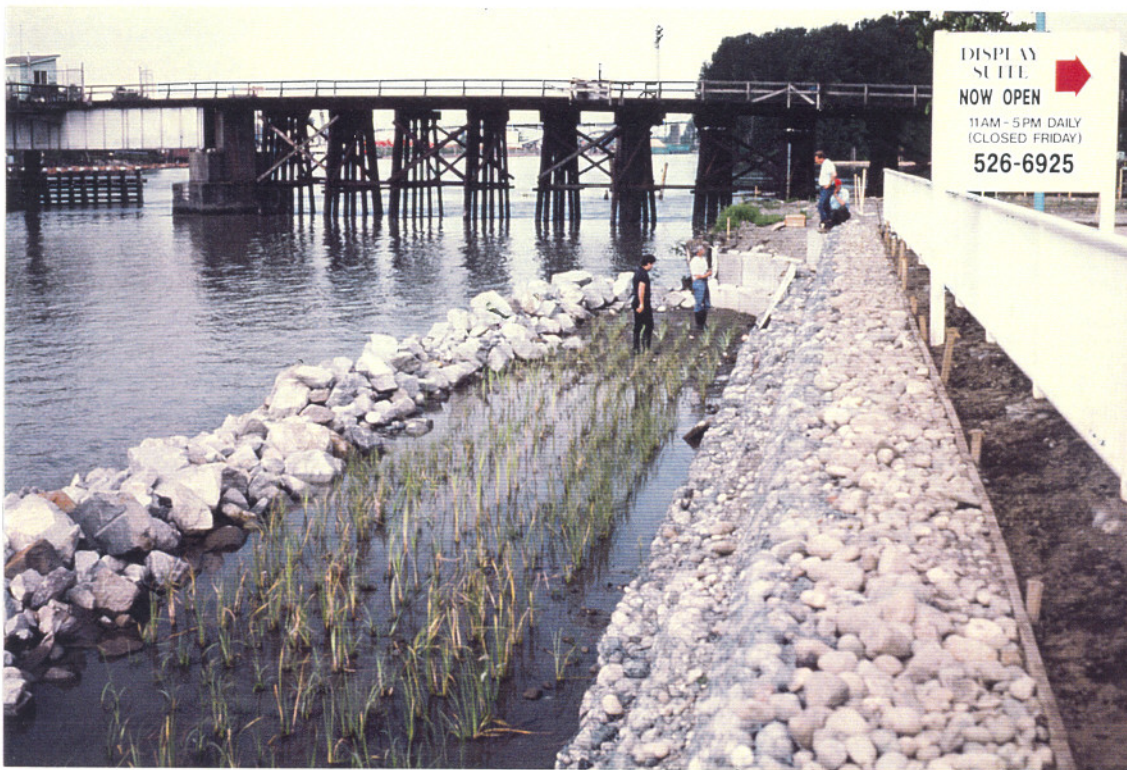
**Site # 13-001, CPR # 8611-0076. Westminster Quay, Phase 1**

This is an example of a high-elevation marsh bench that was incorporated into a rip-rap structure.

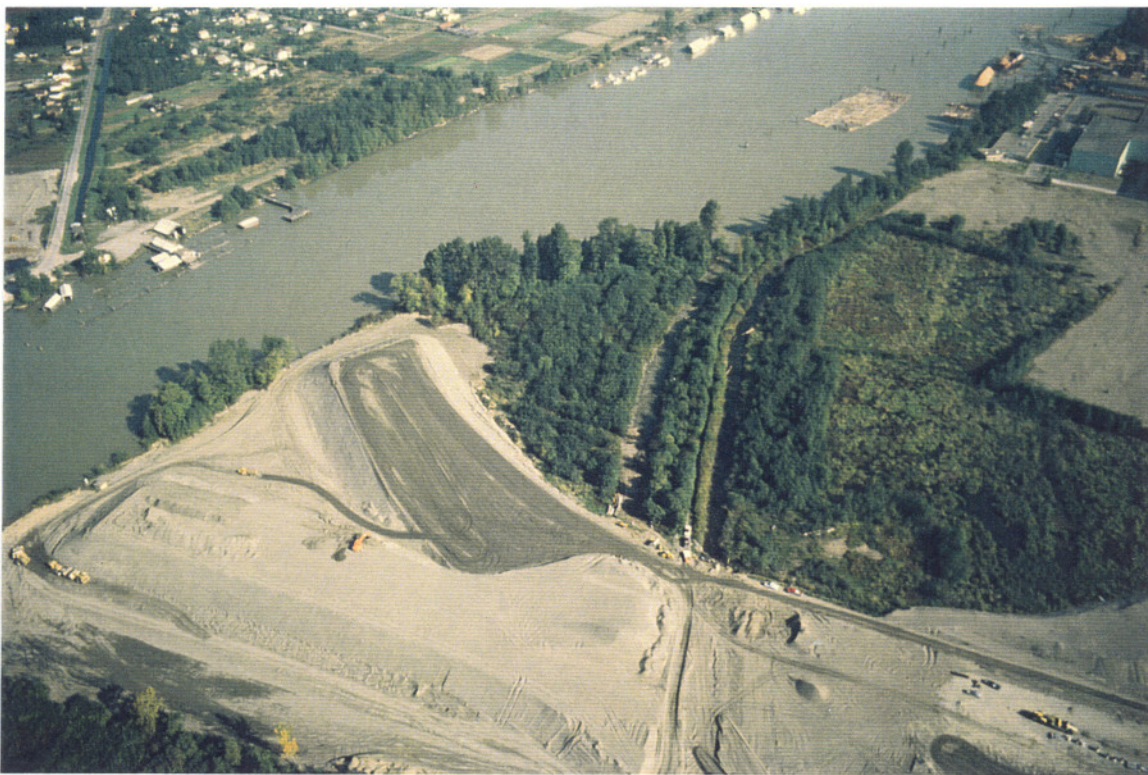
**Site # 11-001, CPR # N.A. Patrick Is. Habitat Compensation.**

Pre-construction aerial view of the compensation site before it was excavated and when it supported an undyked floodplain forest.

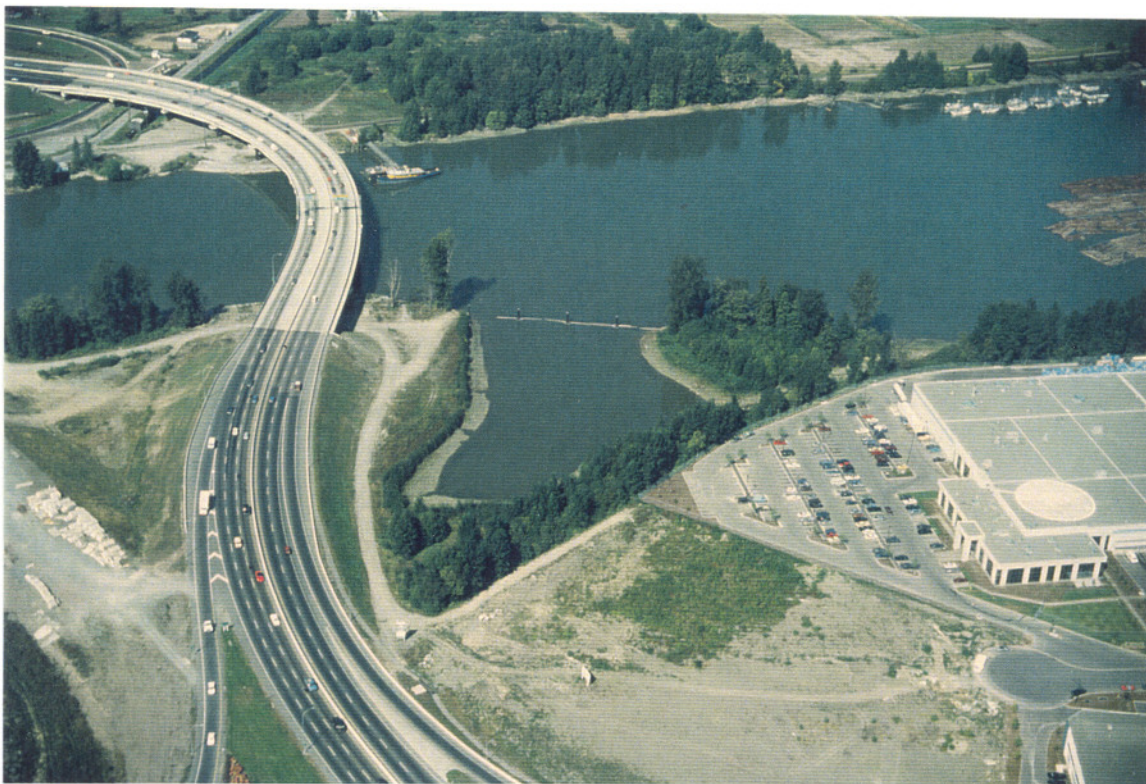
**Site # 11-001, CPR # N.A. Patrick Is. Habitat Compensation.**

Post -construction aerial view of the compensation site when the floodplain forest was replaced with a subtidal embayment and a fringe intertidal marsh and mudflat.
