COMMISSION OF  
INQUIRY INTO THE  
AIR ONTARIO CRASH  
AT DRYDEN, ONTARIO

Final Report

Technical  
Appendices

The Honourable Virgil P. Moshansky  
Commissioner

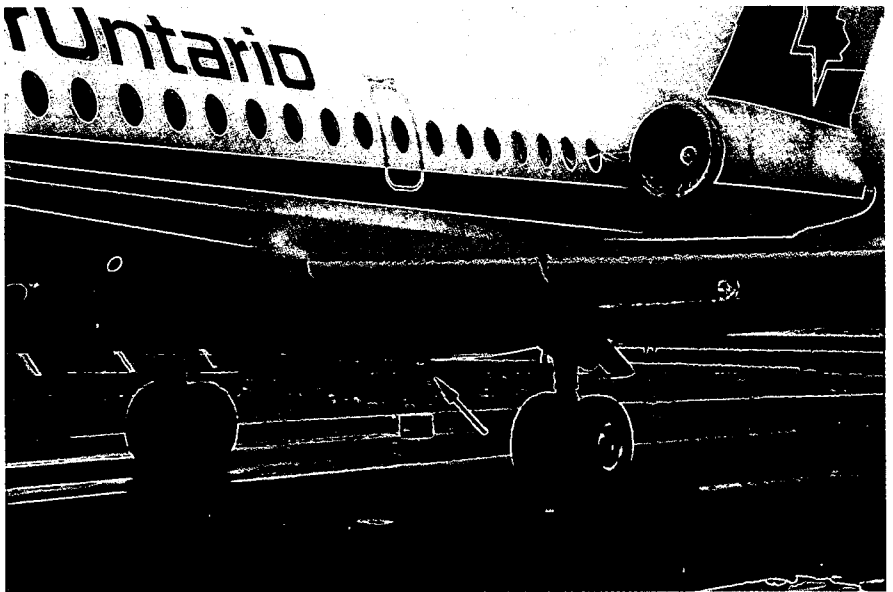
**Figure 3 - View of Fokker F28, C-FONG, showing the location of the anti-collision light mounted on the fuselage belly (arrow).**

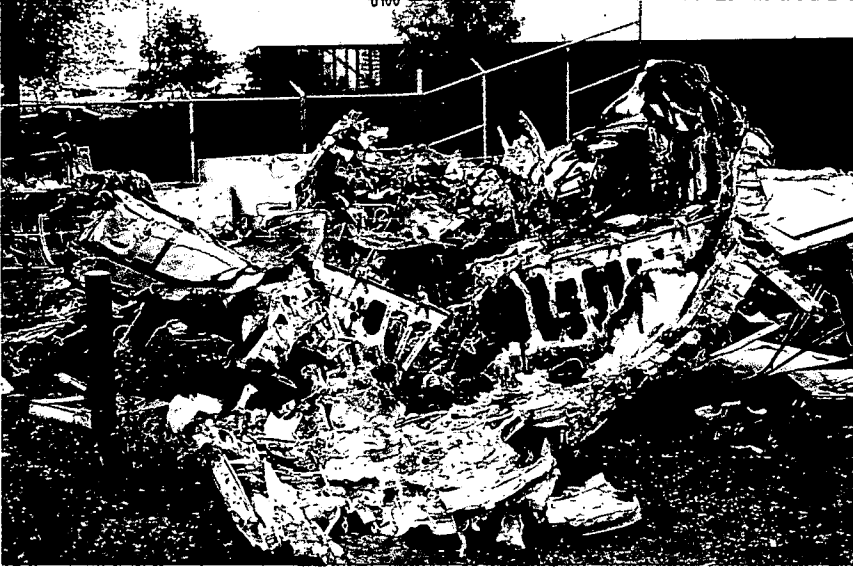
The fuselage from the interior of the cockpit back to the rear pressure bulkhead was gutted by post crash fire. Although the fuselage was gutted the fire appeared to have been more intense on the left side than the right. This is based upon the observation that part of the right side of the fuselage (containing the overwing exit and nine windows) was still in place and the exterior paint scheme, although charred, was still recognizable. The exterior nose of the aircraft was relatively free of fire damage. The cockpit floor was burnt away revealing the remains of the nose gear and steel belts from the tires. The left side of the instrument panel was completely burnt out whereas the centre (engine panel) and right panel were relatively intact although they were also burnt and physically damaged. The engines, tail section and empennage exhibited superficial sooting and the interior of the tail section was in good condition.

All of the wreckage was sorted and a partial reconstruction of the major pieces was carried out. In this manner, the break-up patterns and fire damage could be examined, and all major components of the fuselage and wings could be identified. The tail section was essentially intact, and although the cockpit area was gutted due to post-impact fire, it was roughly in one main piece. A general photo of the burned out cabin area of the fuselage is shown in Figure C-1.

Fuselage view from rear showing burnt out cabin area.
