## Metal Can Defects

Identification and Classification

### TABLE OF CONTENTS - DOUBLE SEAM DEFECTS

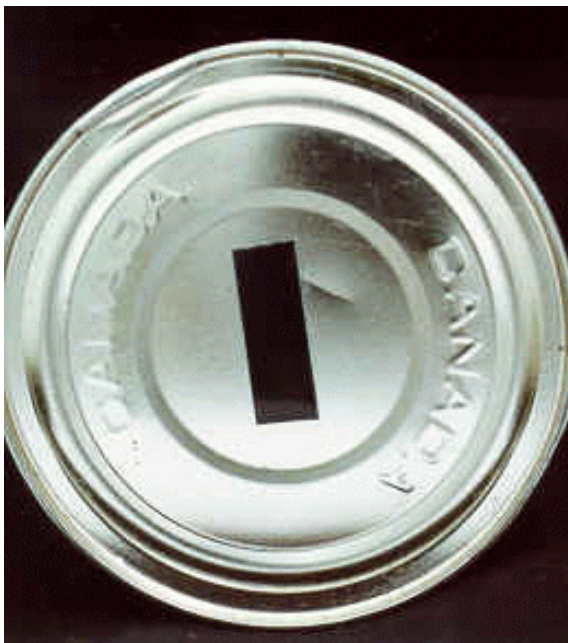
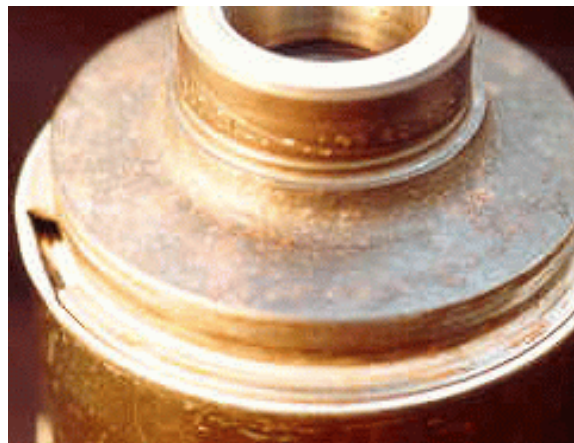
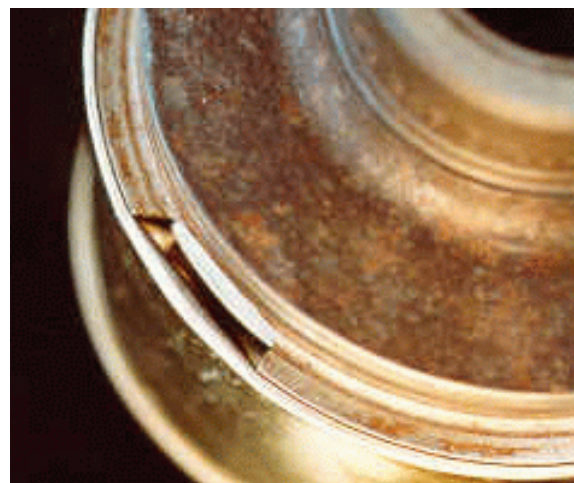
### DEFECT: BROKEN CHUCK

A broken chuck is considered a serious seam defect, due to absence of tightness at the point of the defect.

A portion of the double seam which is not properly ironed-out because of a void in the chuck lip (insufficiently tight), and appearing as an irregularity on the countersink wall of the seam.

1. Chipped seaming chuck caused by a jam-up, or improper set-up.
-

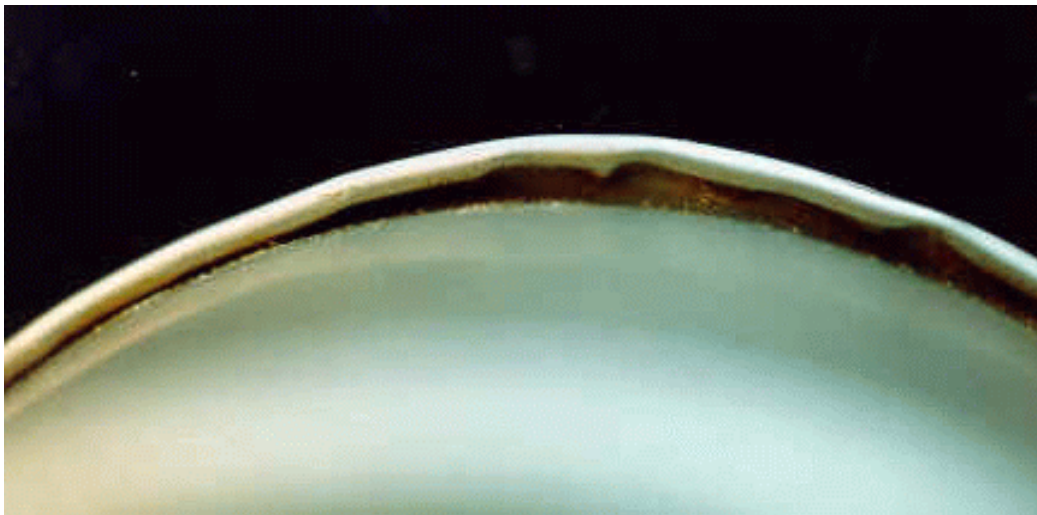
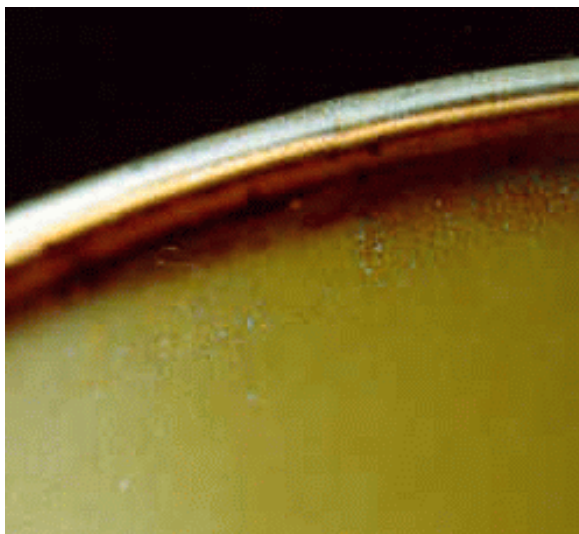
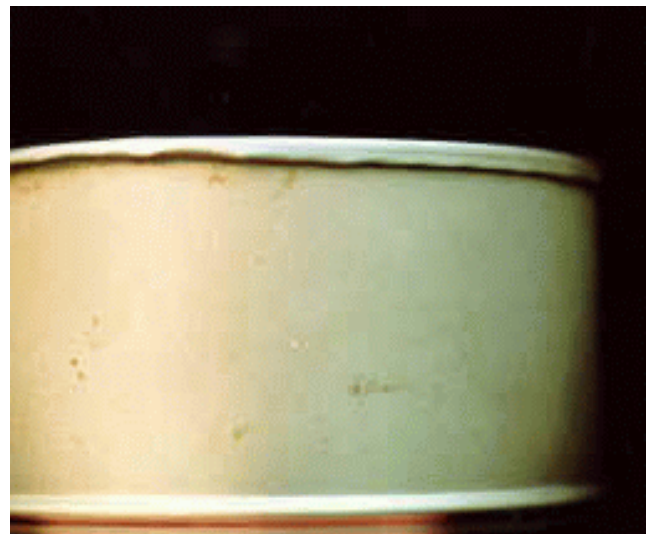
**DEFECT: CLINCHED ONLY**

Clinched only is considered as a serious double seam defect.

Only the clinching operation was completed. Cans are removed to check the clinching operation; these cans must be replaced so that the seaming operation will be completed.

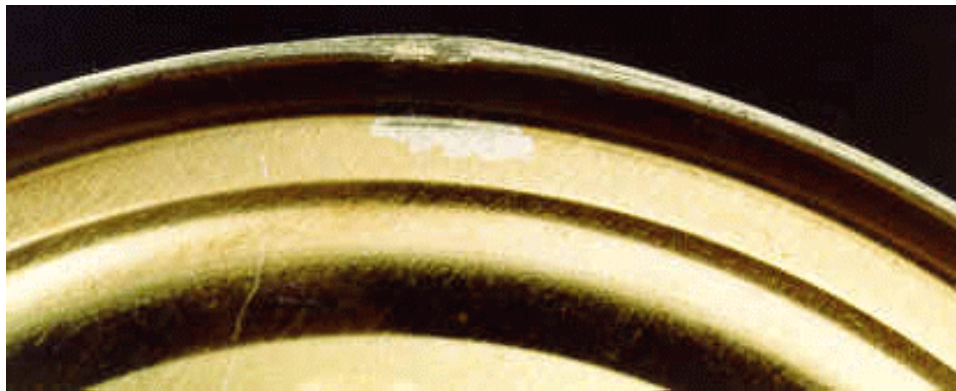
**DEFECT: CUTOVER**

A cutover is a sharp seam that has fractured and is considered a serious seam defect. A sharp seam is considered a minor seam defect.

A sharp seam is a sharp fin of metal formed when the seaming panel radius of the end is forced over the top of the seaming chuck flange during the seaming operation. Cutovers are sharp seams which have fractured and often occur at the crossover and with product inclusions but may occur all the way around the double seam; are best detected by running a finger around the inside of the seam. Alternate Terms: Wire Edge, Feather, Feather Edge

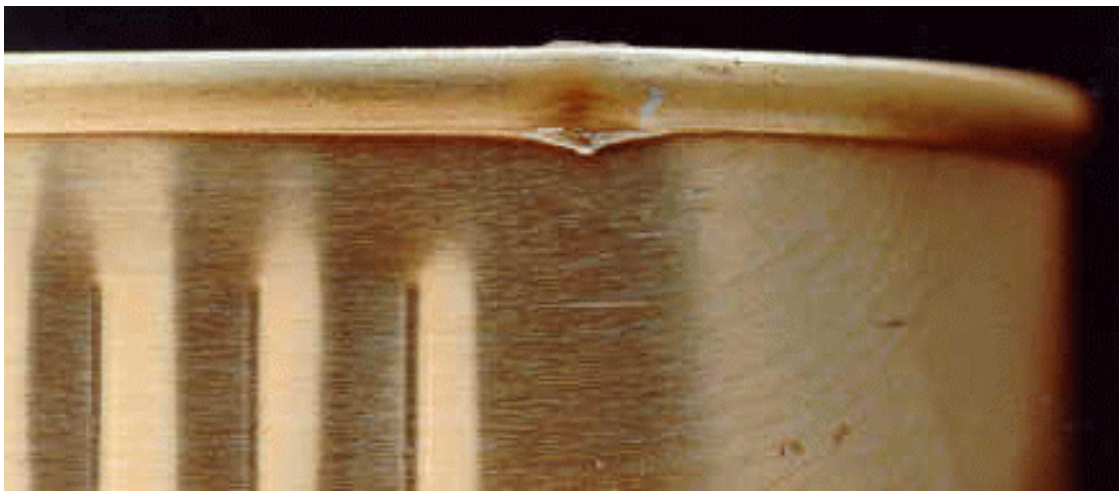
### DEFECT: CUTOVER

Cutovers are often accompanied by other external double seam defects (as shown above KDC with Cutover)

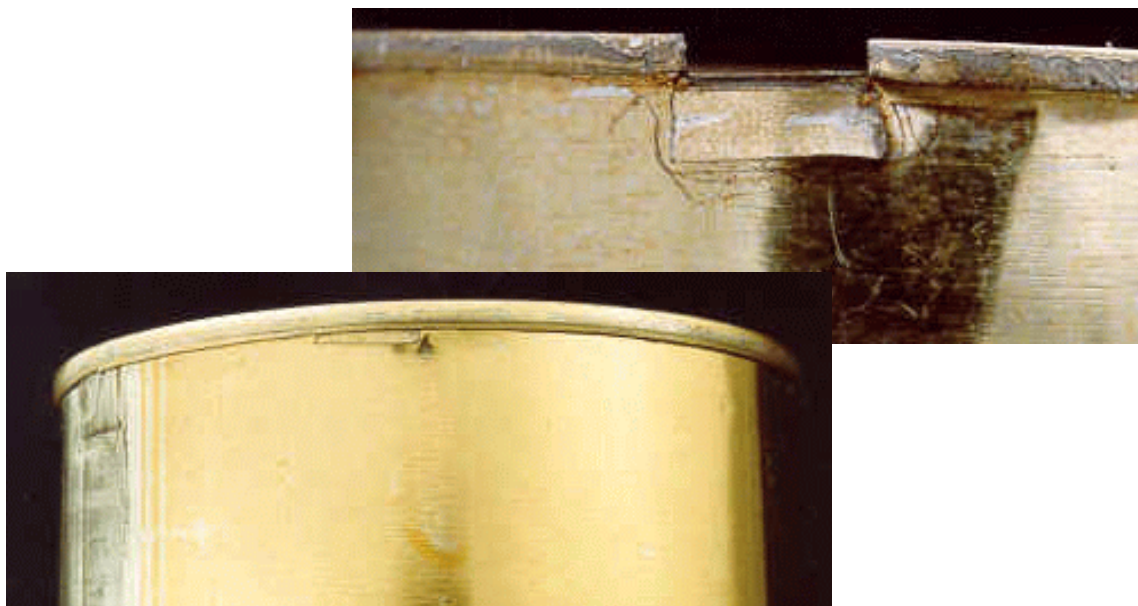
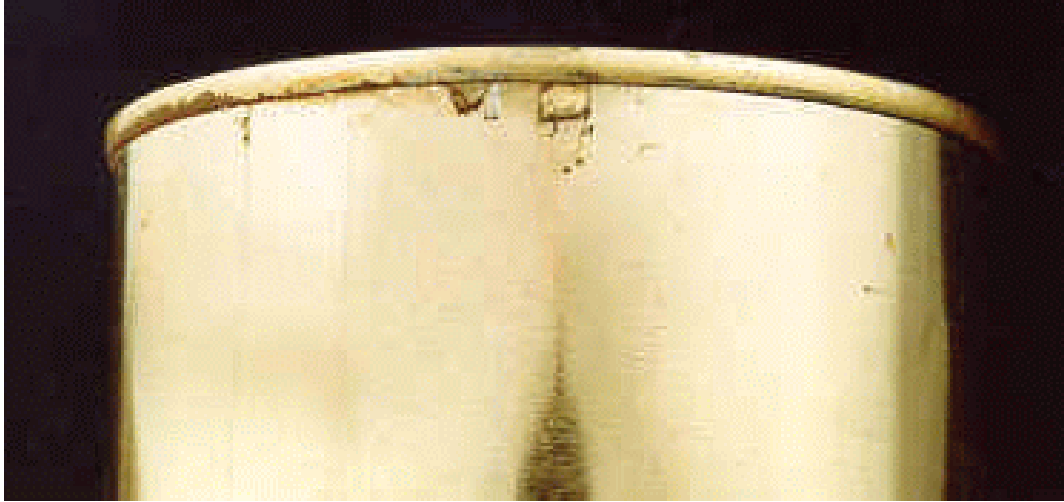
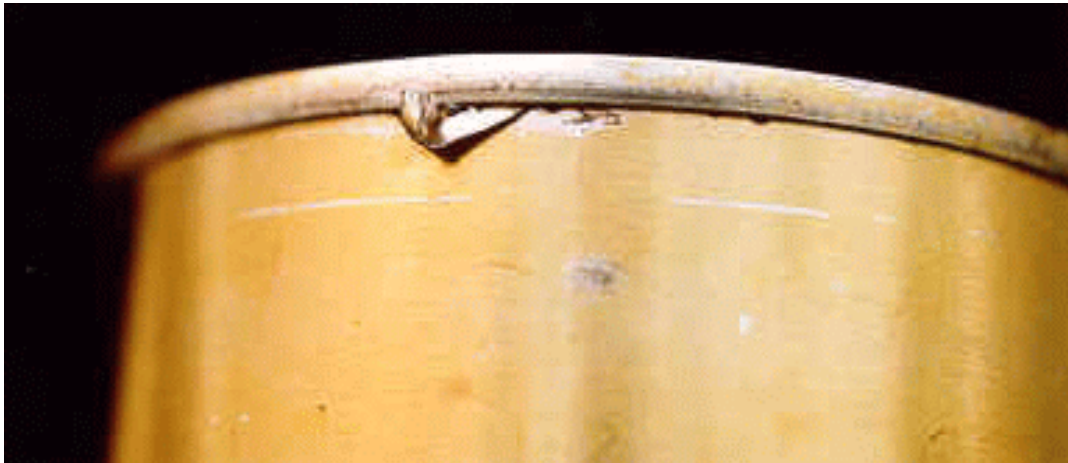
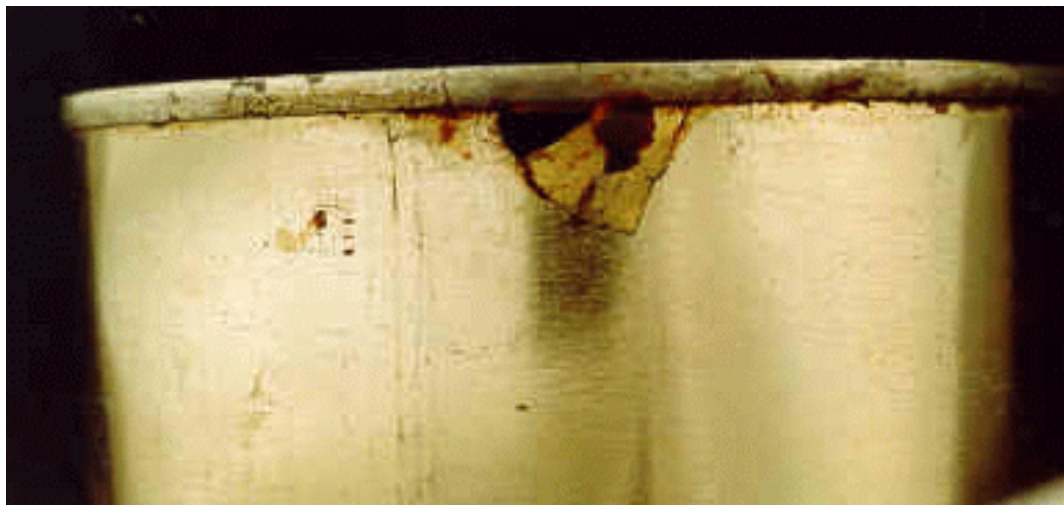
### DEFECT: CUT-DOWN FLANGE (CDF)

A cut-down flange is considered a serious seam defect due to the absence of overlap.

A portion of the body flange which is torn or cut with part of the flange turned back against the can body, without being engaged with the end hook, and may protrude below the bottom of the normal seam. Severe forms of this defect result in a hole in the can body just below the double seam.

A unique type of CDF is the "index fault" found on reformed cans which consists of a characteristic tear in the flange approximately 10-15 mm from the reform ridge on the can body, due to flange damage caused by the reformer picker finger.

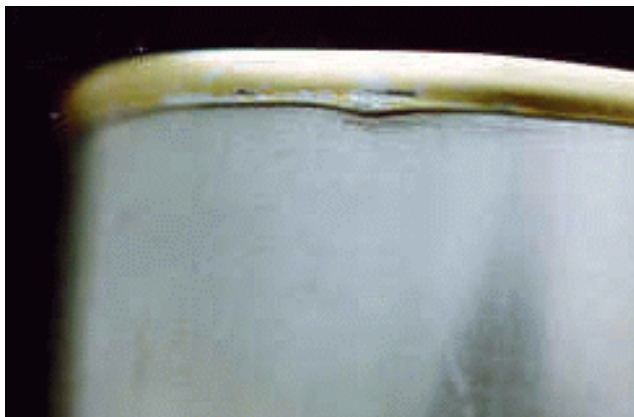
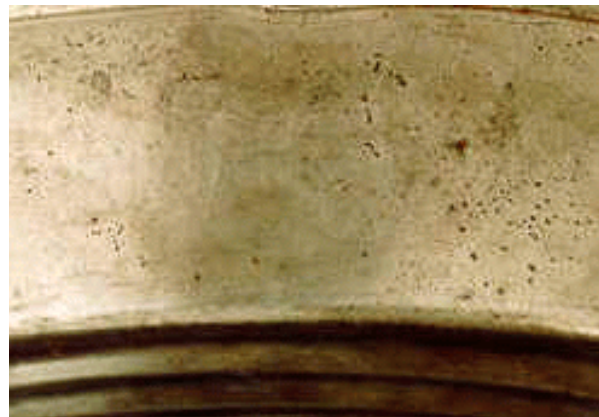
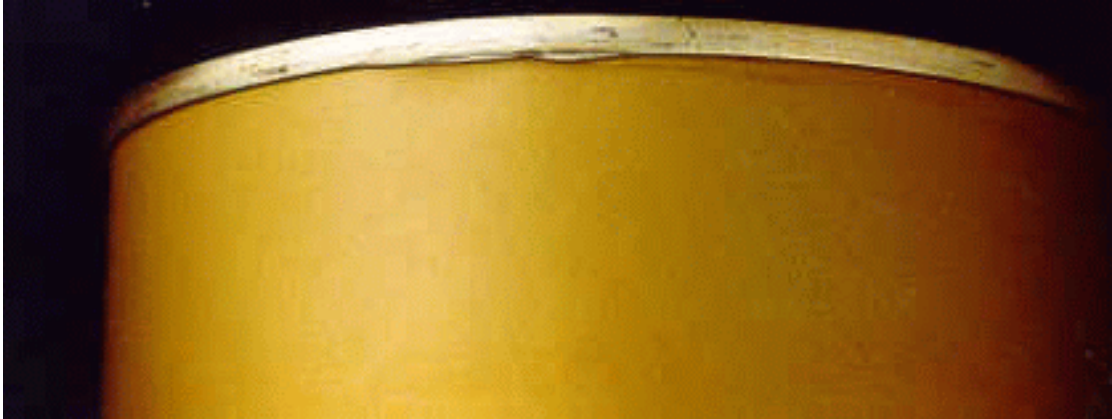
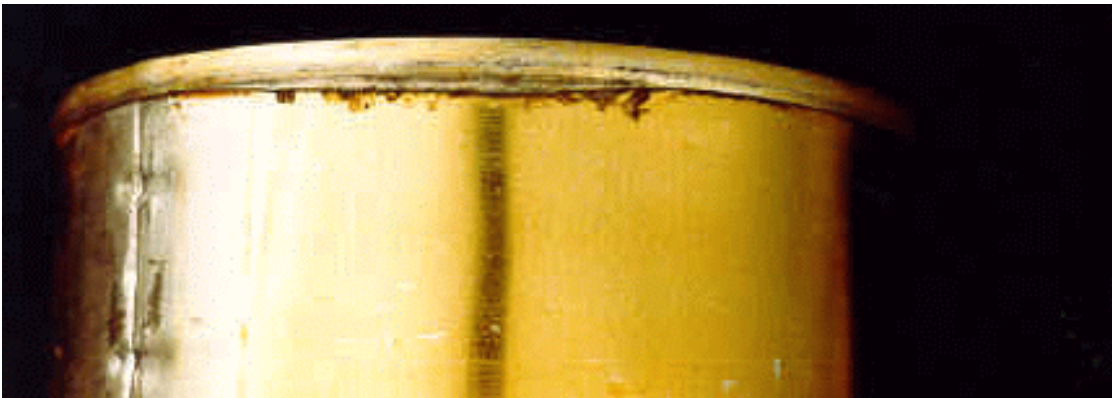
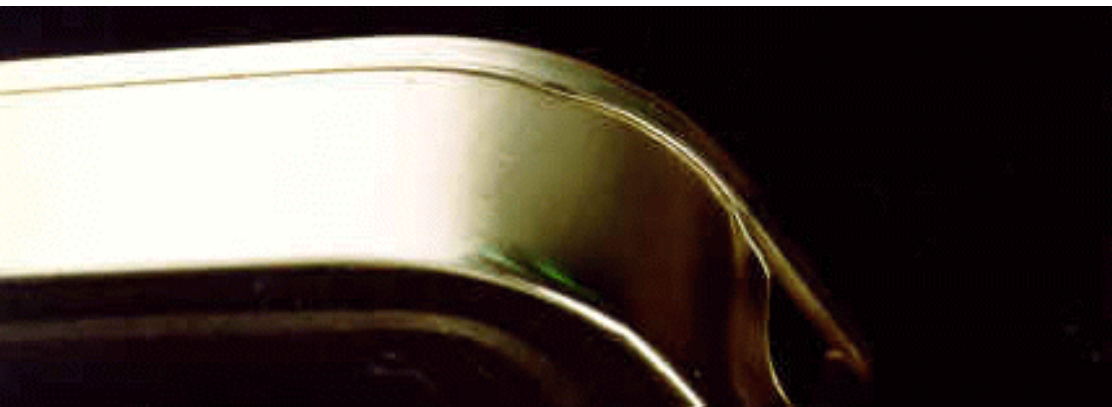
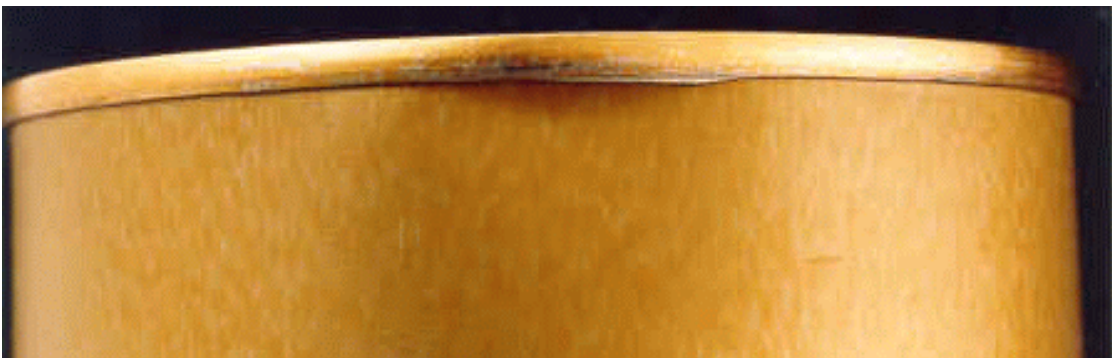
### DEFECT: DROOP

Any droop assessed as having 25% or less optical overlap will be classified as a serious double seam defect.

Any droop assessed as having 25% to 50% optical overlap will be classified as a minor double seam defect.

A smooth projection of the end hook of the double seam below the bottom of the normal seam. A droop which shows signs of second operation roll marks will be assessed for classification in terms of overlap; otherwise see FRACTURED SEAM (7.5.7).

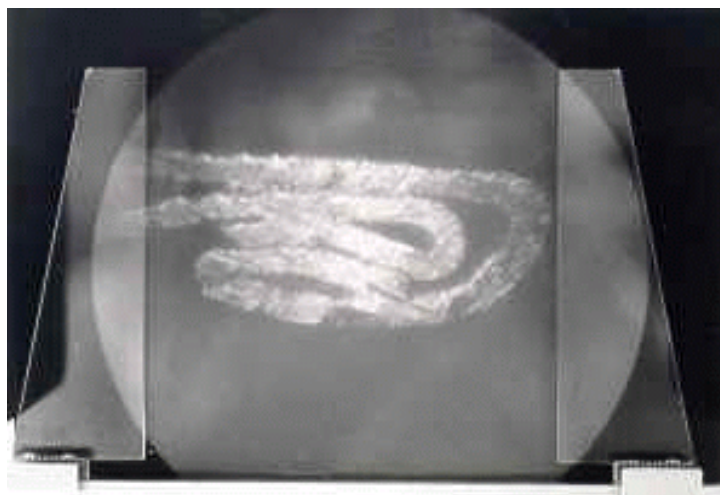
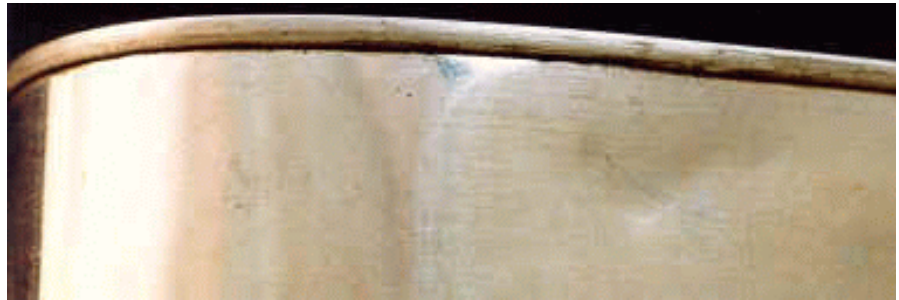
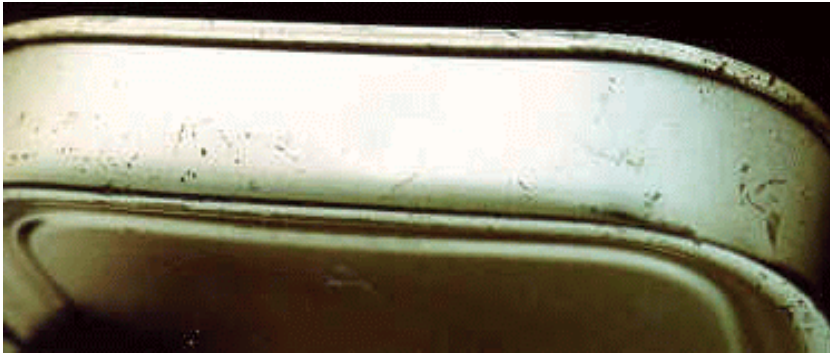
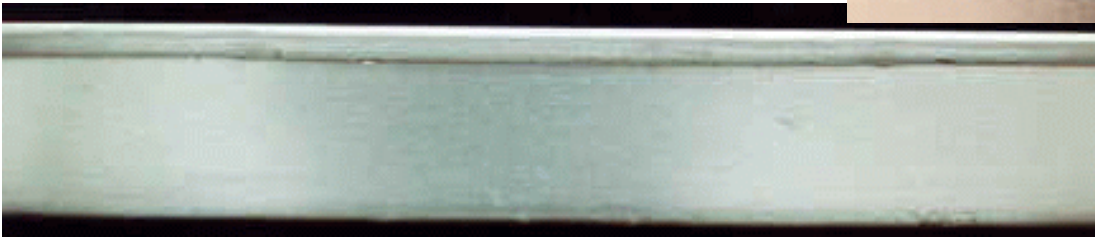
### DEFECT: FALSE SEAM

A false seam is considered a serious seam defect due to the absence of overlap.

A defect where a portion of the body flange is bent back against the body, without being engaged with the end hook, but does not protrude below the bottom of the end hook radius. This is similar to a knocked-down flange defect where the body flange is visible below the end hook radius. This defect is difficult to observe and requires close visual inspection of the underside of the double seam where sometimes two layers of metal can be seen. Confirmation of this classification often requires a seam cut to observe the configuration of the end curl and body flange.

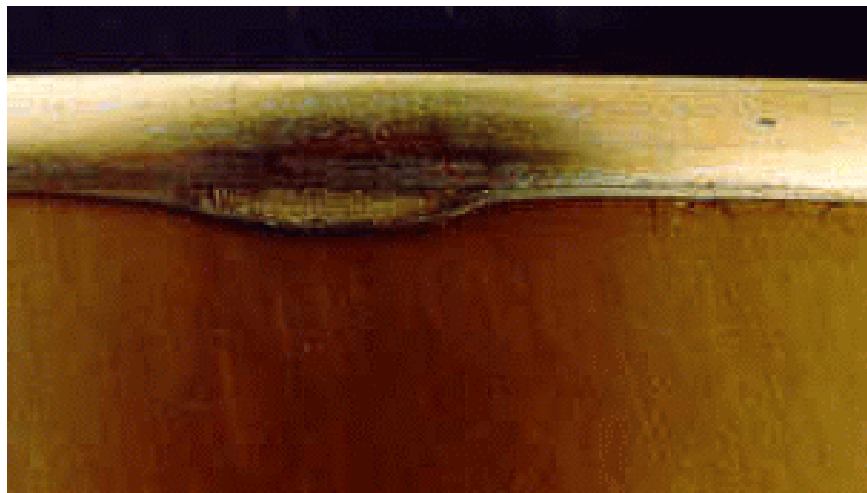
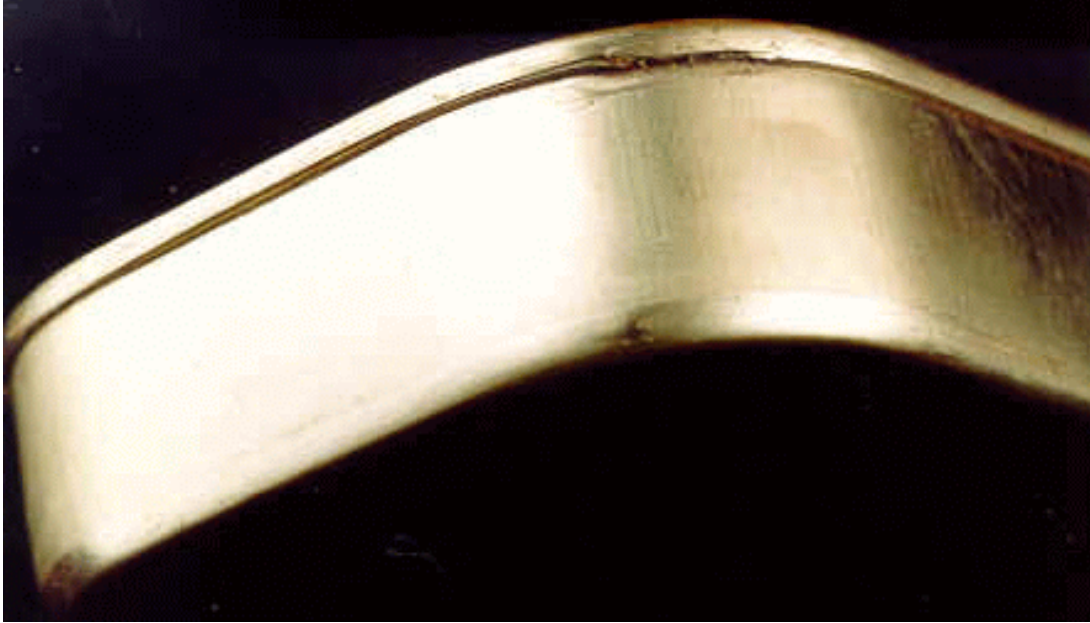
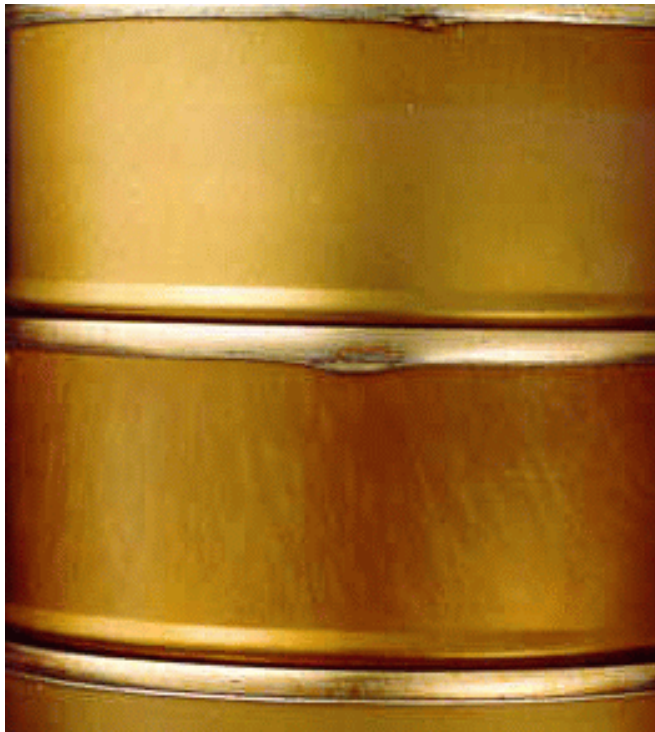
### DEFECT: FRACTURED SEAM

A fractured seam is considered a serious seam defect when the metal is fractured.

A fracture or break in the end hook radius. This defect may be difficult to observe without magnification. Seams which show second operation roll marks should be closely examined for this defect, particularly at the side seam or if a droop is present.

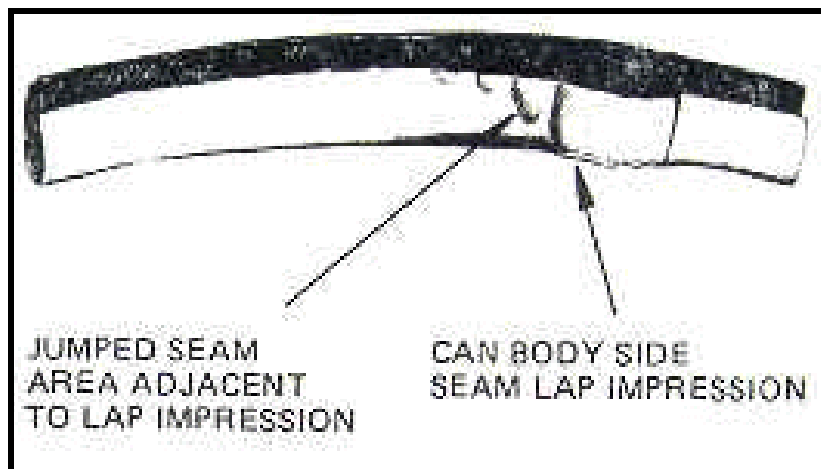
### DEFECT: JUMPED SEAM

A jumped seam is considered a serious seam defect due to inadequate seam tightness.

Externally, this defect may appear as a looseness of the seam at one side of the crossover. Internally this defect appears as two or three looseness wrinkles at one side of the crossover. The defect occurs when the seaming rolls jump off the extra thickness of the crossover area. The side of the crossover on which the defect occurs depends on the seaming roll direction in relation to the crossover.

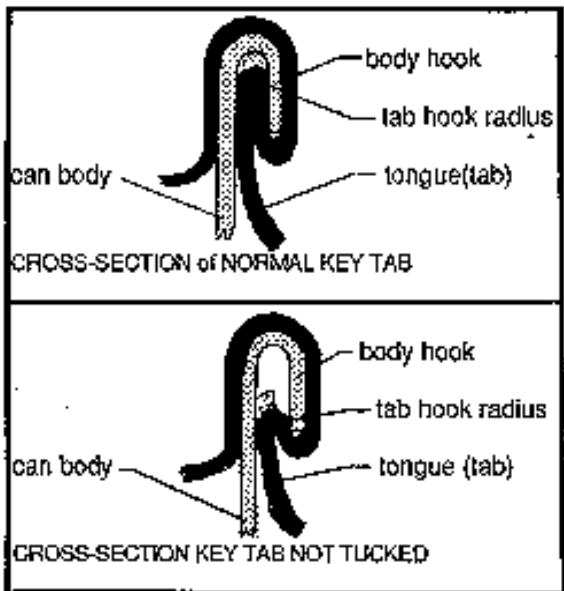
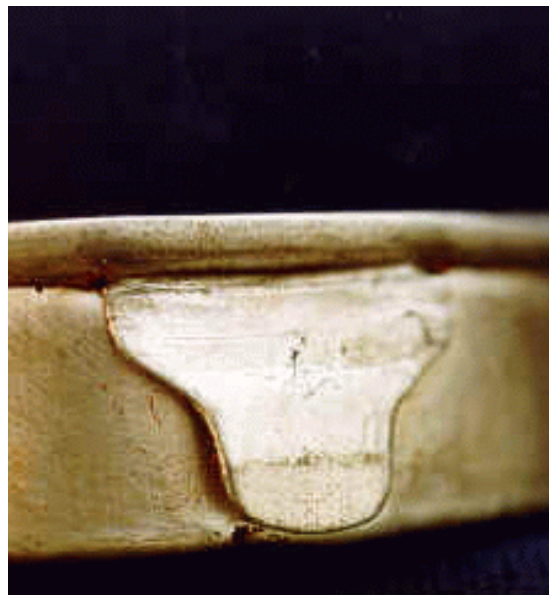
**DEFECT: KEY TAB NOT PROPERLY TUCKED**

Key tab not properly tucked is considered a serious double seam defect if:

- 1) there is insufficient overlap (7.5.8) present at the key tab area of the double seam; or
- 2) there are vees present adjacent to key tab; or
- 3) there is evidence of leakage.

The key tab portion of end curl not properly incorporated into the double seam resulting in reduced or no overlap. The key tab may be cocked (crooked) or extended downward (partially or completely). Vees may be present on either side of the key tab and the double seam may be fractured.

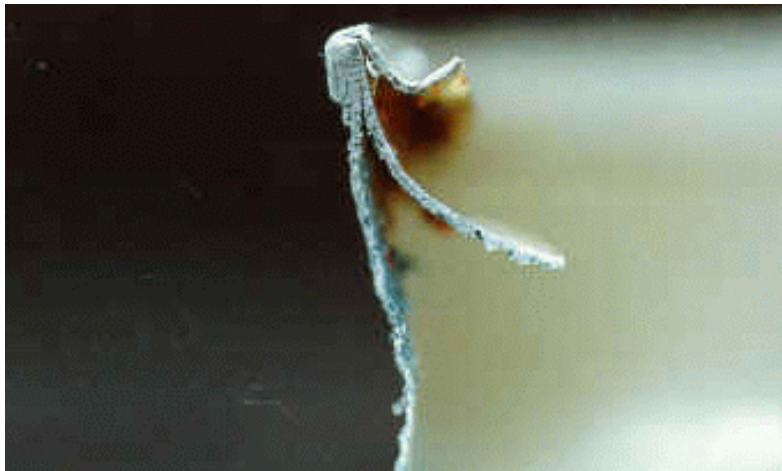
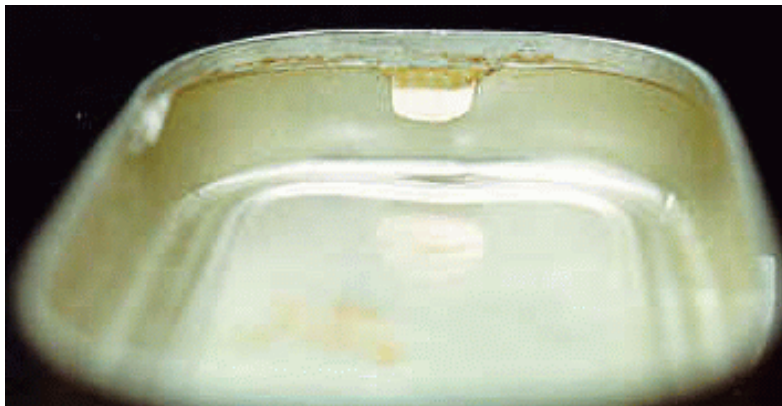
**DEFECT: KEY TAB SEAMED TO INSIDE**

A key tab seamed to the inside of the double seam is considered a serious double seam defect.

The key tab is not visible from the exterior of the can. There may be vees on either side of the area where the key tab is normally located. The tab is seen on the inside of the can when opened.

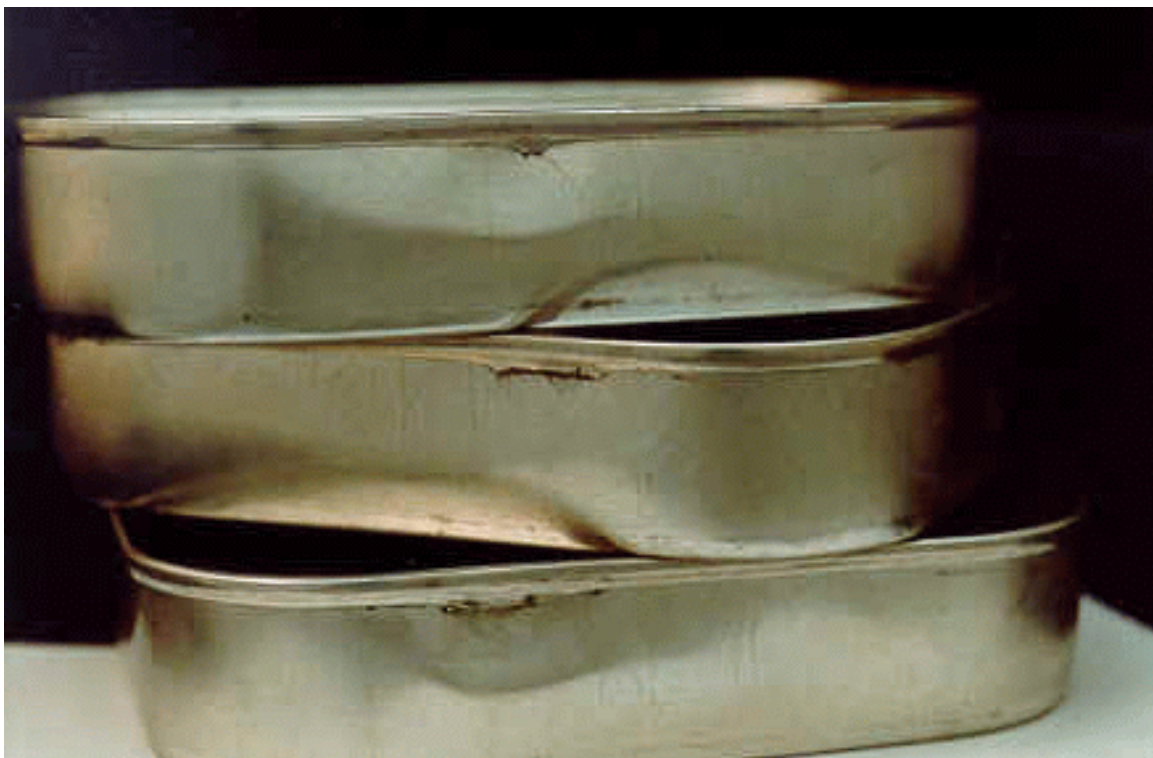
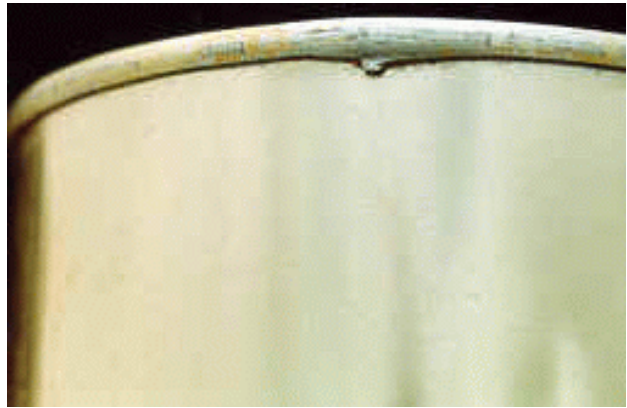
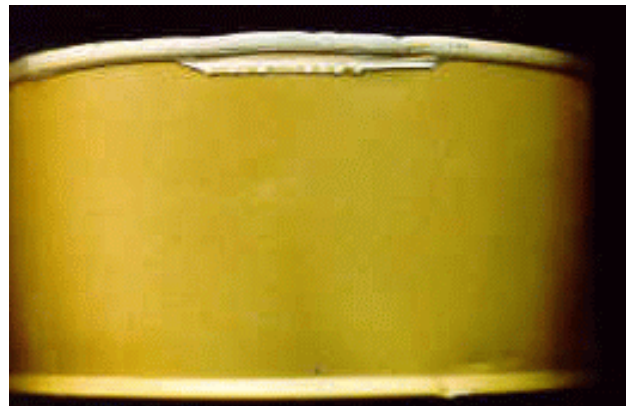
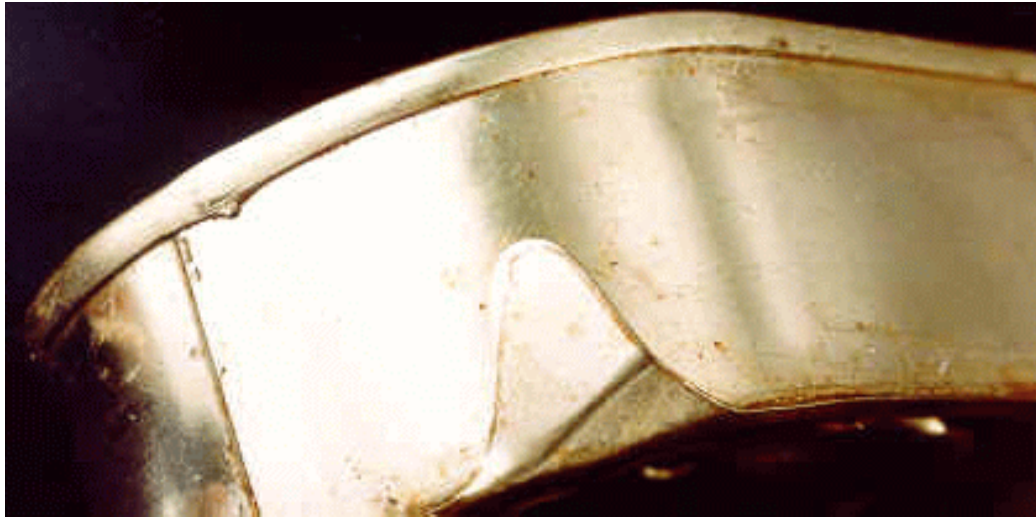
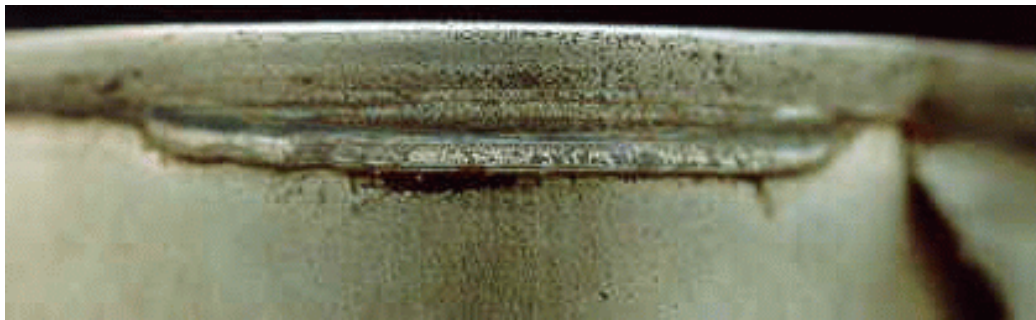
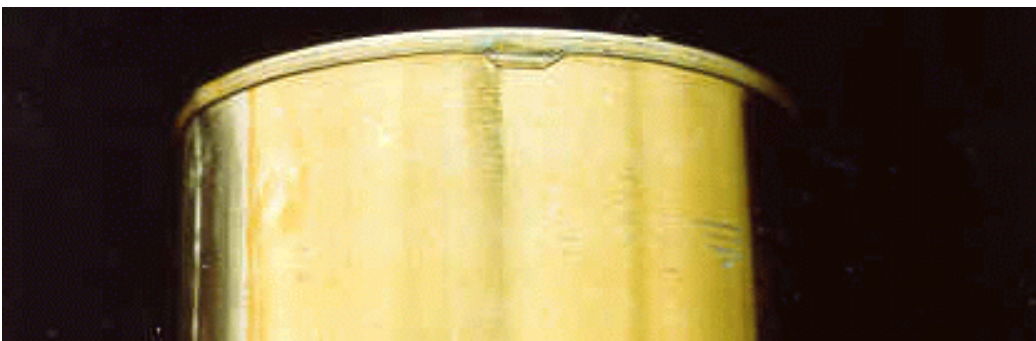
### DEFECTS: KNOCKED-DOWN CURL (KDC)

A knocked-down curl is considered a serious double seam defect due to the absence of overlap.

A portion of the end hook which is not engaged with the body hook but is turned down against the can body exposing the cut edge of the end plate. Variations of this defect can range from a 'V' with the edge of the end plate exposed, to complete knocking-down of the end hook all the way around the can.

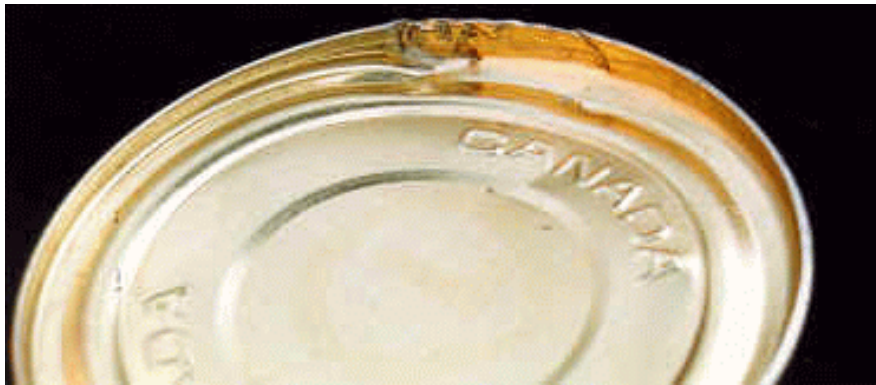
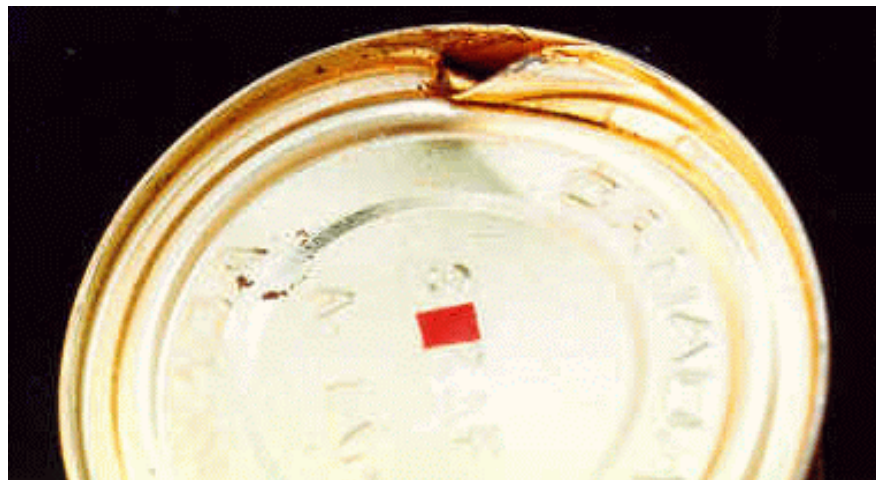
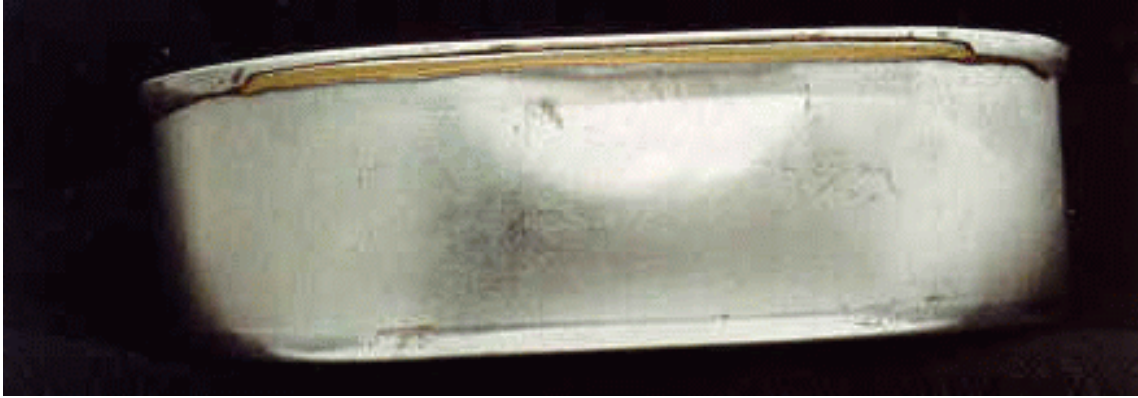
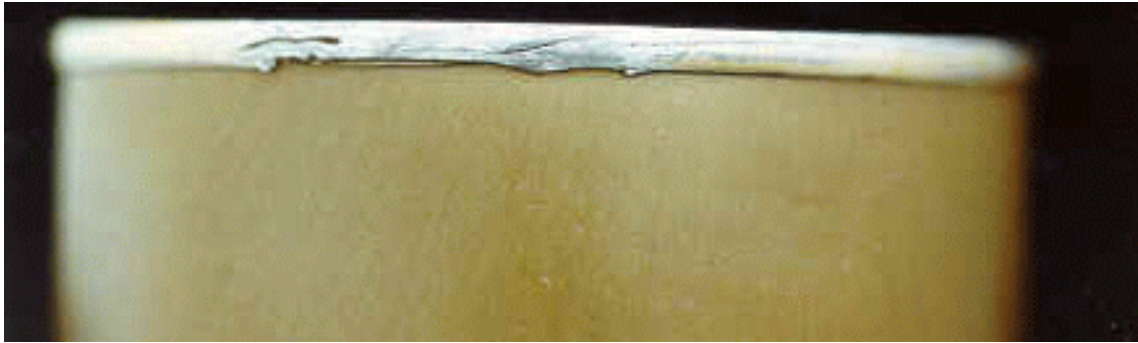
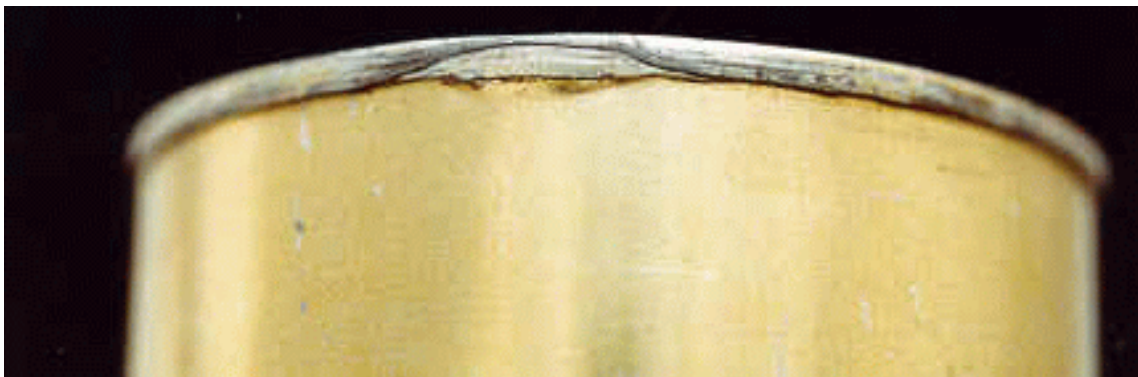
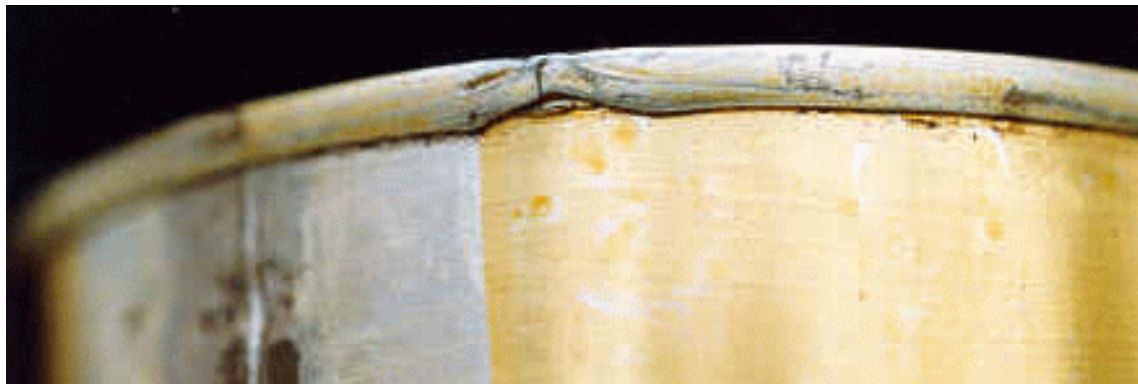
### DEFECT: KNOCKED-DOWN END (KDE)

A knocked-down end is considered a serious seam defect, due to the absence of overlap.

Severe distortion of the can end, as though struck by a downward blow inside the countersink, such that the hooks are disengaged or fail to engage, and part of the curl is pulled back to expose the flange. In severe forms of this defect the end curl is pulled back to expose (form) a hole in the can end.

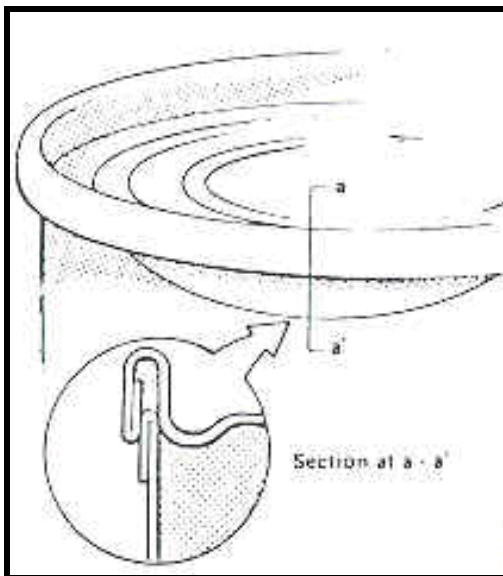
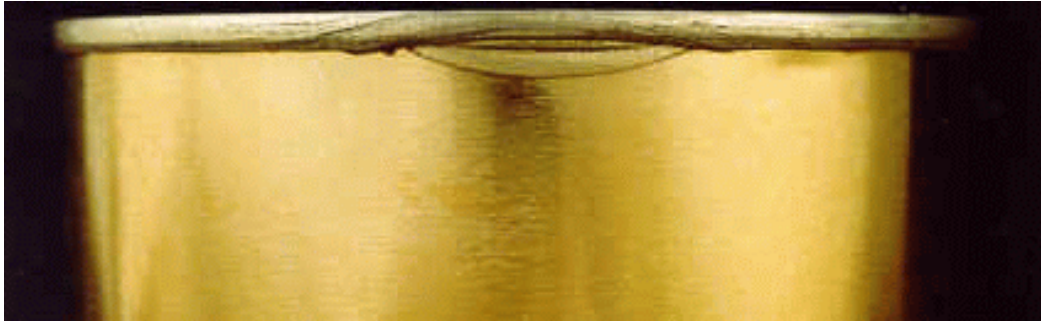
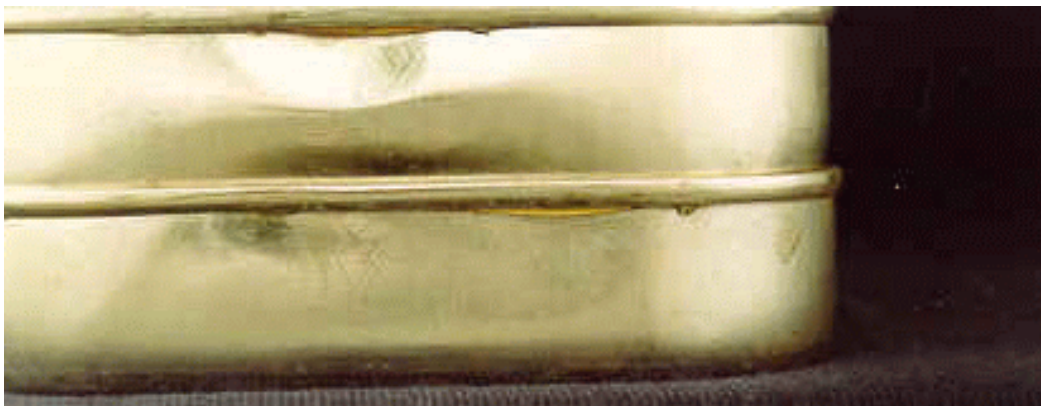
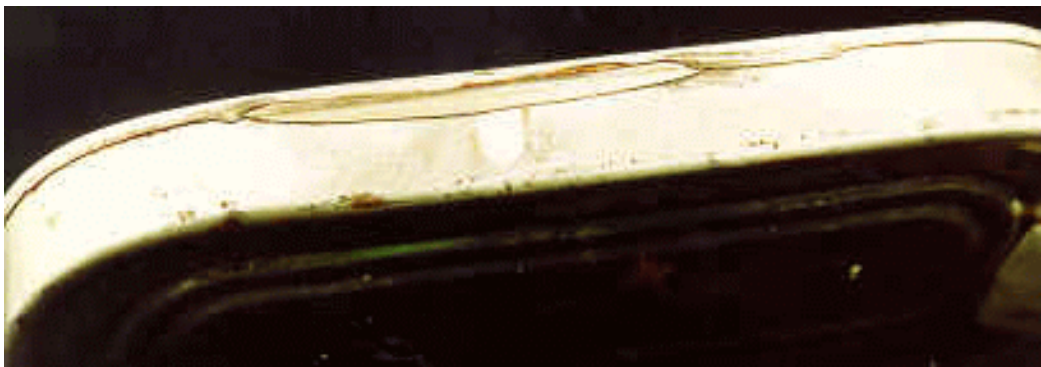
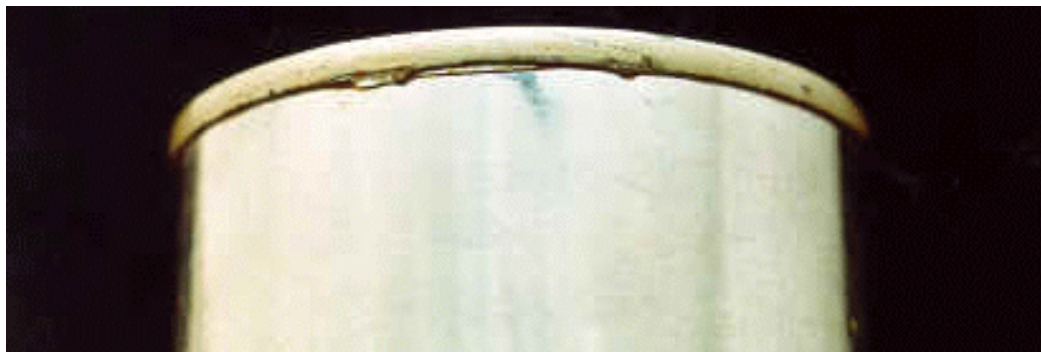
**DEFECT: KNOCKED-DOWN FLANGE (KDF)**

A knocked-down flange is considered a serious seam defect due to the absence of overlap.

A portion of the body flange which is bent back against the body, without being engaged with the end hook, and protruding below the bottom of the end hook radius. This is similar to a false seam defect where the body flange is not readily visible below the end hook radius. Severe forms of this defect involve knocking-down of both the flange and body leaving a distinctive gap between the can end and body. When caused by a feed screw (spacer) on the canning line, the defect has a distinctive "V"-shaped dent to the flange and body with a "signature" scratch down the centre.

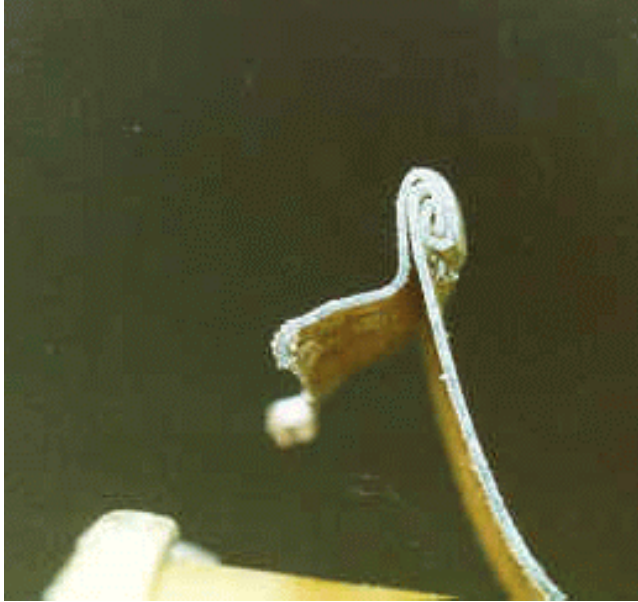
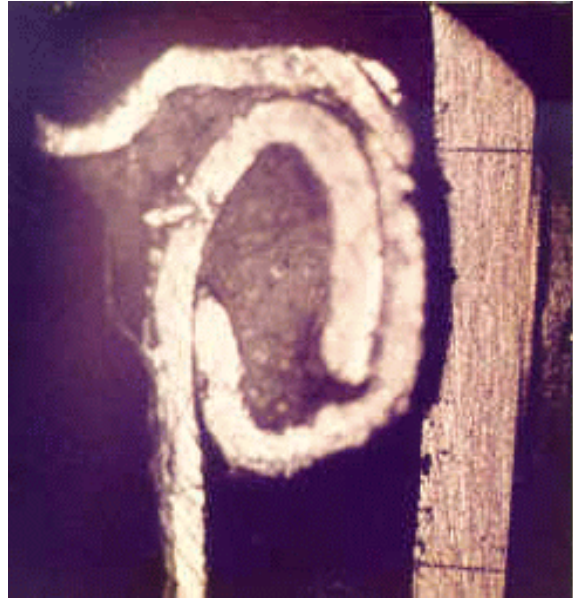
**DEFECT: LOOSE SEAMS**

A loose seam is considered a serious double seam defect if:

- 1) seam tightness is less than the minimum required by the can manufacturer's guidelines; or
  - 2) for round can product where can manufacturer's published guidelines are not available, tightness ratings as specified in table 4.1.5 will be applied; or
  - 3) containers which are non-round and are designed for no vacuum, and where can manufacturer's guidelines are not available, tightness ratings are less than 50%, and for other non-rounded containers and where manufacturer's guidelines are not available, tightness ratings as specified in table 4.1.5 will be applied; or
  - 4) there is any evidence of leakage; or
  - 5) the percentage "free space" exceeds 33% of the combined metal thickness comprising of the double seam or the percentage "compactness" is less than 75% in the prime sealing area.
-

A loose seam is normally characterized by one or more of the following conditions: rounded appearance of the double seam profile (a bowed seam configuration); seam thickness which exceeds accepted can manufacturer's guidelines; the can has a faint or no pressure ridge; and a low tightness rating. In severe examples of loose seams, the body hook and the end hook of a cut out (seam saw cross section) double seam may slide apart. This slippage condition in the double seam would demonstrate loose seam condition.

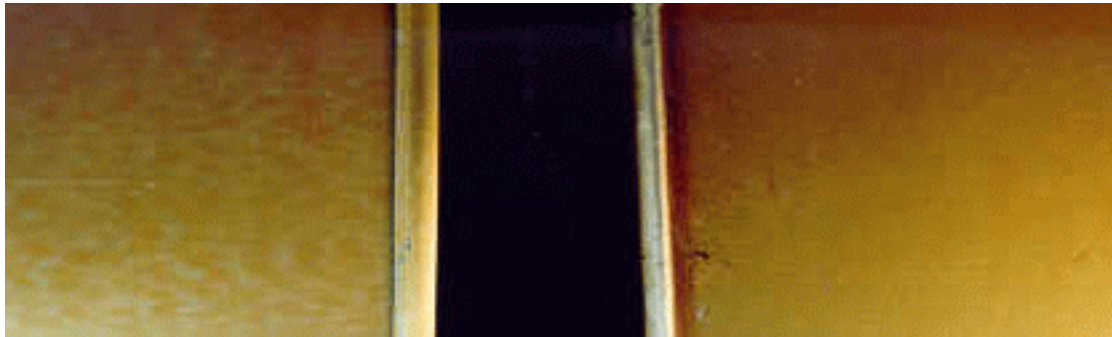
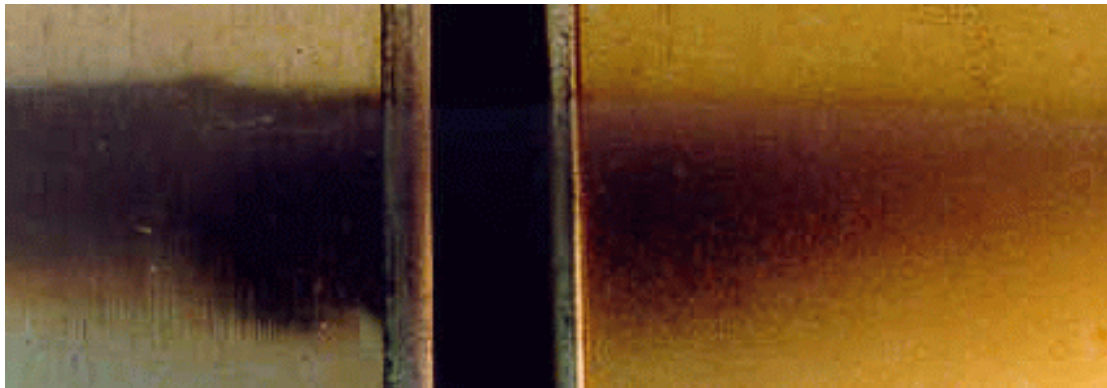
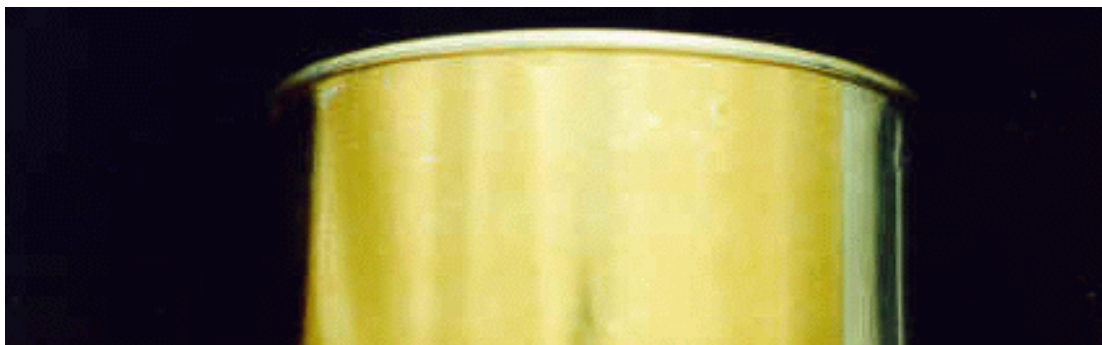
NO SECOND OPERATION

No second operation is considered as a serious double seam defect.

Only the first operation was completed. Cans are removed to check the first seaming operation; these cans must be replaced so that the second operation seaming will be completed.
