## Metal Can Defects

Identification and Classification

### TABLE OF CONTENTS - DOUBLE SEAM DEFECTS

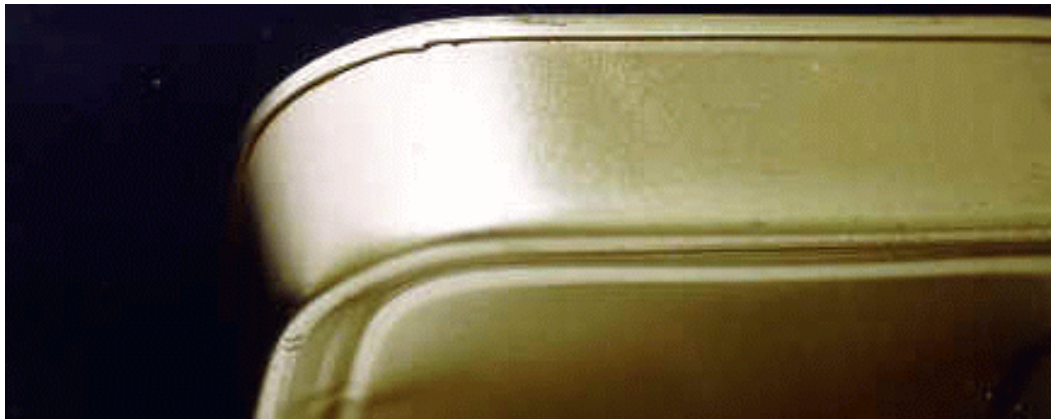
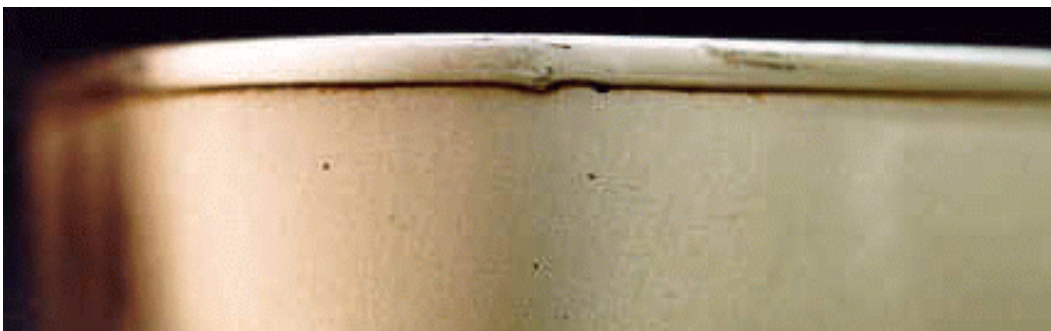
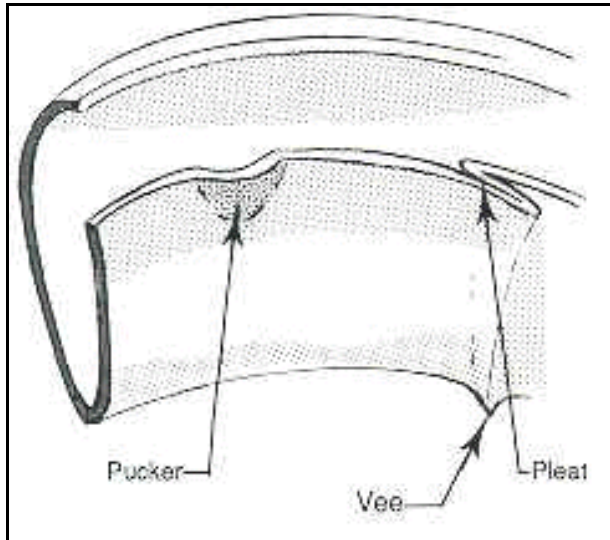
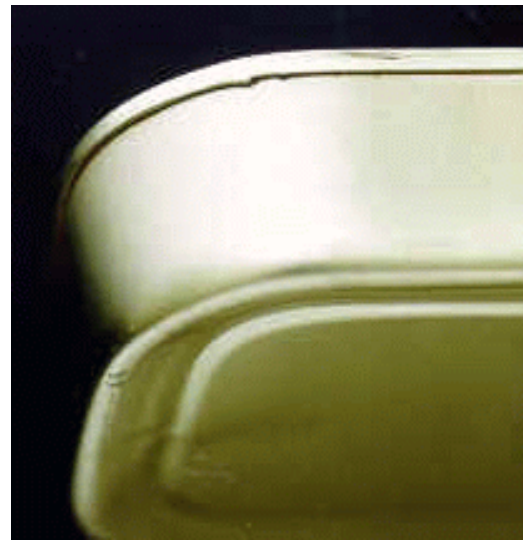
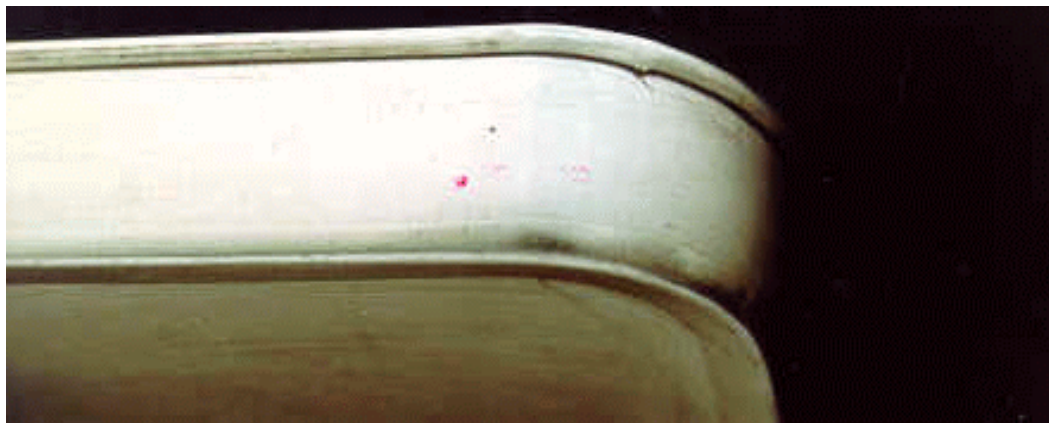
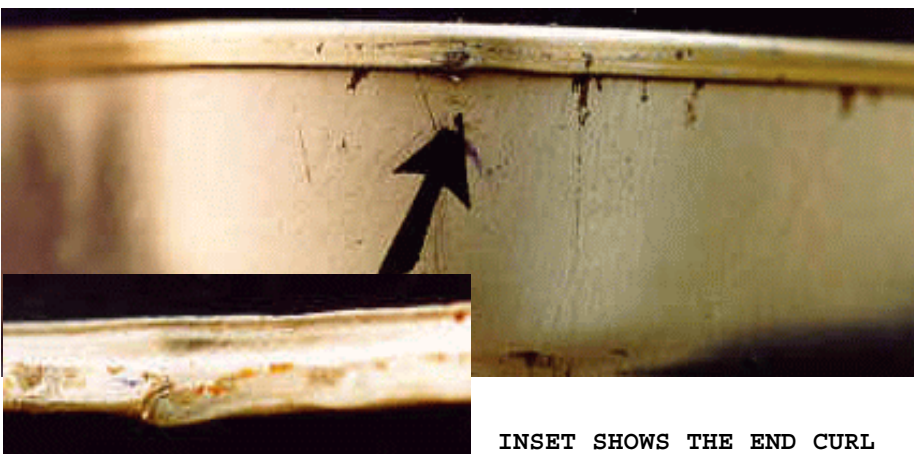
### DEFECTS: PLEATS

A pleat is considered a serious defect if the pleat extends to the bottom of the double seam.

A pleat is a fold in the end hook which may be accompanied by a small vee-shaped projection of the end hook radius and the metal of the fold may be fractured. A pucker is intermediate between a wrinkle and a pleat, where the end hook is locally distorted downwards; it may or may not be externally visible.

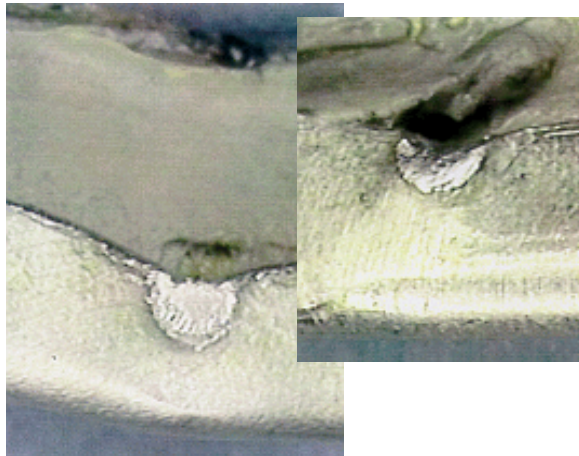
**DEFECTS: PUCKER**

A pucker is considered a serious defect if there is insufficient overlap (7.5.8).

A pucker is intermediate between a wrinkle and a pleat where the end hook is locally distorted downwards; it may or may not be externally visible.

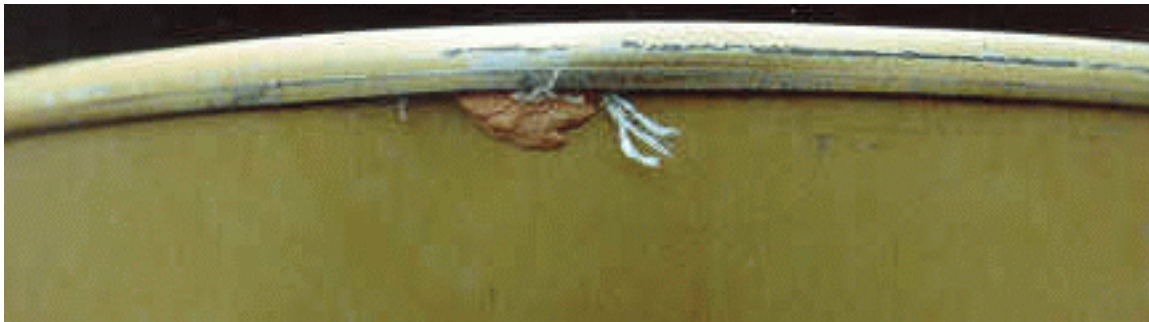
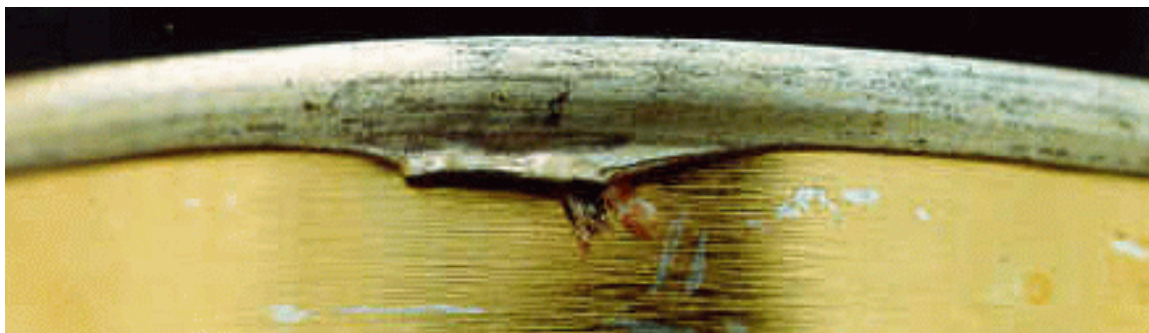
### DEFECT: SEAM INCLUSIONS

Seam inclusions are considered as serious double seam defects.

PARCHMENT PAPER FORMED  
INTO DOUBLE SEAM.

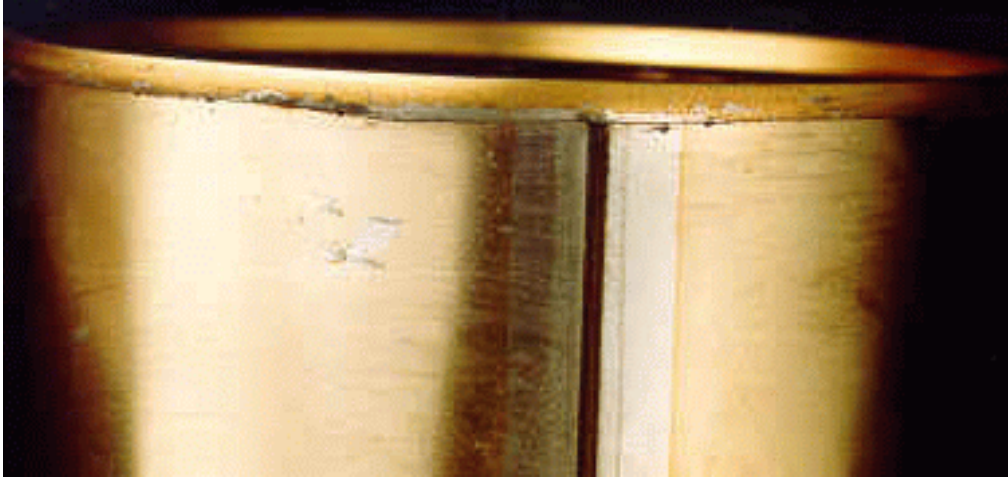
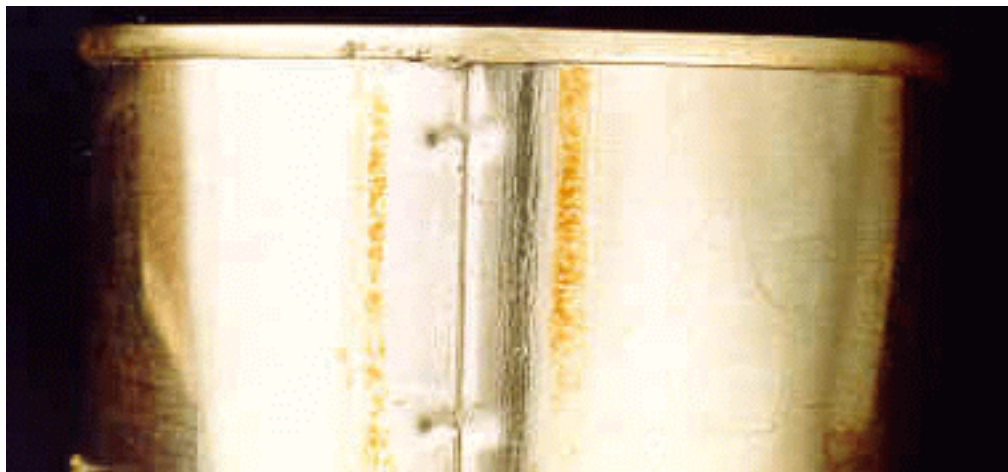
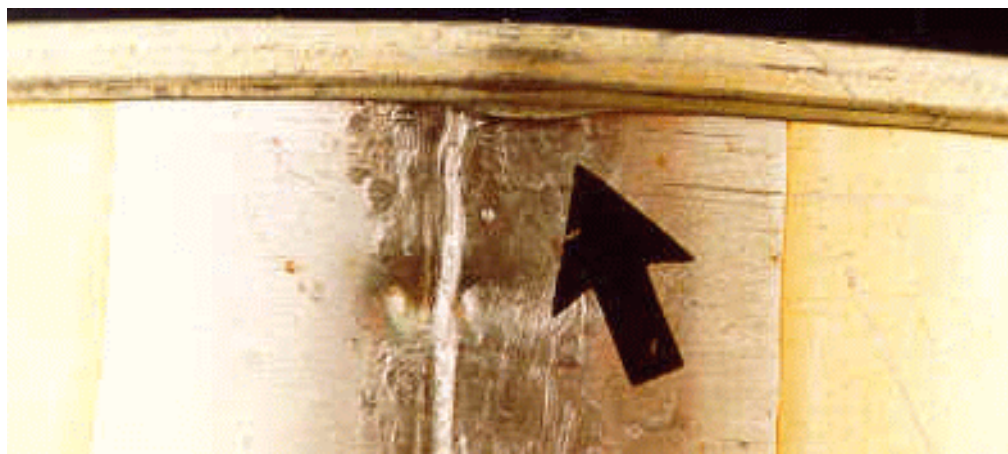
DEFECT: SIDE SEAM DROOP

Any side seam droop assessed as having 25% or less optical overlap will be classified as a serious double seam defect.

Any side seam droop assessed as having 25% to 50% optical overlap will be classified as a minor double seam defect.

A smooth projection of the end hook of the double seam below the bottom of the normal seam at the crossover. A slight droop at the crossover may be considered normal because of the additional plate thicknesses incorporated in the seam structure. However, excessive droop at this point is not acceptable.

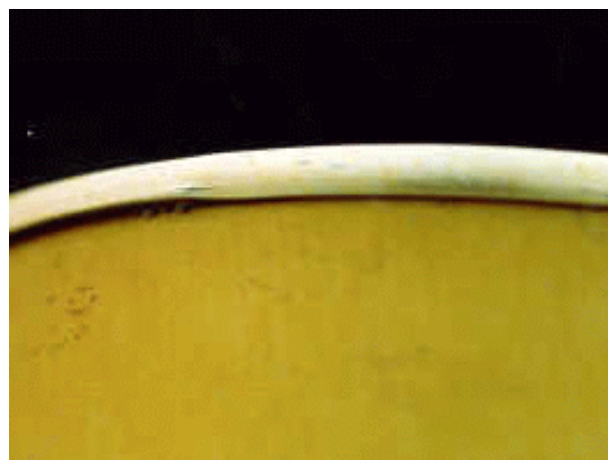
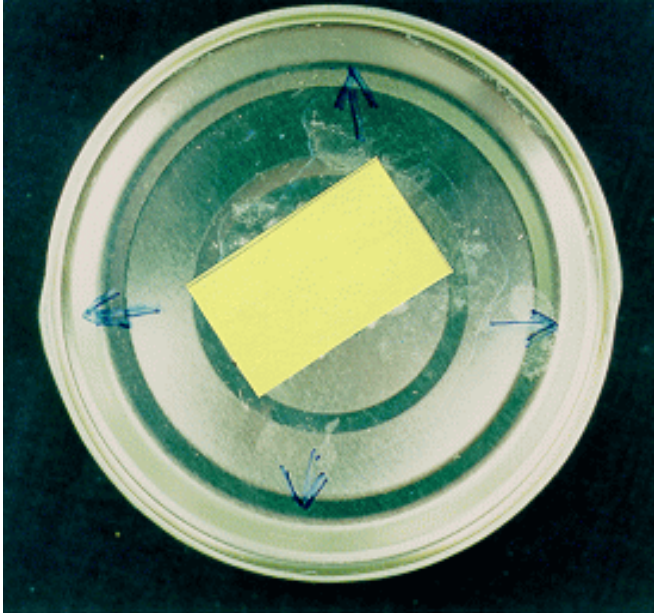
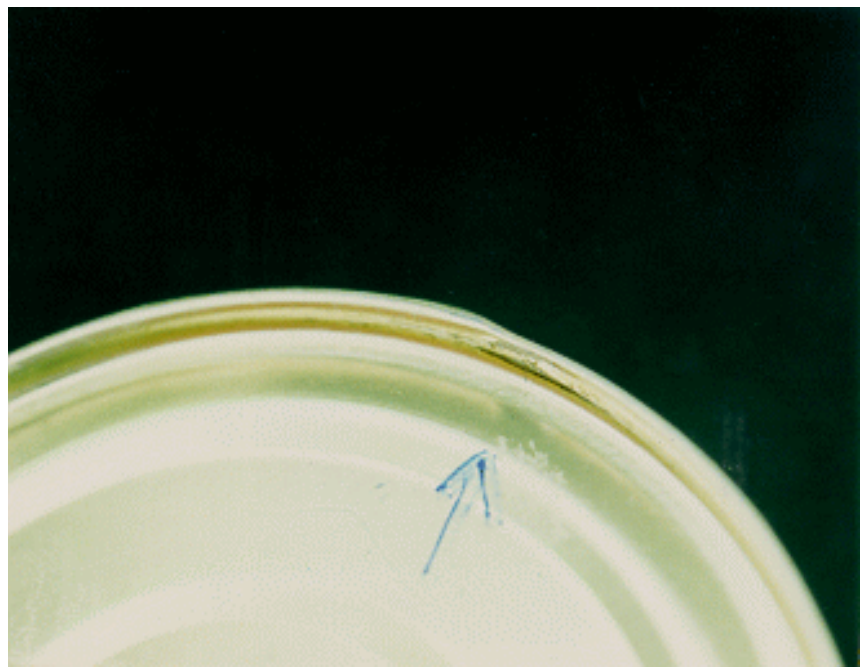
**DEFECT: SPINNER**

A spinner is considered a serious seam defect due to inadequate tightness.

A spinner is an incompletely ironed out double seam. It occurs when the chuck slips on the can end. This defect is characterized by part of the seam having normal thickness and part of the seam being loose (thick). This defect may be accompanied by a scuffing of the countersink wall radius caused by the chuck slipping. First operation spinner shows signs of vees around can, second operation spinner has incomplete double seam.

Top view showing  
incompletely ironed  
out double seam

Countersink wall radius  
showing scuffing caused  
by chuck slipping

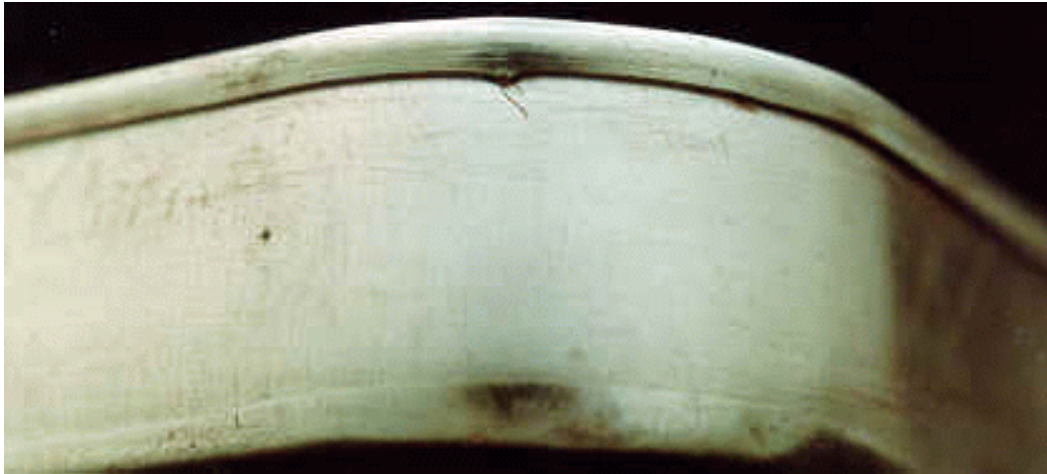
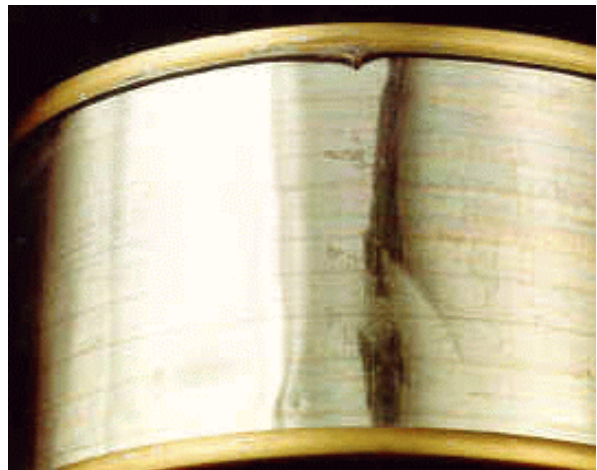
**DEFECT: VEE**

Vees are considered to be serious double seam defects due to the absence of overlap at the point of the vee.

A sharp 'V' shaped projection of the end hook of the double seam below the bottom of the normal seam which results in no overlap.

**MULTIPLE DEFECTS MAY OCCUR -  
AS SHOWN A KNOCKED DOWN CURL  
PLUS A SERIOUS VEE.**
