SAPPERS AND SLAG

Caroline Phillips

This paper briefly summarizes the role that the construction of the Rideau Canal in 1826-32 played in the establishment of the City of Ottawa. Remains from this construction period have recently been uncovered in downtown Ottawa. Restoration of the Plaza Bridge (which spans the Rideau Canal between the Parliament Buildings and the Chateau Laurier) commenced in 1996 when Public Works and Government Services Canada transferred ownership of the bridge, along with funds for its restoration, to the Regional Municipality of Ottawa-Carleton. Two seasons of initial testing took place in 1996 and 1997 on land beneath the west arch of the Plaza Bridge which is part of the Rideau Canal National Historic Site. When construction started in February 1998, Parks Canada archaeologists located the remains of the original contractor's smith shop and the Sappers' Bridge (with the aid of a backhoe and the construction crew) at a depth of three metres below the road grade. Results of test excavations within the shop and of the excavation of most of the blacksmith shop midden will be presented. This project offers a best-case scenario of cooperation between developer

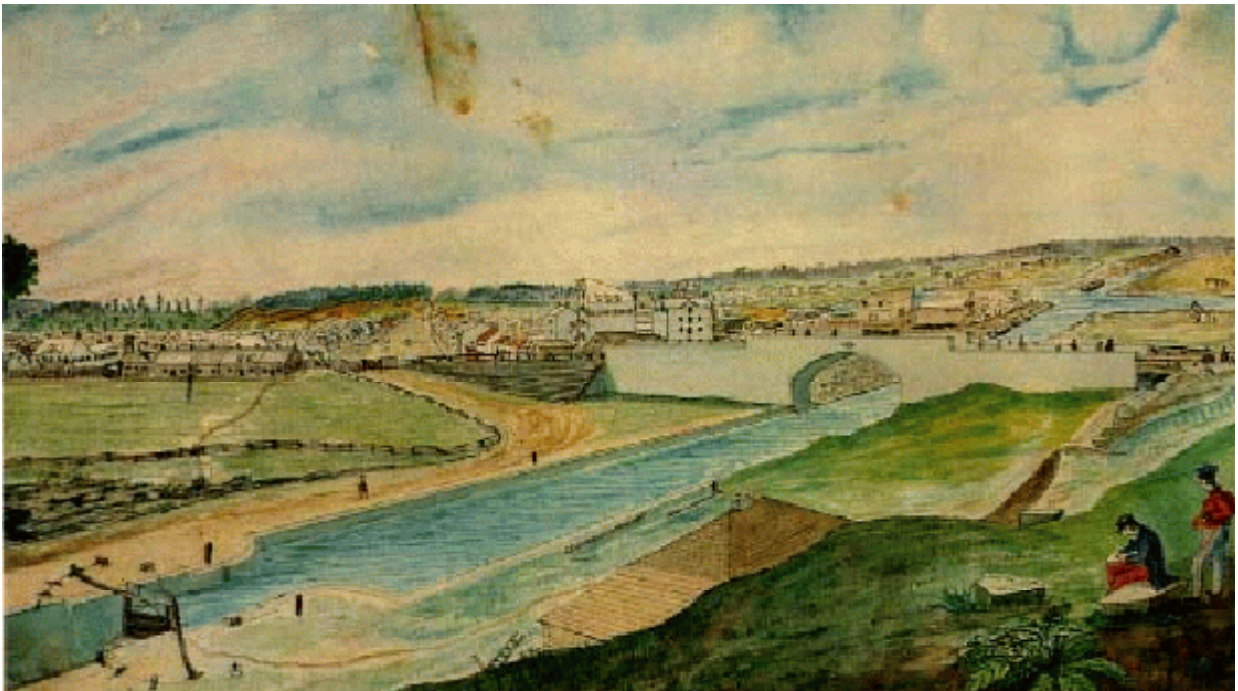
Figure 2. Lower Bytown from the Barrack Hill Near the head of the Eighth Lock and the 'Sappers' Bridge: 1845". The bump in the ground on the west side of the Sappers' Bridge is the bedrock outcropping where the remains were located. The roof of the blacksmith shop is visible in the bottom centre of the drawing. The road to the locks went beneath a wooden ramp at the west (right) end of the Sappers' Bridge masonry. (Thomas Burrowes Sketch # 11, Ontario Archives, Toronto).

Sometime between 1826 when McKay first started clearing the site and 1829 when it first appears on a map (Fig. 1), McKay built the "contractor's Smith Shop". This stone building was built on the west side of the canal and given that it would have been the contractor's main shop where tools and equipment would have been repaired, it was probably built closer to 1827 than 1829, making it one of the first buildings in Bytown. Not being a military building, very little information on this structure has survived, only a few maps and a couple of drawings showing mainly the roof (Fig. 2).

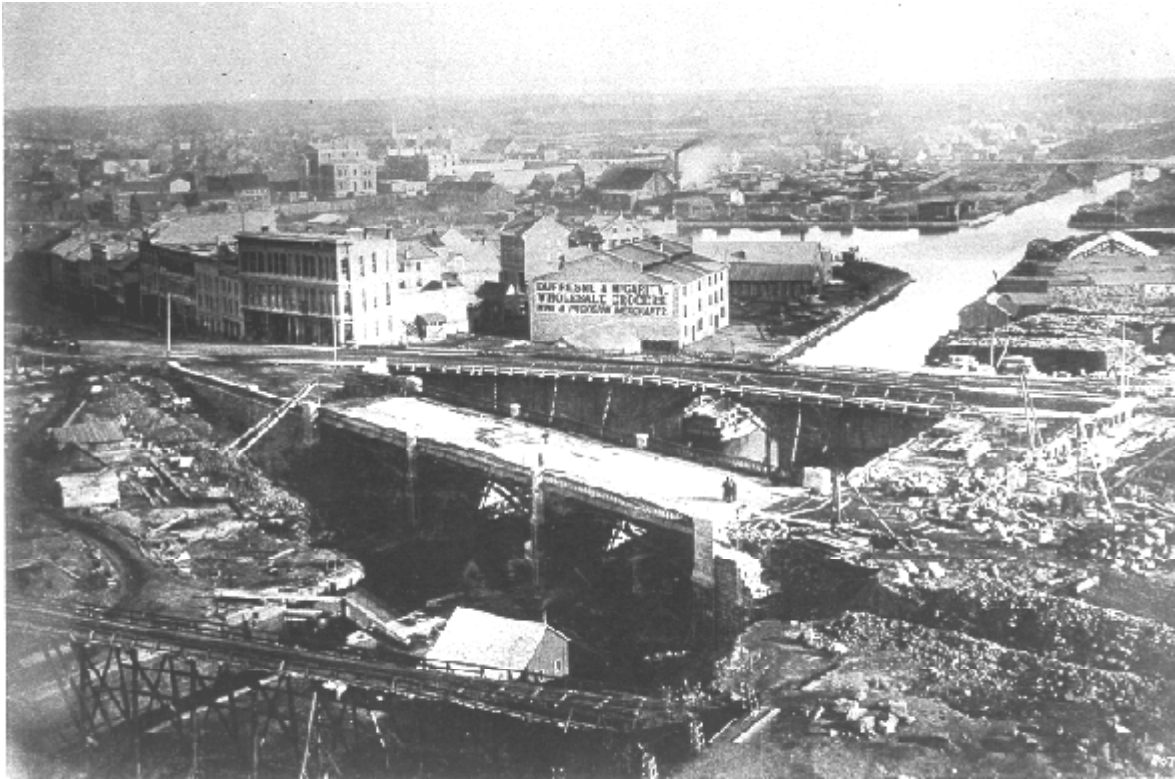
Figure 4. "Dufferin Bridge during the course of construction, ca. 1874". The Sappers' Bridge is also being widened and the new cut through its masonry for the road is not yet completed. (Public Archives of Canada; C493).

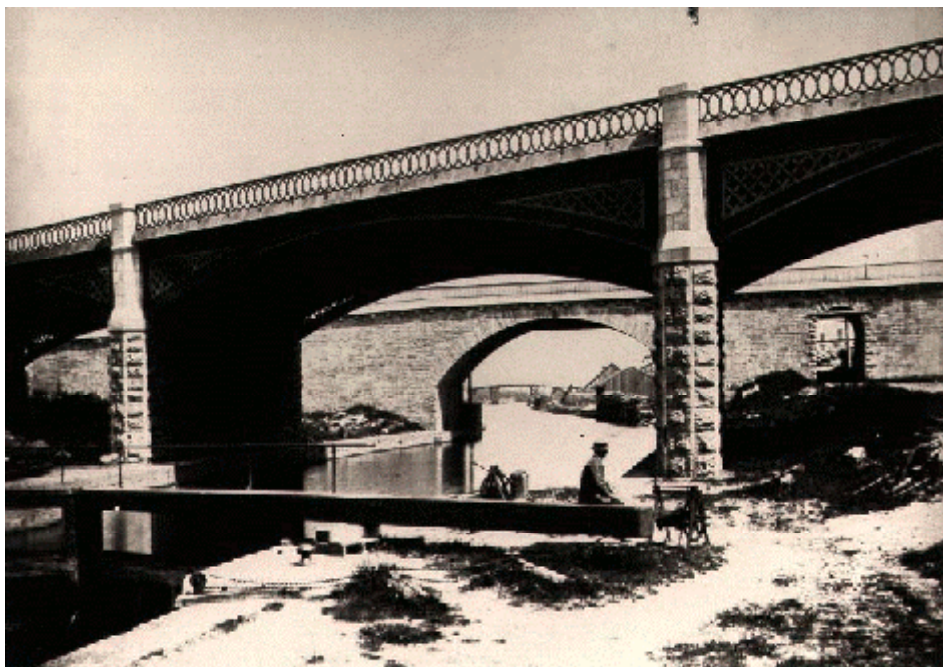
Figure 5. "Under Dufferin Bridge, Looking South" 1882. The new opening through Sappers' Bridge masonry is visible on the left. (Public Archives of Canada, 9306).

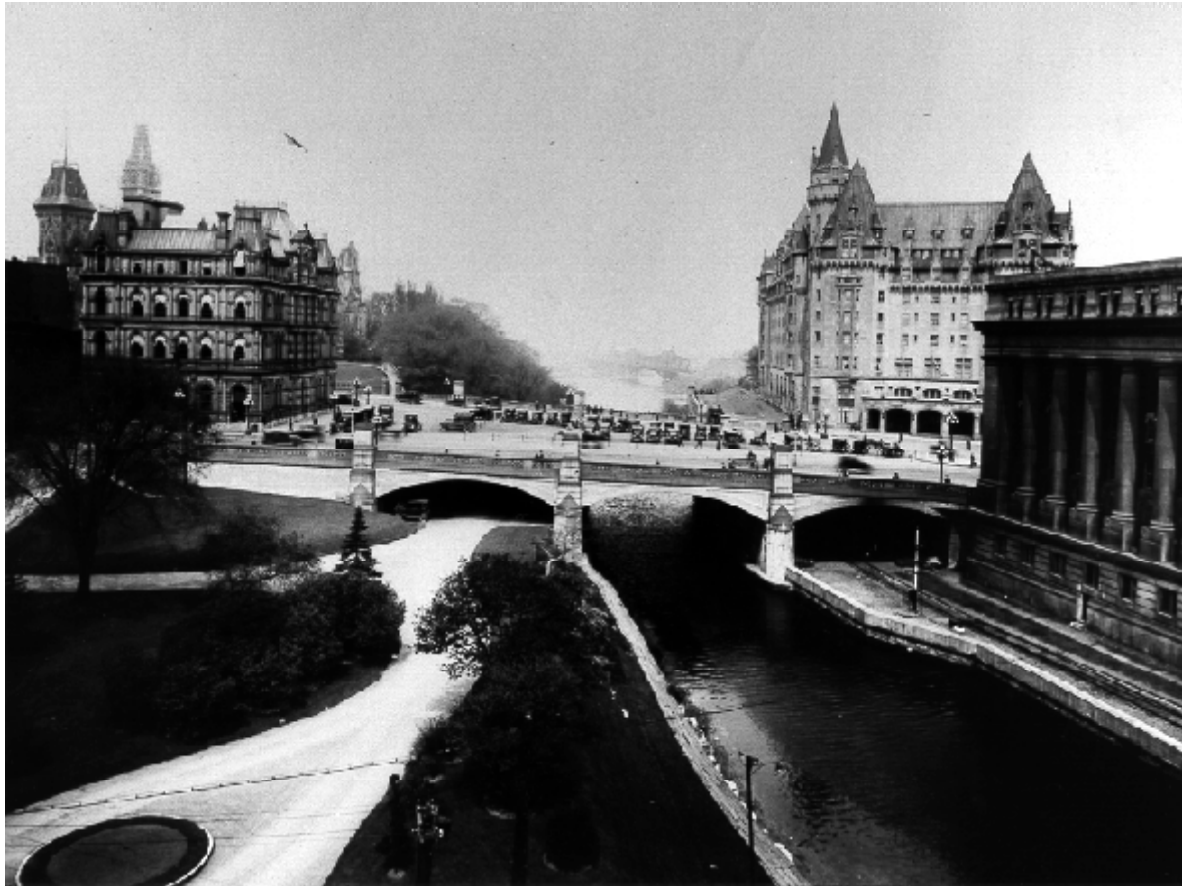
Figure 7 Demolition of the Sappers' Bridge. (Ottawa Historical Society; P799).

Major changes took place in 1911 and 1912. Union Station and the Chateau Laurier were built on the east side of the canal. The Sappers’ Bridge was demolished (Fig. 7) and parts of the Dufferin Bridge were incorporated into the new, wider Plaza Bridge (Fig. 8). Underneath the west arch of the Plaza, garages and shops were built by Public Works and the Post Office, the first around 1922 (Fig. 9). The post office garage was extended in 1931. In 1938 the Post Office was torn down in to provide space for the National War Memorial (Fig. 10) and an extension was added to south side of Plaza Bridge beneath which was a Public Works warehouse. Between 1939 and 1951, more garages were added, then mezzanines over the garages and eventually the whole area converted to parking spaces (Public Archives of Canada NMC 30605-11).

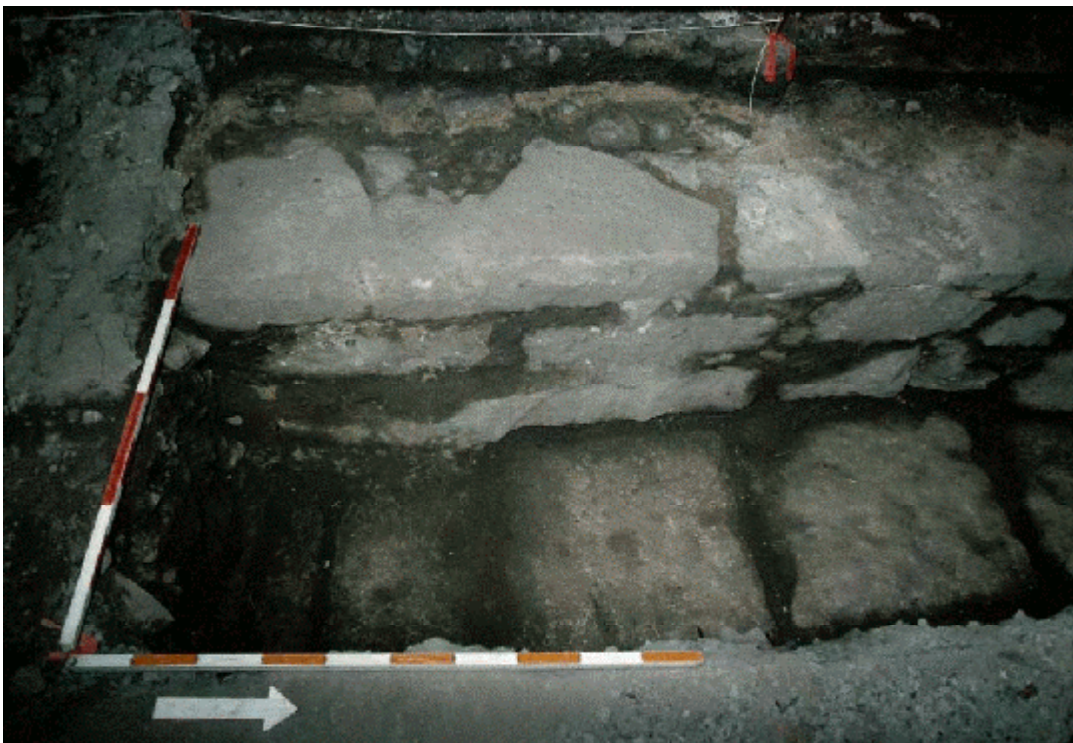
Figure 11. Planview of remains of the masonry of the 1872 widening of the Sappers' Bridge. (Parks Canada photo by C. Phillips; 34H-1390).

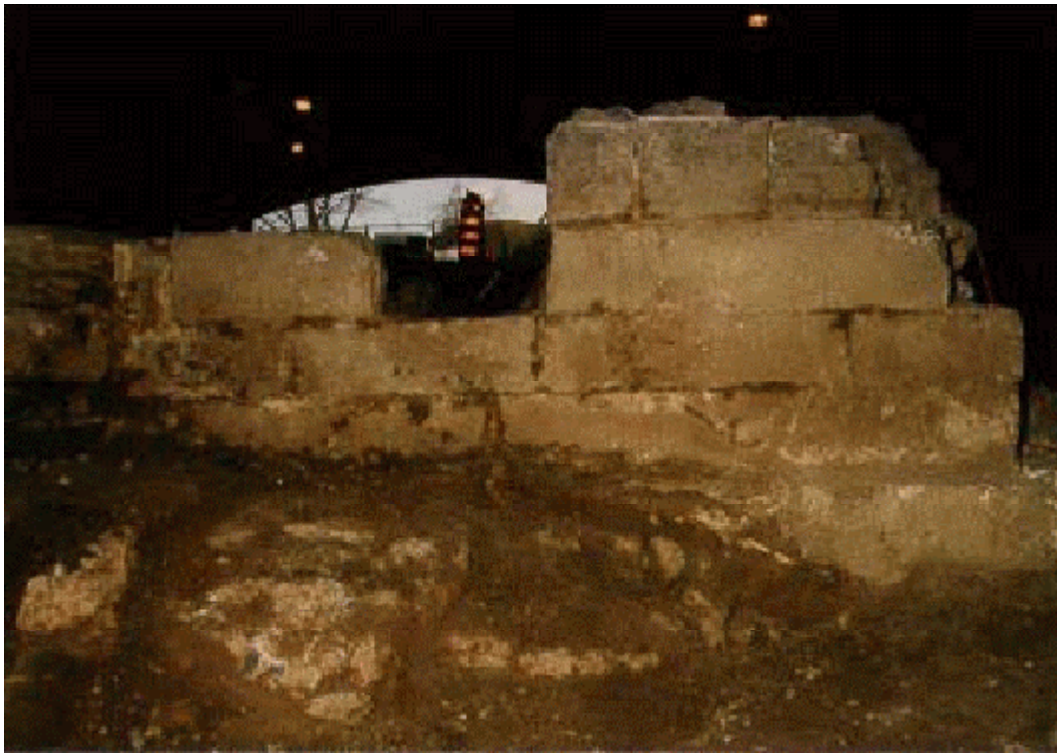
Figure 12. Remains of the north face of the Sappers' Bridge on a bedrock outcropping as found in February, 1998. The four courses of dressed ashlar to the right remain and are now displayed *in situ*. (Parks Canada photo by J.-P. Jérôme; J-2/10)

The excavations started in 1998, in February, in Ottawa! It was -20C as the hoe ram and backhoe began the removals. By the afternoon of the first day, a line of lime-mortared rock was exposed (and quickly froze) three metres below surface, exposing the entire west wall of the blacksmith shop. As the backhoe proceeded south up the west side, it approached the area where the bridge remains had been found in 1996 and 1997 and by the end of that first week a section of the north face of the Sappers' Bridge had been found, firmly mortared on to the bedrock just as it was built in 1827 (Fig. 11). The west side had been destroyed by the construction of the garages and later the Plaza Bridge. The section that had survived was also the piece which had been cut through around 1872 to permit access to Ottawa Locks and the Ottawa Post Office. The only record of this opening was a few photographs (Fig. 12), so it was very satisfying to locate the opening and the first course of masonry from this portal. Unfortunately the east side of the opening had to be recorded and then removed as the former road allowance was too narrow to permit access for modern emergency vehicles. The masonry from the 1872 Sappers' Bridge widening was again exposed revealing a section of the two parts of the Sappers' Bridge, interrupted in places by the concrete garage footings.

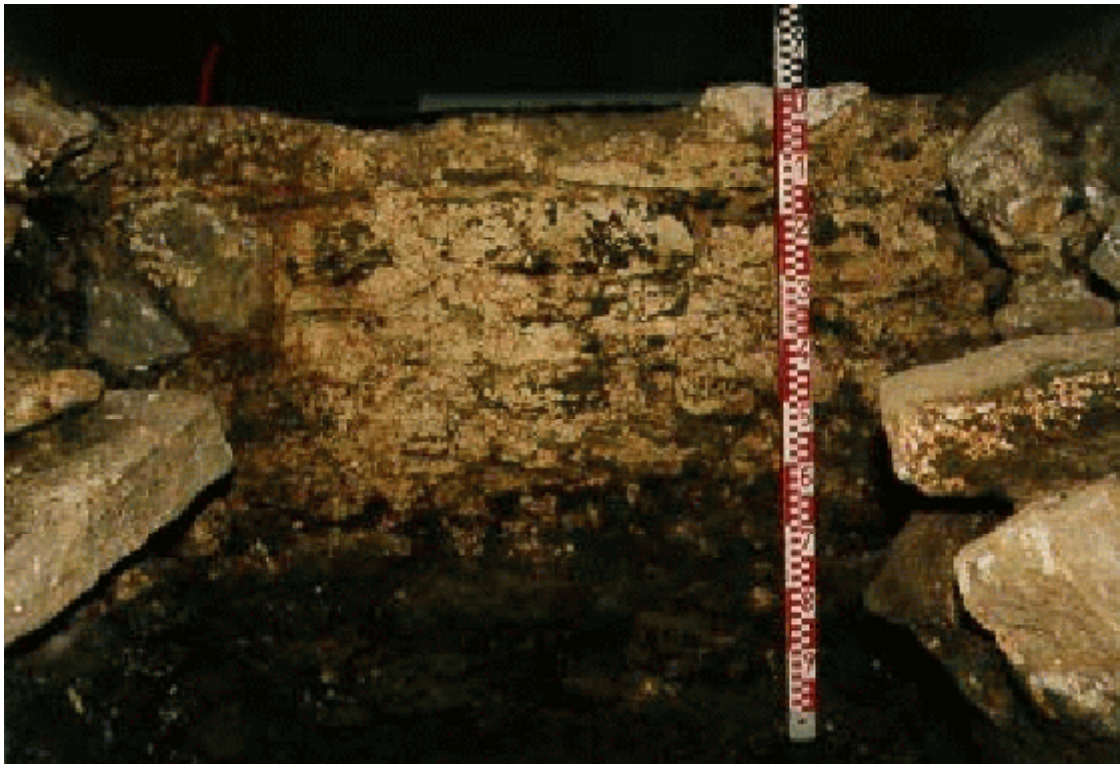
Figure 15. Interior north wall of the blacksmith shop. The whitewash stops approximately 30 cm above the blacksmith floor level. (Parks Canada photo by J.-P. Jérôme; K-26/11)

At the floor level of the original shop, over 1 m of the interior white-washed (Fig. 15) walls were found to remain. There was no footing; at

50 cm thick on a clay base, today's Plaza Bridge engineers declared it solid and that a footing was not required. In Figure 15, the whitewash stops about 30 cm above the smithy floor. Despite 15 to 18 different layers excavated, there was no layer between the 1872 wall demolition debris and the 1832 smithy floor with material dating to the later use of the building as a "tool store" or "lock office". Possibly there was once a raised wooden floor to combat the damp and the interior walls were whitewashed down to this floor. However, no evidence of wood or flooring nails in either of the excavation units was found. Given the wet conditions, a wooden floor would have rotted; it is strange to think that it would have been removed prior to shoving in the walls.

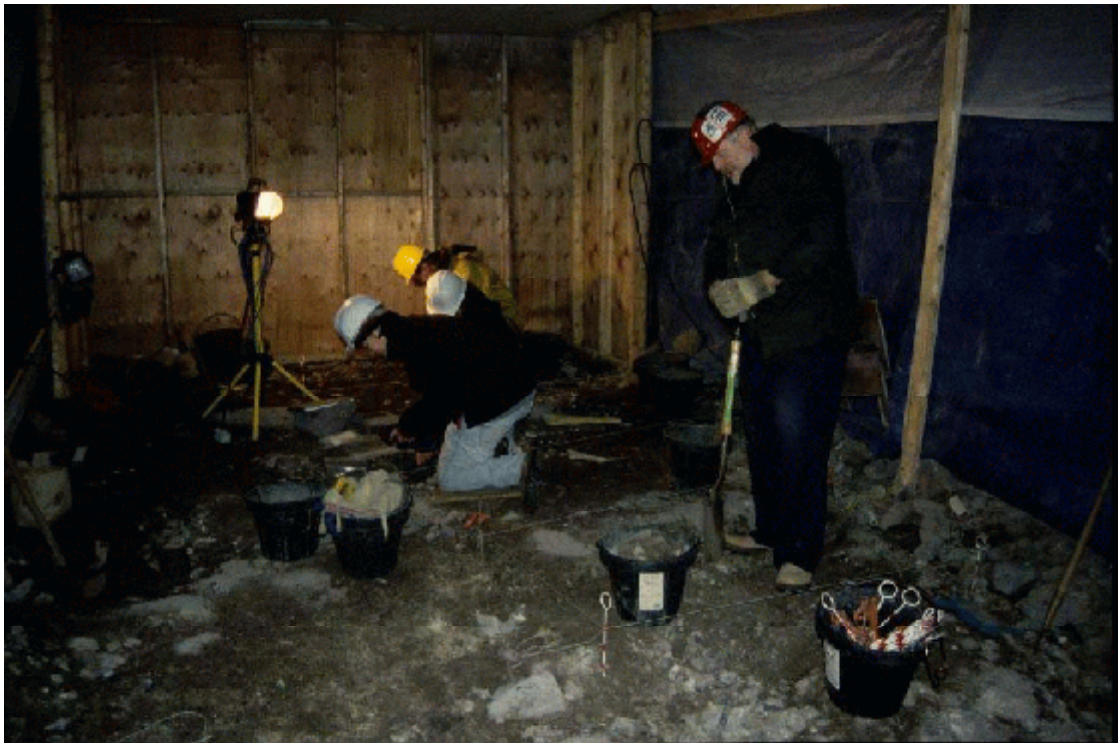
Figure 17. Excavation of the blacksmith shop midden. (*Parks Canada photo by C. Phillips; 34H-1547T*).

Based on the known depth of the 1827 buried surface in the adjacent bore hole and smithy, one metre over the midden was carefully removed by backhoe. A service trench three metres by eight metres was necessary. With the top metre removed, a heated shelter was constructed over the site to thaw the soil and the archaeologists. In two weeks the midden was excavated (Fig. 17), mostly by hand. When time ran out

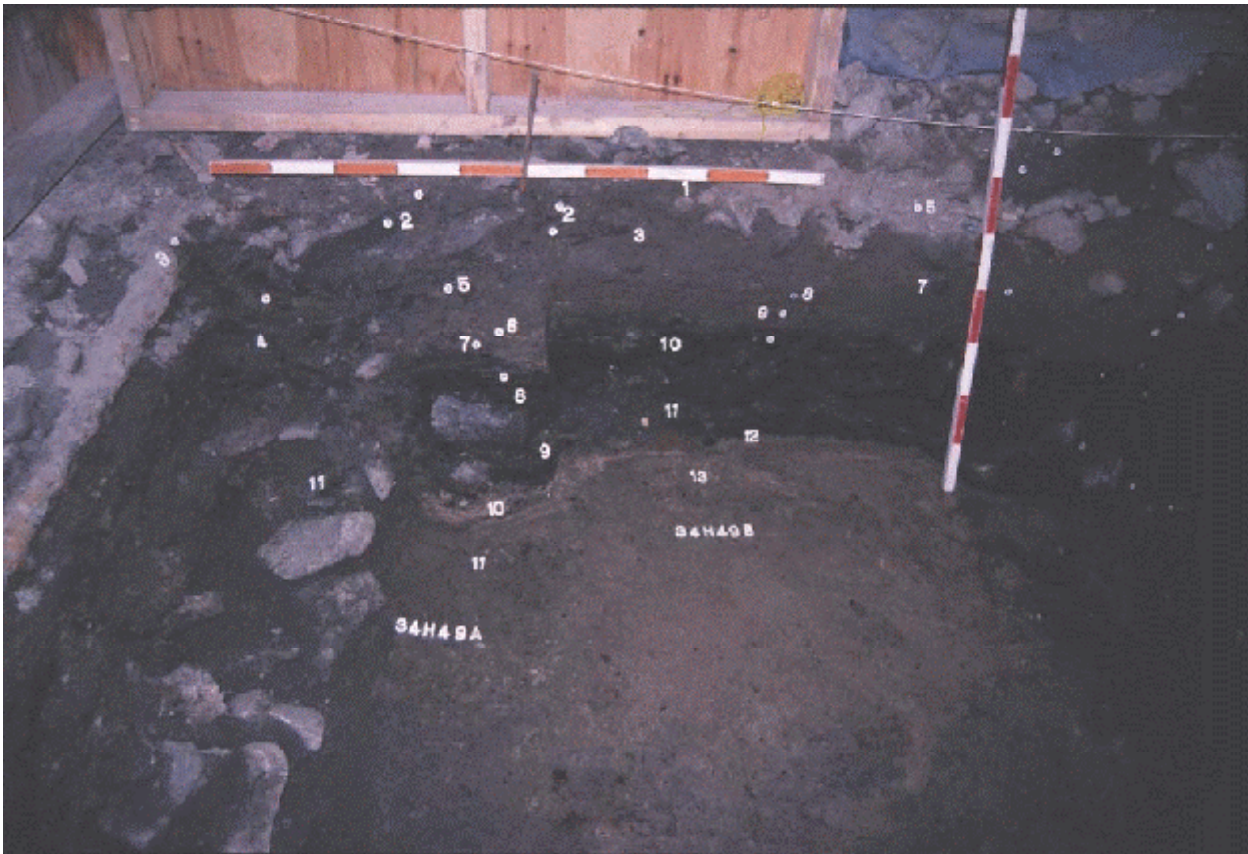
Figure 19. West profile at the south edge of the midden. (Parks Canada photo by C. Phillips; 34H-1565T).

Twenty-four boxes of material from this midden were collected, including slag, samples of unspent charcoal, and artifacts including: glass, copper and shell buttons, one coin, pipe fragments, slate pencils, fish, bird and mammal bone and , stoneware and pearlware (Fig. 18) ceramics. As this surface is also at the canal water level, all of the iron is heavily corroded. Most of the material lay on the black organic buried surface, with some artifacts pressed into the sands and clays below. The ash, slag and charcoal deposit (Fig. 19) was 27 cm thick at the south end, tapering to less than 10 cm at the south.
