## AVIATION INVESTIGATION REPORT

A08P0125

### LOSS OF ENGINE POWER AND COLLISION WITH TERRAIN

**BIGHORN HELICOPTERS INC.  
BELL 206B JET RANGER (HELICOPTER) C-GCHE  
CRANBROOK, BRITISH COLUMBIA  
13 MAY 2008**

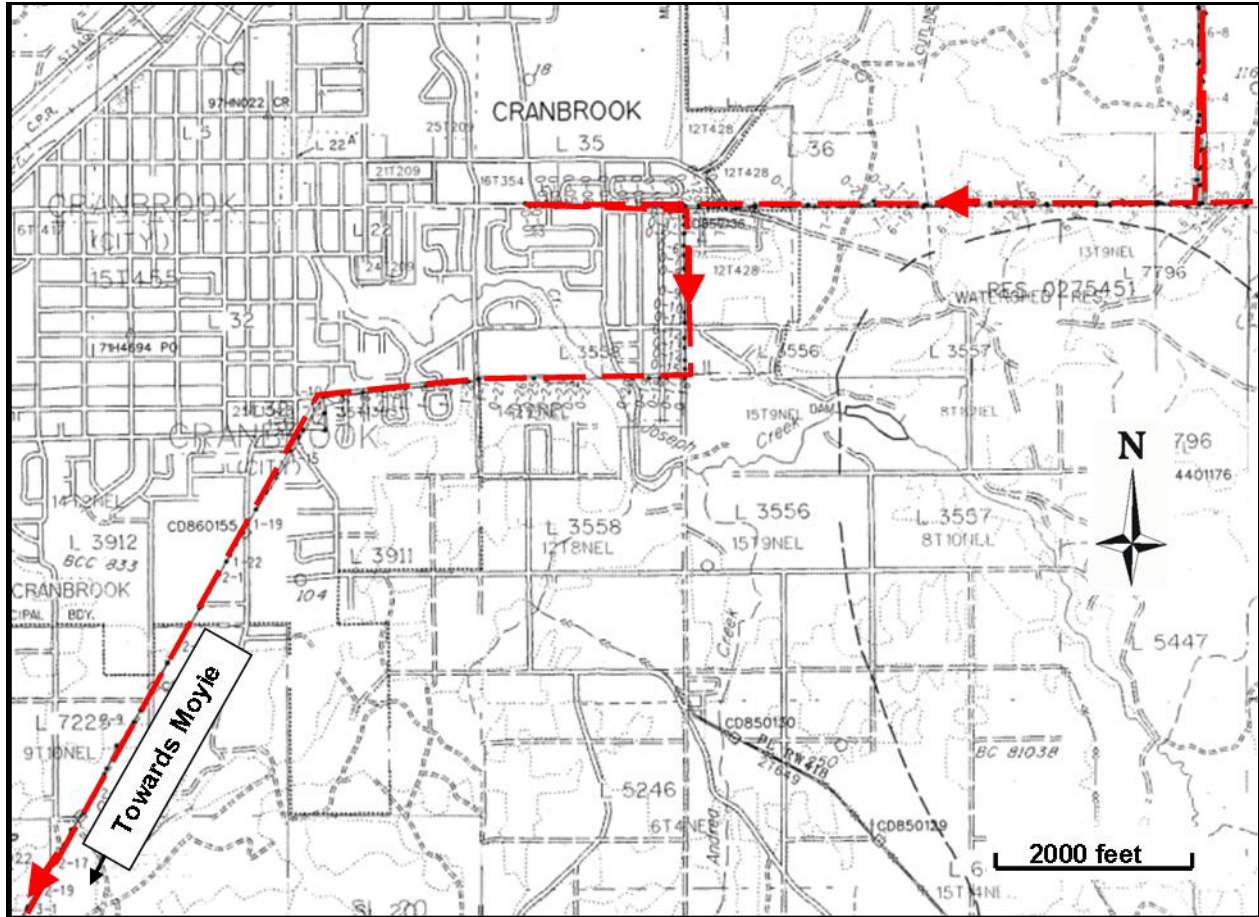
# Appendix A – Planned Power Line Inspection Route

While the accident flight involved the aerial inspection of power lines, these were located within a residential community. The helicopter performed manoeuvres over homes in the vicinity of the power lines. Therefore, the accident flight took place over a built-up area and would have been bound by the general prohibition under Section 602.14 and/or the conditions set out in Subpart 702.
