THE OCEAN RANGER

CHAPTER TWO THE OCEAN RANGER

CHAPTER THREE MANNING

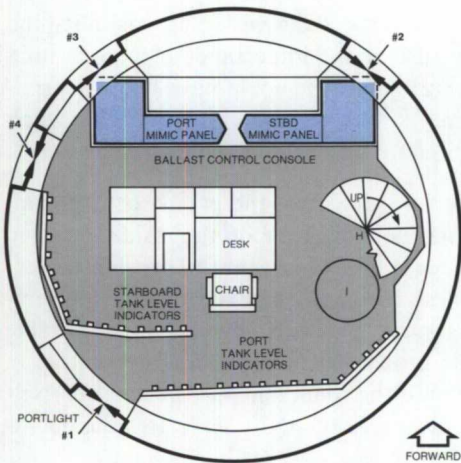
2.3 Of the 32 pontoon tanks, 24 were used to store ballast water, with the remainder used to store drill water and fuel oil. The ballast control room was located in the column above starboard tanks 10-13.

the pump to the overboard discharge. When the pump was started, ballast was pumped out of the tank and overboard. In order to take on ballast, the valves leading from the sea chest to a tank were opened, and sea water was allowed to “free flood”¹ into the tank. By discharging or taking on ballast the ballast control operator maintained the rig level at the desired draft.
