APPENDIX F

| Report A, EP 266/82 – Portholes Examination | 271 |
| Report B, EP 90/83 – Porthole Glass Pressure Tests | 278 |
| Report C, EP 265/82 – Analysis of Solenoid Control Valves | 286 |

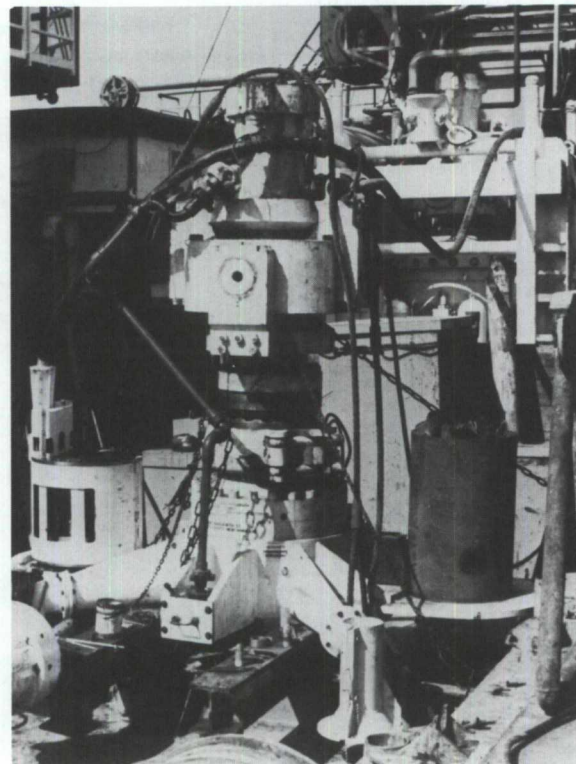
FIGURE 4 LMRP assembly by Mobil for re-entry to Hibernia J-34. Note: Only one control pod has been installed.

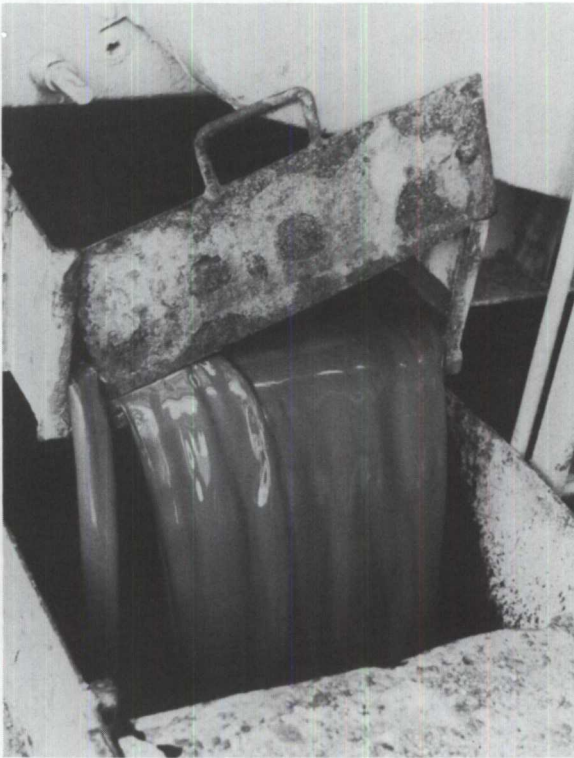
FIGURE 5 Drill fluid being pumped from the J-34 well.

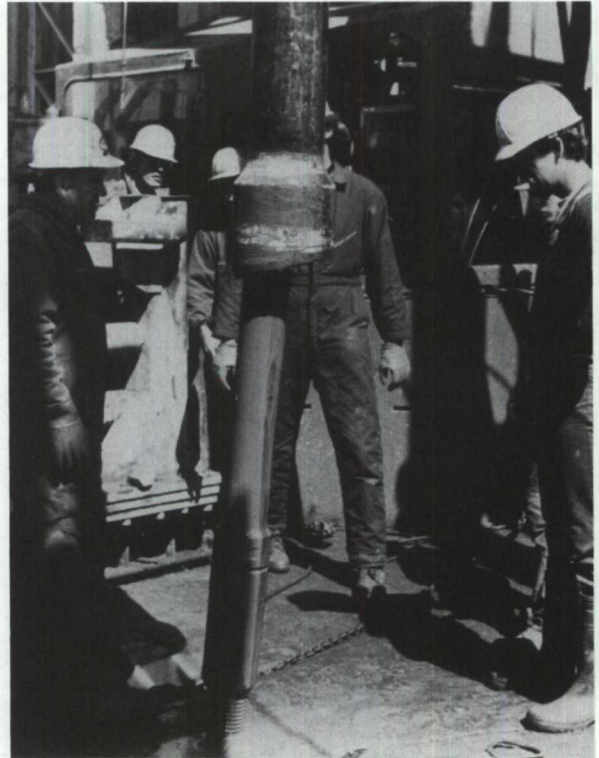
FIGURE 6 Mill pulled from hole with sheared pipe wedged in its throat. Note top of hang-off tool.

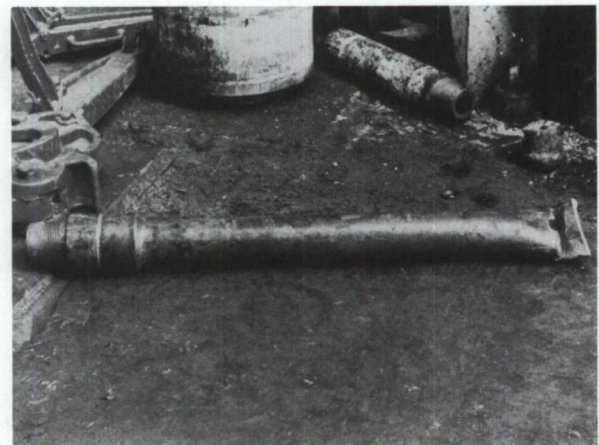
FIGURE 8 Sheared pipe removed from mill.

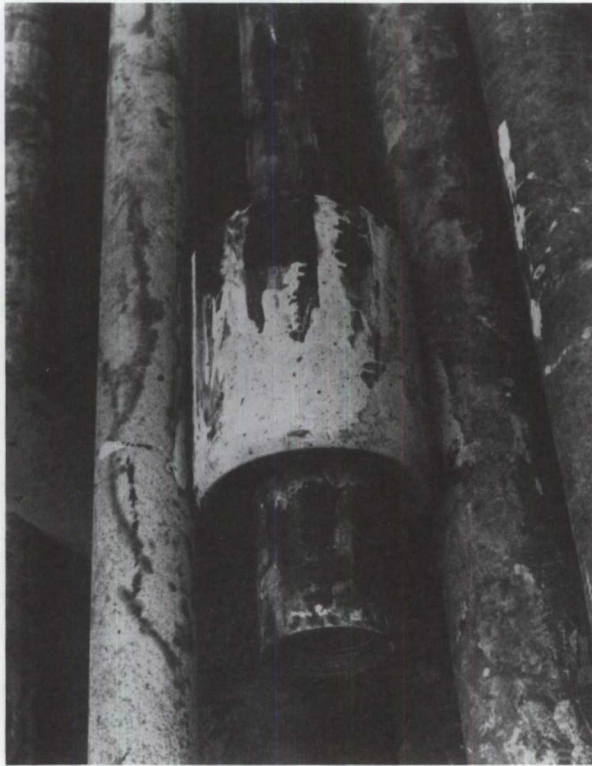
FIGURE 10 *Ocean Ranger* hang-off tool. The large diameter steel bottom section is designed to rest on the pipe rams of the BOP stack.

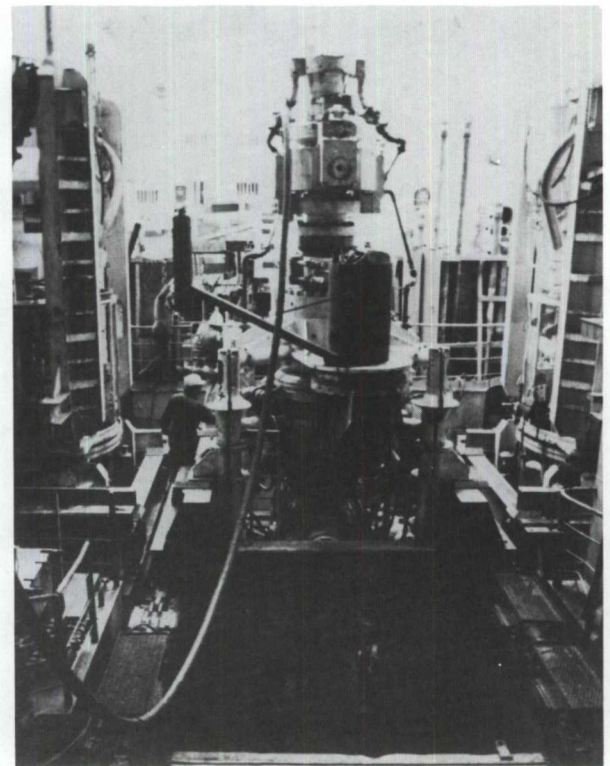
FIGURE 13 BOP stack pulled back.

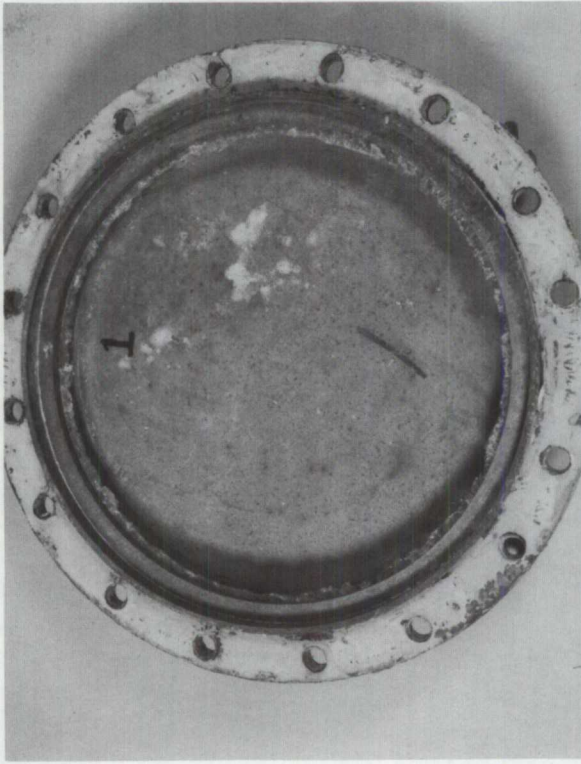
No. 1, inboard aft porthole, broken, containing fragments of glass. This porthole was removed to allow entry into the ballast control room during the diving survey;

PHOTO 3 Porthole No. 1 with deadlight closed, view looking inboard.

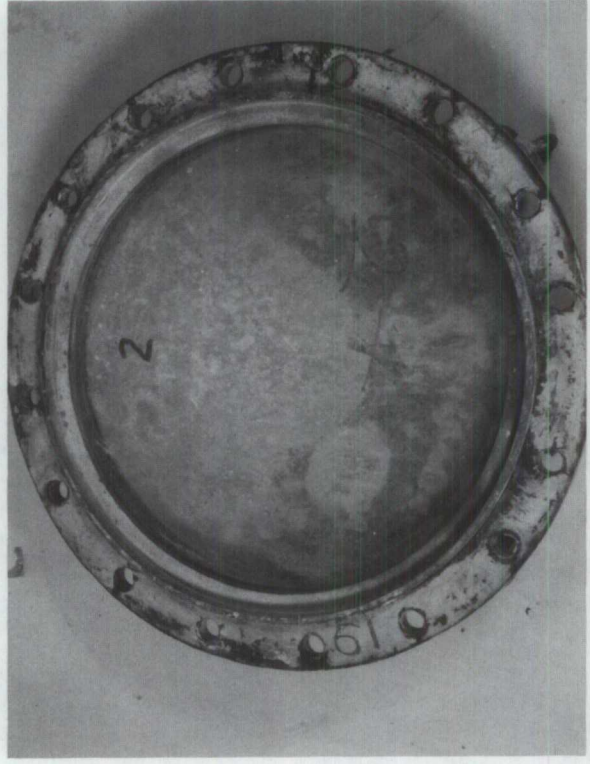
No. 2, porthole not broken (to be used in burst test);

PHOTO 5 Porthole No. 2 with deadlight closed, view looking inboard.

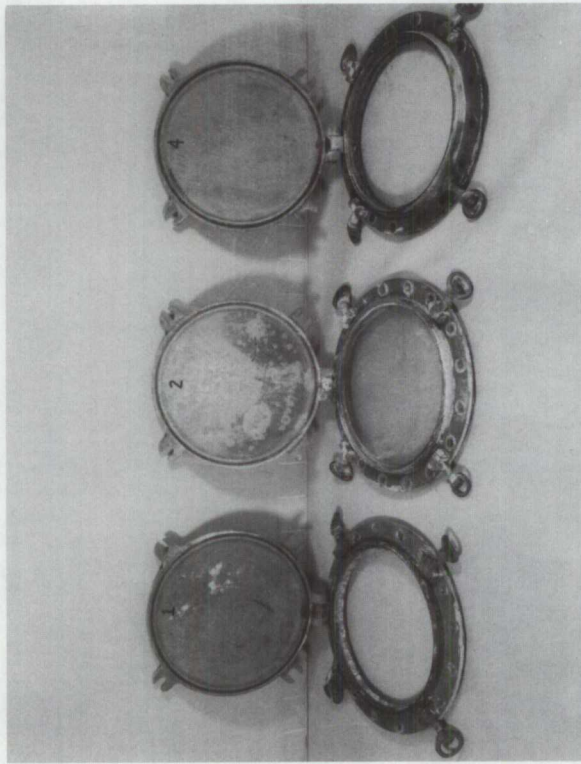
PHOTO 2 Portholes with deadlights open show the glass condition in each case.

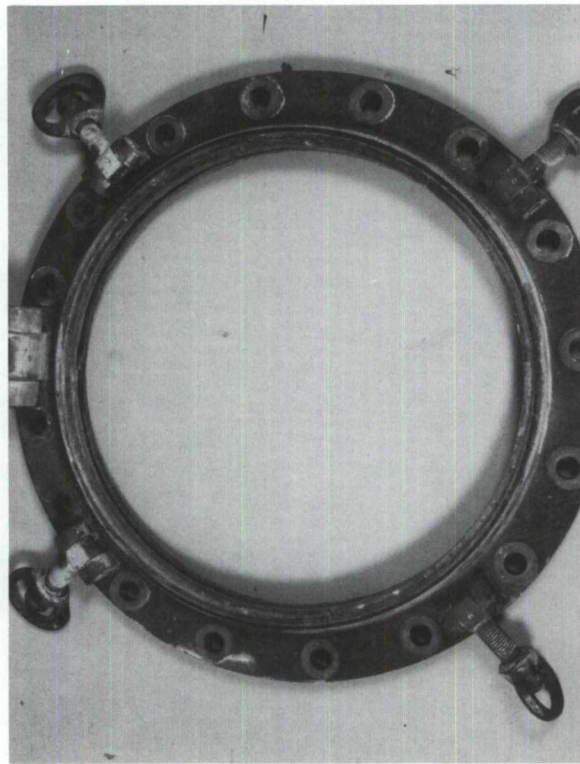
There was no glass in porthole No. 4. The rubber glass seal was in place in the seal groove of the glass support flange. The seal was broken at one location adjacent to the deadlight hinge, Photo 9, but none of the seal was missing. On the outboard edges of the glass support flange and porthole, numerous impact marks and gouges were observed, Photo 10. These marks were bright in colour and appeared to be randomly located around the full circumference of the porthole. The marks appeared to be the result of concentrated and repeated impacts. Testing showed that the orientation and severity of the impact marks could only have been made by blows from outside the porthole. They were bright in colour (indicating them to be recent in nature) and it was determined, most likely, that they occurred during removal of the porthole from the rig structure. The glass locking ring was still in place and the width of the groove which held the glass was measured. The groove width measured from the top of the seal was 14.5 mm (0.59 inches) and without

PHOTO 8 Porthole No. 4 with deadlight open, view looking outboard. Note glass completely removed, no fragments.

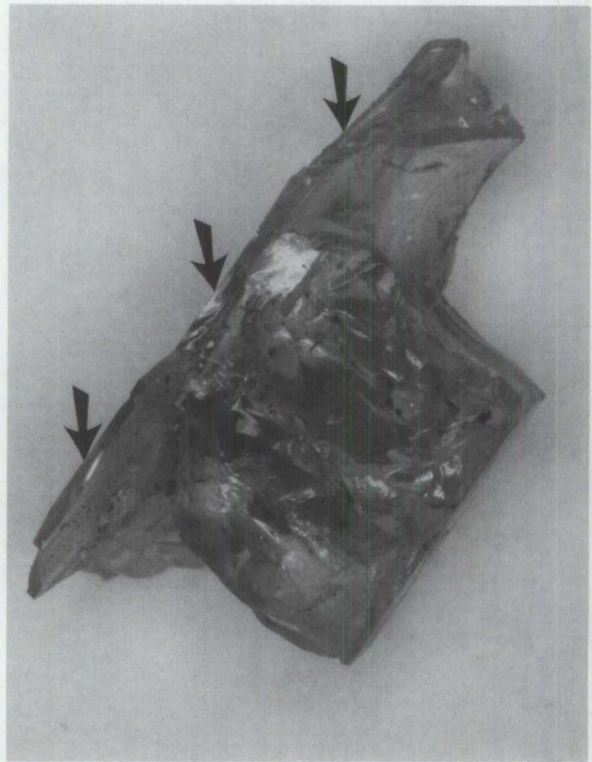
2.3 Detailed examination of porthole No. 1 revealed that the glass remnants were sloped towards the inboard side of the porthole. Using a level and a dial indicator, it was possible to measure the slope of the glass on the outboard surface. The calculated slope angle of the glass surface was 2.3 degrees. The direction of slope on the glass indicates an inward force on the glass caused failure. The locking ring was removed from the porthole and the glass was removed, Photo 11. The rubber glass seal was found intact and in place in its groove. One distinctive characteristic of the glass fragments was the pattern of cracking, Photo 12. In all cases, the outboard surface of the glass had formed what could be described as a "shear lip". This cracking pattern is typical of a bending overload failure with the direction of force acting from the outboard to the inboard side of the glass.

PHOTO 12 Glass fragment from porthole No. 1 displays a distinctive shear lip on the outboard side of the glass (arrows).

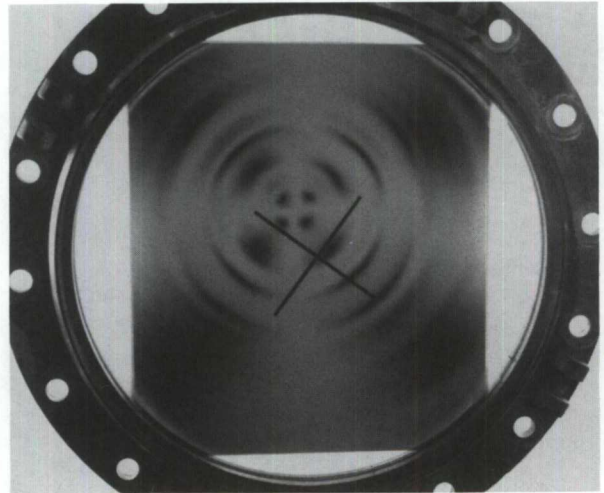
PHOTO 3 Bifringe pattern of *Ocean Ranger* #2 porthole glass, showing strong stress gradients.

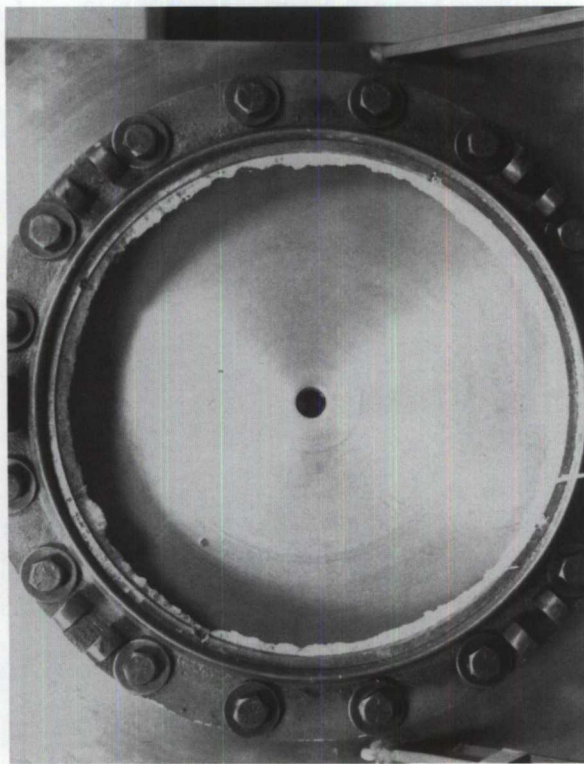
1. Close examination of the glass retaining ring from porthole No. 2 was carried out in-situ prior to pressure testing. There was no indication of any material lip observed on the ring. The No. 2 porthole is shown mounted on the test rig in Photo 6 following the pressure test to glass failure. The glass retaining ring was removed, brushed clean and examined optically. A continuous "lip" of material was observed around the full circumference of the ring on the side adjacent to the glass, see Photos 7 and 8. This material lip was very similar in nature to the protruding material lip observed on the glass retaining ring from porthole No. 4, see Photo 9.

PHOTO 6 Porthole No. 2 following testing mounted on the test rig. Glass retaining ring in place.

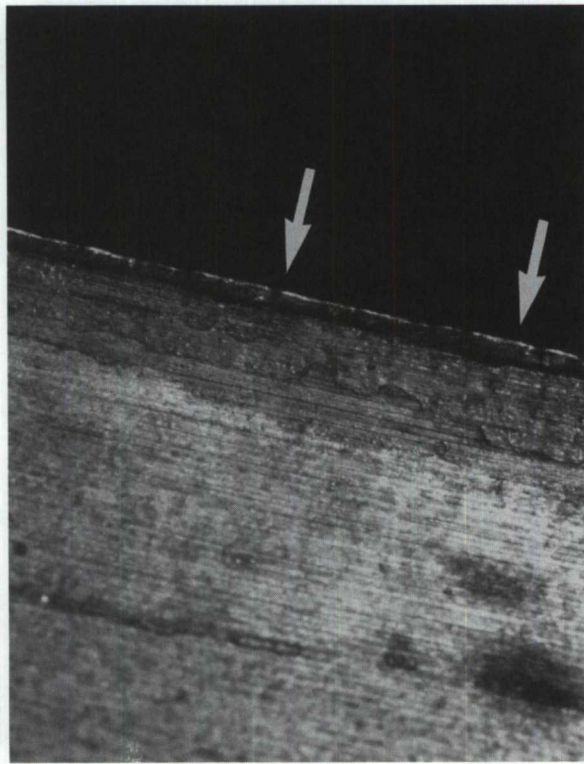
PHOTO 8 Close-up view of the material lip (arrows).

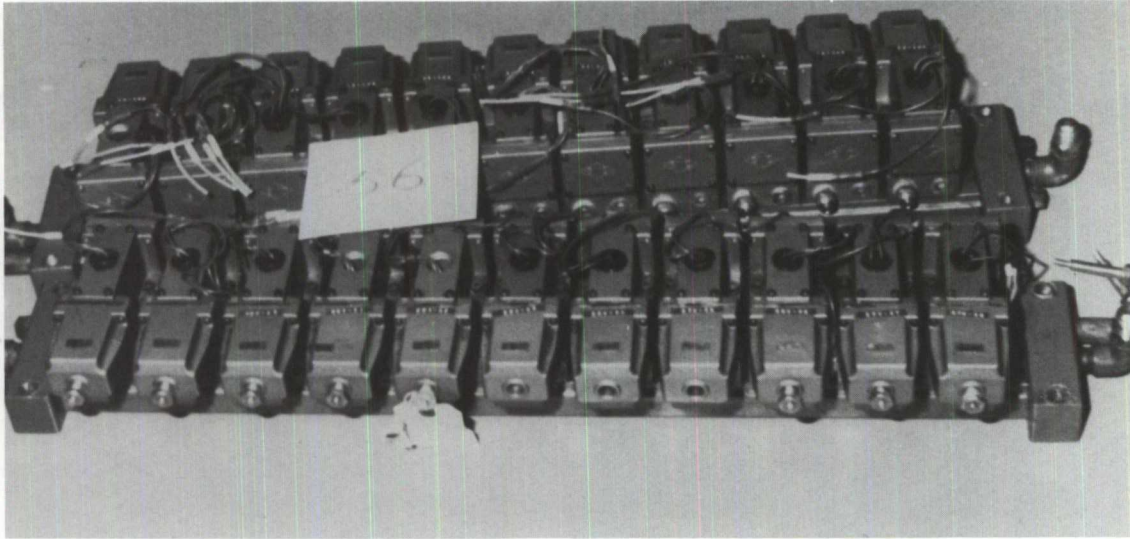
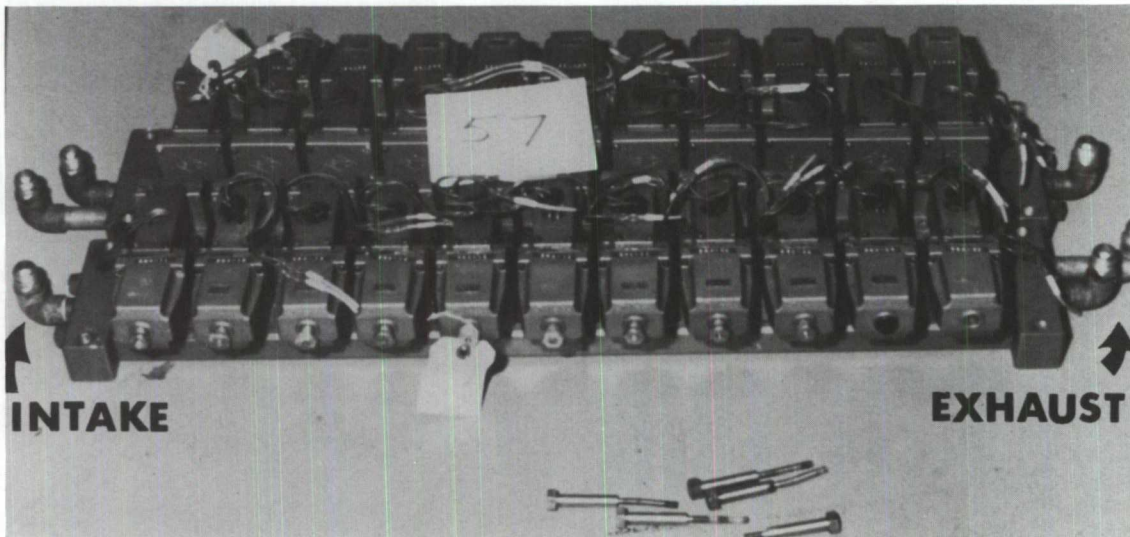
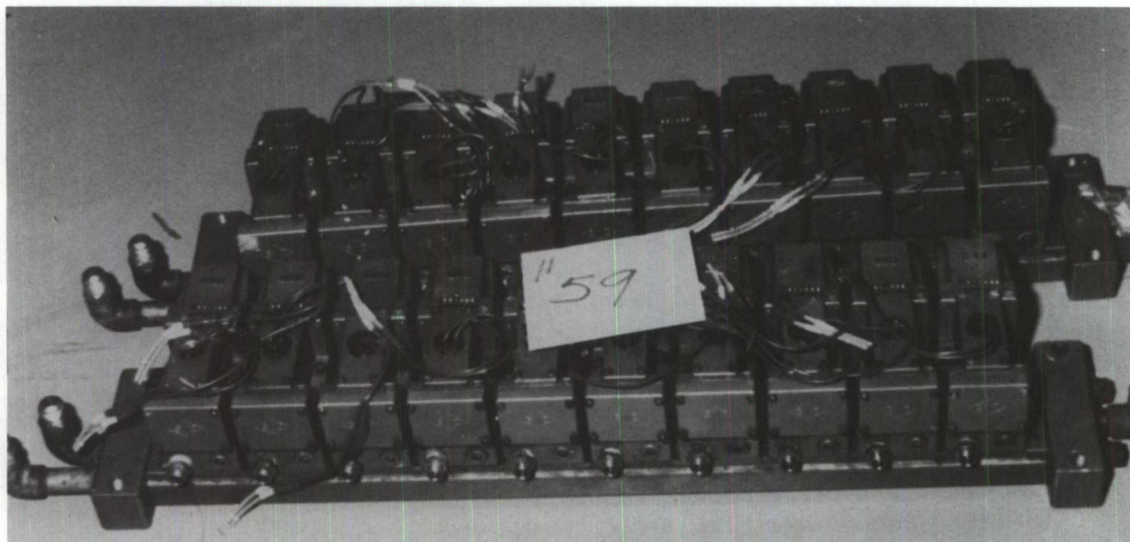
PHOTOS 1-3 The six solenoid valve banks as received. The manifold intake and exhaust ends are indicated in the centre photograph.

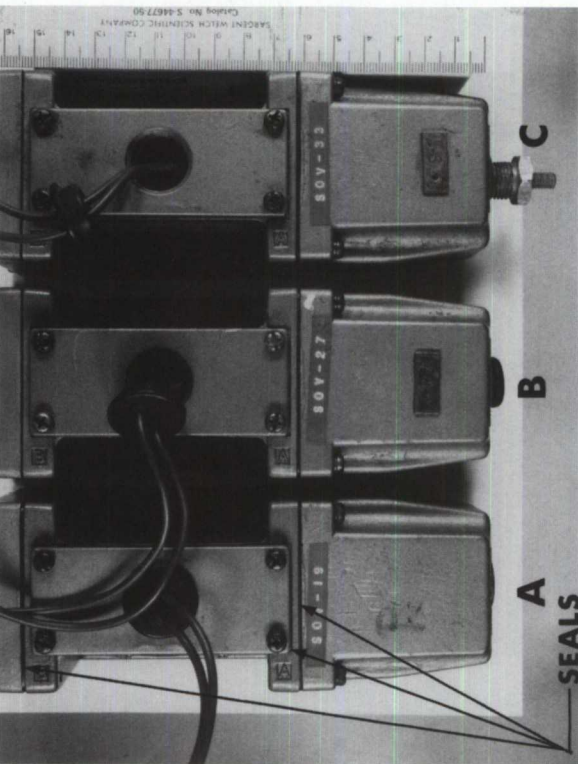
PHOTO 4 Samples of solenoid valves: without rubber plug or brass plug, A, with a rubber plug, B, with a brass plug and actuator rod remnant, C. Note brass plate lettering and plastic label tapes.

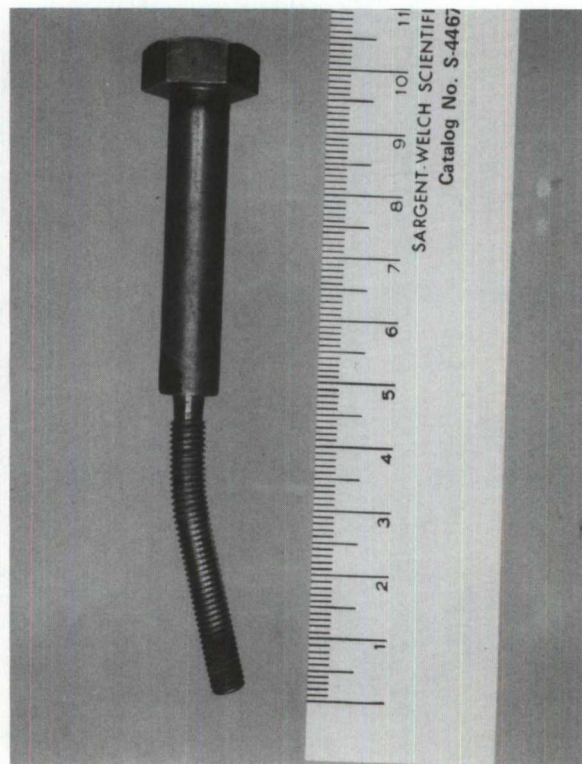
2.3 The capability for manual activation of the solenoid control valves is provided for emergencies in the form of a brass plug and actuator rod. Photo 5 illustrates a broken and an intact actuator rod, both inserted into a brass plug. An actuator rod received in a bent condition is shown on Photo 6. The threaded section of a non-broken actuator rod was measured as 1.9 inch and its shank as 2.3 inches. The diameter was measured as 0.21 inch.

i) the broken actuator rods all failed through bending overload, and were considered most likely to have all been broken when the solenoid valve banks were being retrieved from the wreckage, and not prior to or during the accident.

PHOTO 6 A bent actuator rod, as received.

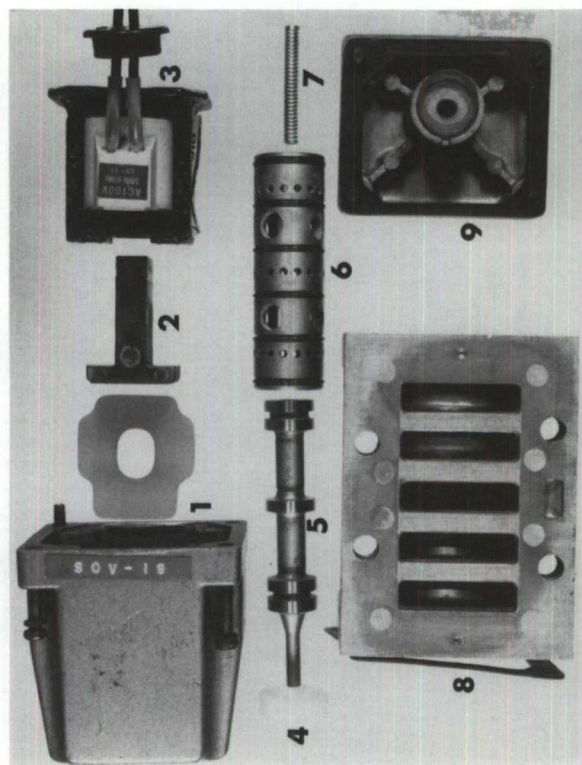
PHOTO 7 The various solenoid valve components: 1) front cover and gasket 2) solenoid core 3) solenoid 4) plastic keeper 5) spool 6) sleeve 7) spring 8) main valve body 9) back plate and gasket.

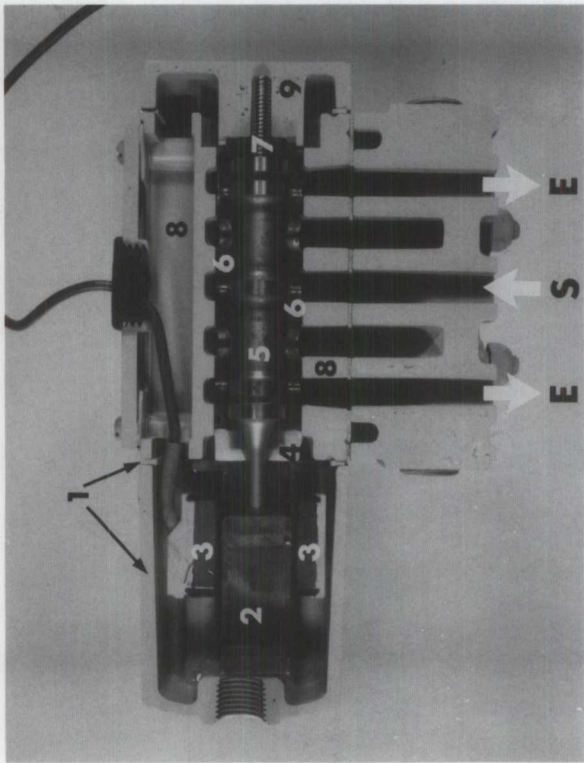
PHOTO 8 Cross-section of a valve, illustrating the internal mechanism. The same numerical identification as in photo 7 is used. The air supply and two exhausts are respectively arrowed as S and E.

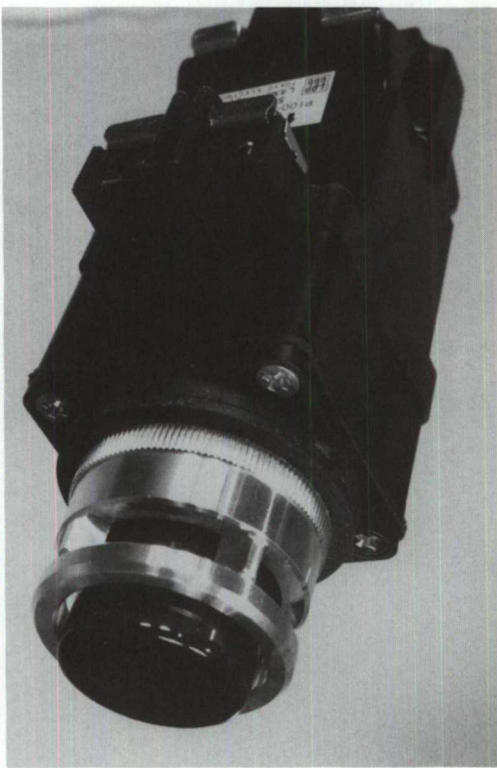
2.12 The pump switches were of a much different design than the micro command switches, as is evident from Photos 11 and 12. A pump switch pair consisted of a momentary push button "run" switch, with a green indicator light which when depressed engaged a self-holding relay which switched "ON" the pump, a self-latching push button "stop" switch, with a red indicator light which when depressed released the relay and stopped the pump. The "stop" button had to be pressed again for the red light to go off and to allow the

PHOTO 11 Pump switch red.

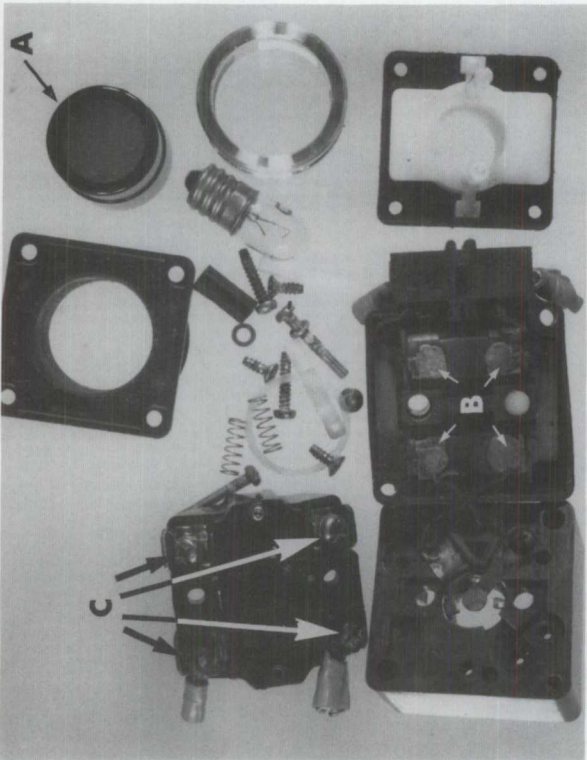
PHOTO 12 Pump switch green.
