## Metal Can Defects

Identification and Classification

### TABLE OF CONTENTS - DOUBLE SEAM DEFECTS

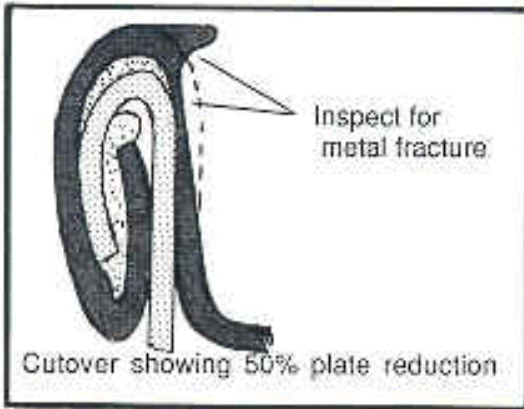
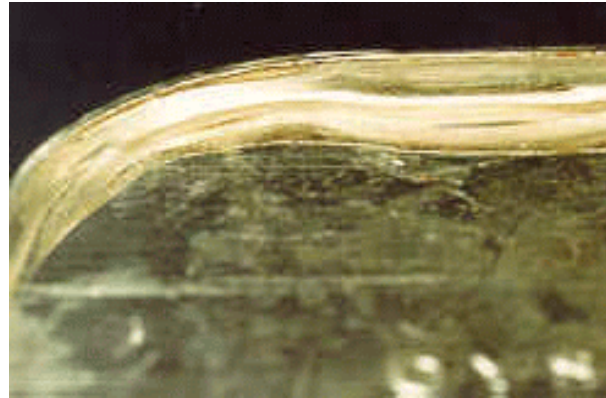
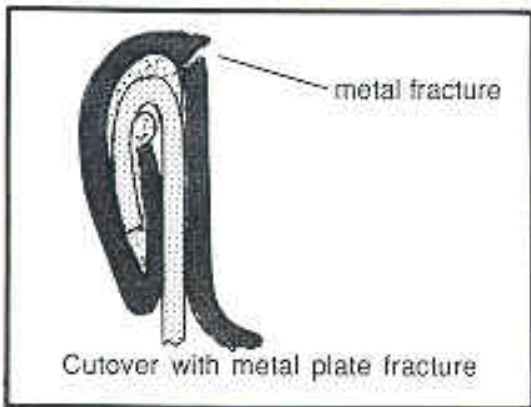
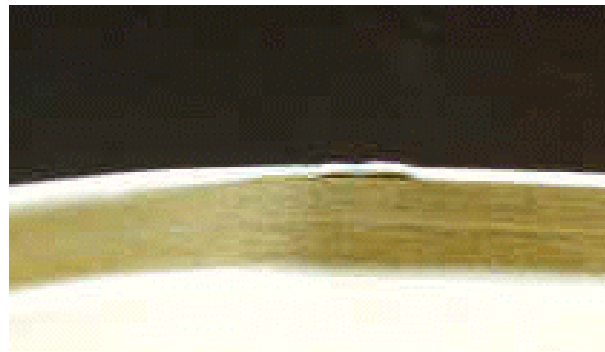
### DEFECT: CUTOVER

Cutovers are often accompanied by other external double seam defects (as shown above KDC with Cutover)

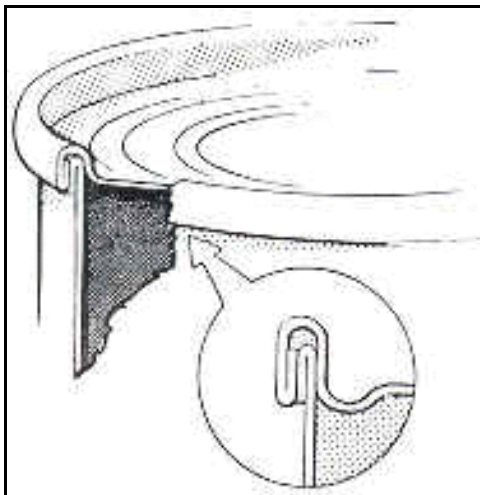
### DEFECT: FALSE SEAM

A false seam is considered a serious seam defect due to the absence of overlap.

A defect where a portion of the body flange is bent back against the body, without being engaged with the end hook, but does not protrude below the bottom of the end hook radius. This is similar to a knocked-down flange defect where the body flange is visible below the end hook radius. This defect is difficult to observe and requires close visual inspection of the underside of the double seam where sometimes two layers of metal can be seen. Confirmation of this classification often requires a seam cut to observe the configuration of the end curl and body flange.

1. Flange damage (bent flange) during shipping, depalletizing, filling the can; from feed screw, the clincher, the seamer; or from product or foreign material on the flange.
  2. Mushroomed can flange.
  3. Damaged or bent end curl.
  4. Misalignment of can during assembly.
-

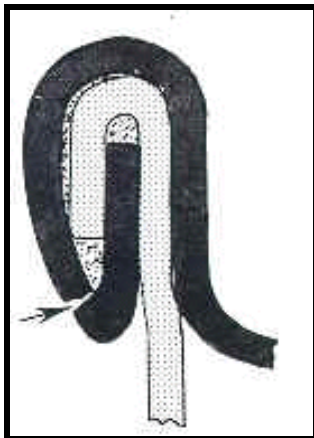
### DEFECT: FRACTURED SEAM

A fractured seam is considered a serious seam defect when the metal is fractured.

A fracture or break in the end hook radius. This defect may be difficult to observe without magnification. Seams which show second operation roll marks should be closely examined for this defect, particularly at the side seam or if a droop is present.

1. Seam too tight.
  2. Excessive solder in the lap.
  3. Defective end plate.
  4. Excessive sealing compound.
  5. Inclusion of product or foreign material in the seam.
  6. Excessively long end hook resulting from first operation being too tight.
-

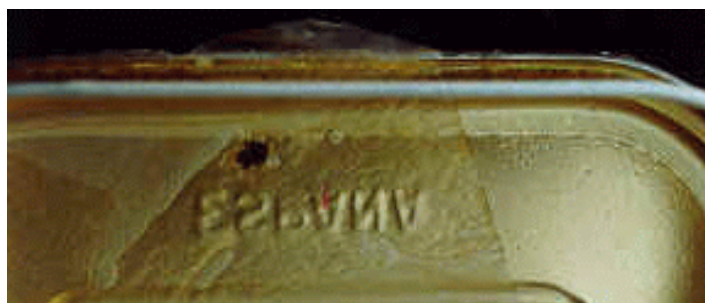
1. Product over flange.
  2. Scrap metal from a filler jam up.
  3. Solder pellets.
-

PARCHMENT PAPER FORMED  
INTO DOUBLE SEAM.

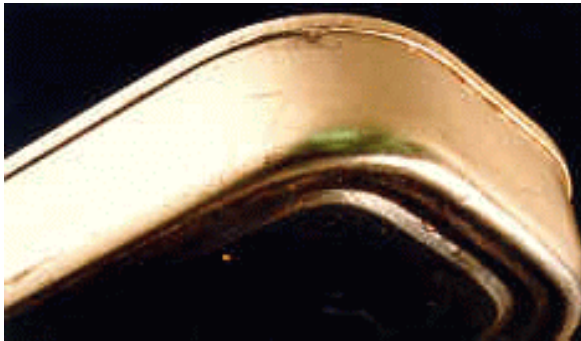
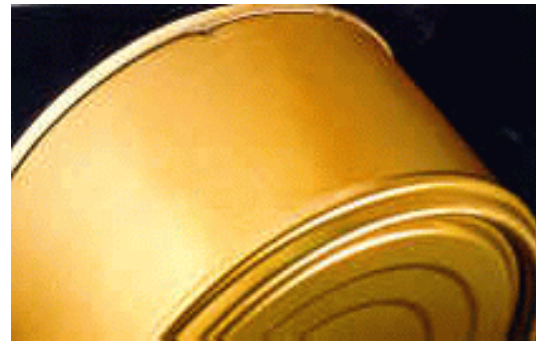
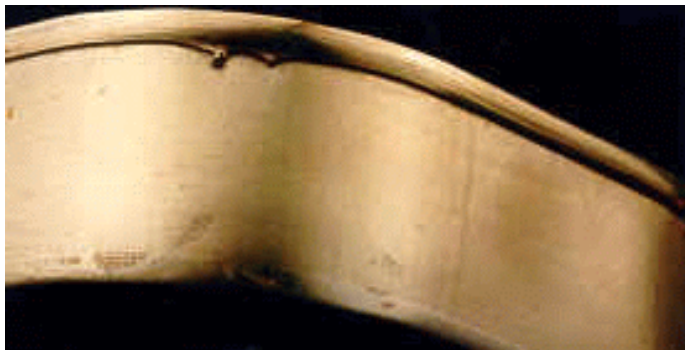
1. Inclusion of product/bones or foreign material in the double seam.
  2. First operation seam too loose.
  3. Worn first operation roll groove.
-

**MULTIPLE DEFECTS MAY OCCUR -  
AS SHOWN A KNOCKED DOWN CURL  
PLUS A SERIOUS VEE.**
