COMMISSION OF  
INQUIRY INTO THE  
AIR ONTARIO CRASH  
AT DRYDEN, ONTARIO

Final Report

Technical  
Appendices

The Honourable Virgil P. Moshansky  
Commissioner

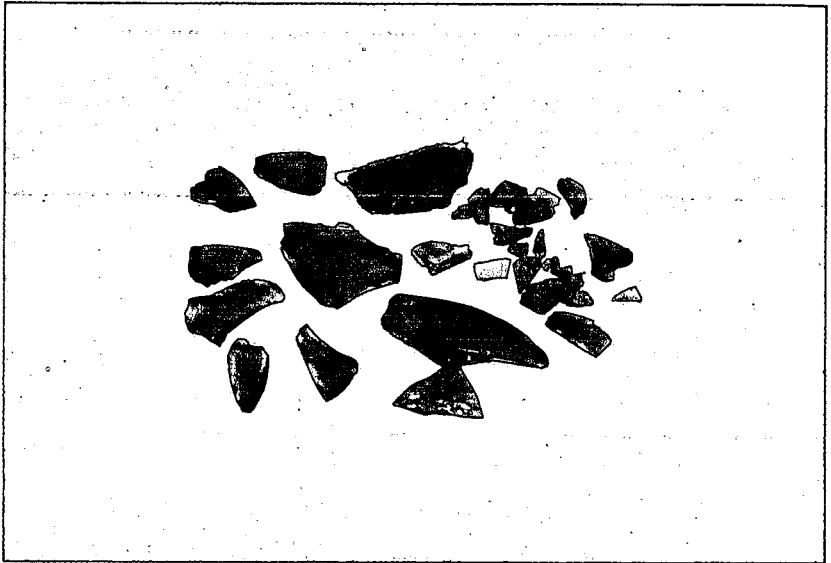
**Figure 5 - Photo of all the pieces of the red lens from the anti-collision light recovered from the vicinity of the first clipped trees off the end of Runway 29.**

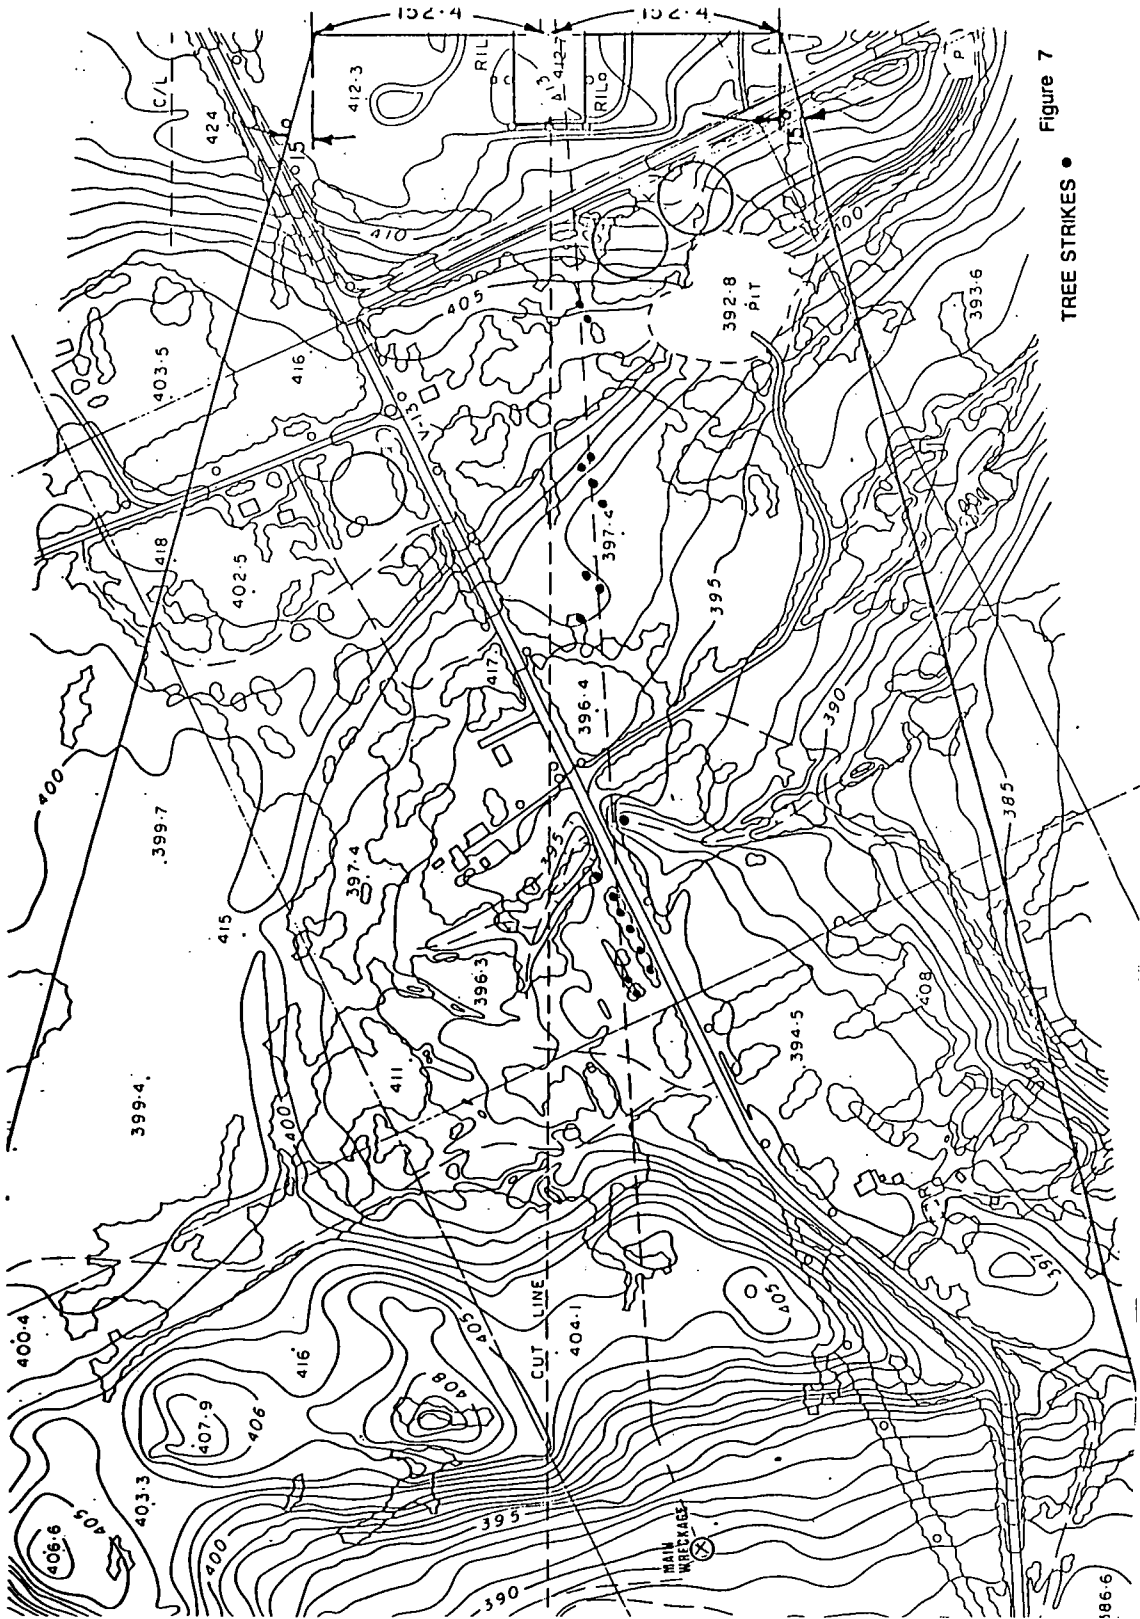
- Figure 7 - Dryden Site Plan showing the tree strikes of the end of Runway 29 and the location of the accident site with respect to the airport.
- Figure 8 - Drawing of Aircraft Flight Path Profile showing the tree strikes off the end of Runway 29 and the relative elevations of the tree strikes.

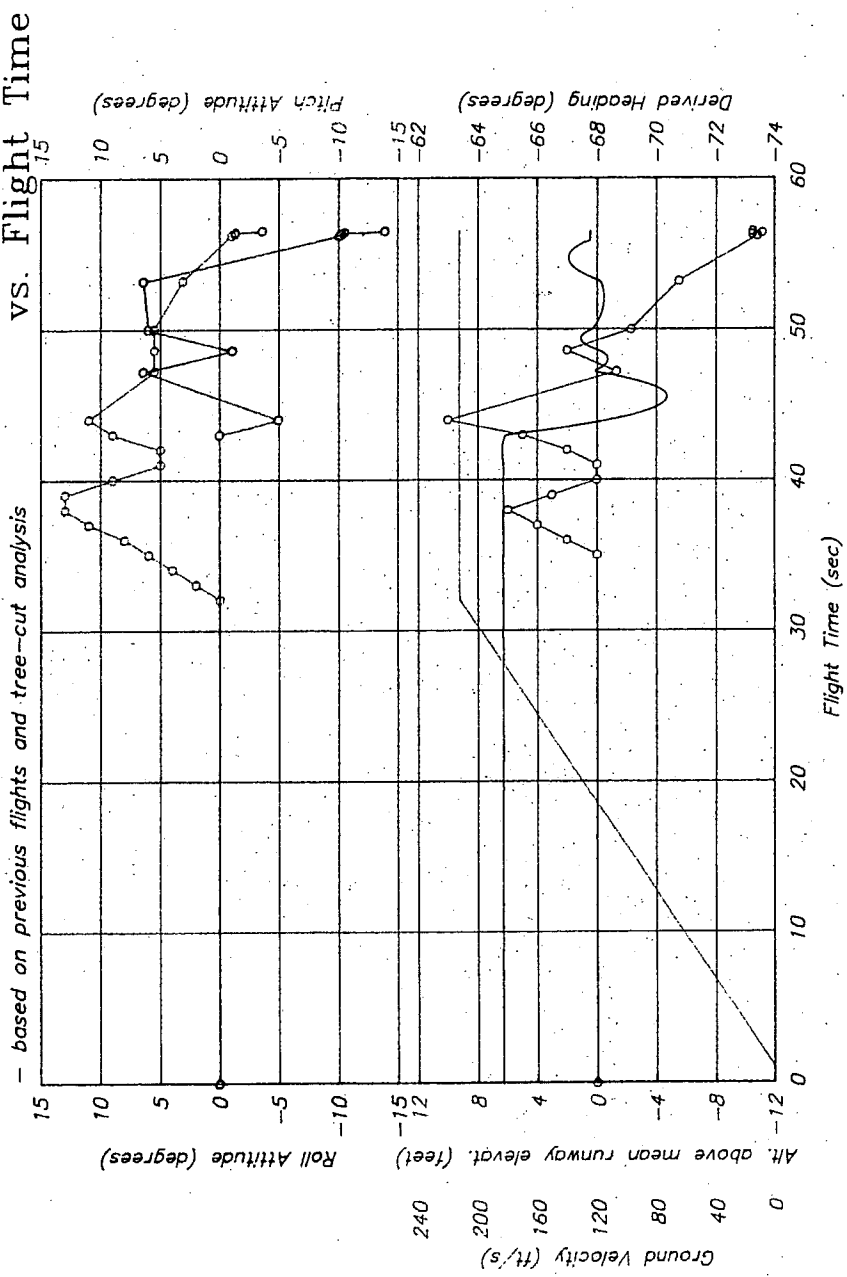
Figure 11

2.4.1 A graphical representation of the ground velocity, heading, roll, pitch and altitude data used in the reconstruction is shown in Figure 11.
