STANDARDS AND GUIDELINES

for the Conservation of Historic Places in Canada

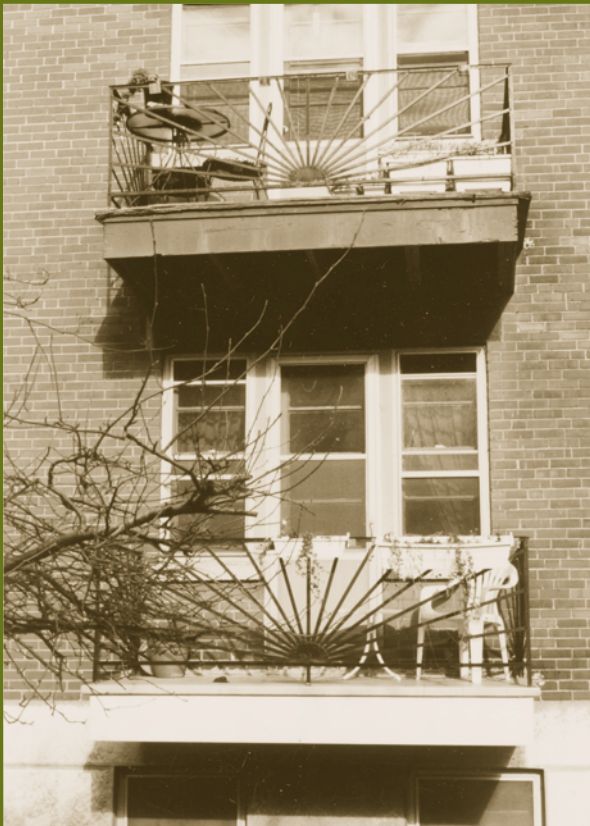
The long-term performance of many substitute materials is uncertain. This is why historic materials should be used wherever possible. Instead of repairing and repainting the wood elements of this character-defining balcony (original balcony above, altered balcony below), the existing wood structure was covered in metal and fiberglass cladding. The original colours that matched the remaining wood windows and details such as a drip moulding were lost. Materials that are considered “low-maintenance” are often used as new substitutes, although they may be less durable in the longer term.

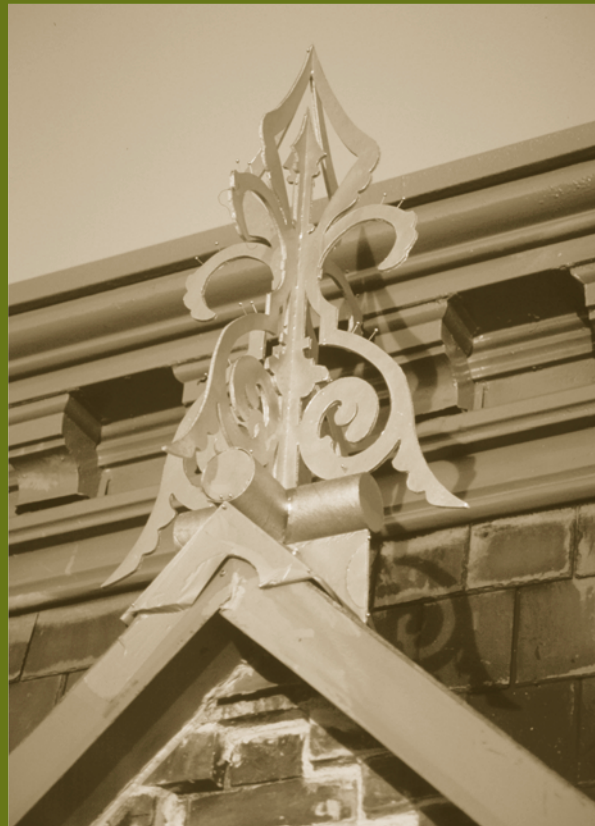
Under certain circumstances, substitute materials may be appropriate. As part of a *Rehabilitation* project, new finials were designed based on remains of originals. The originals were fabricated of wafer thin galvanized metal soldered together. The substitute material used in the new design was plate aluminum.

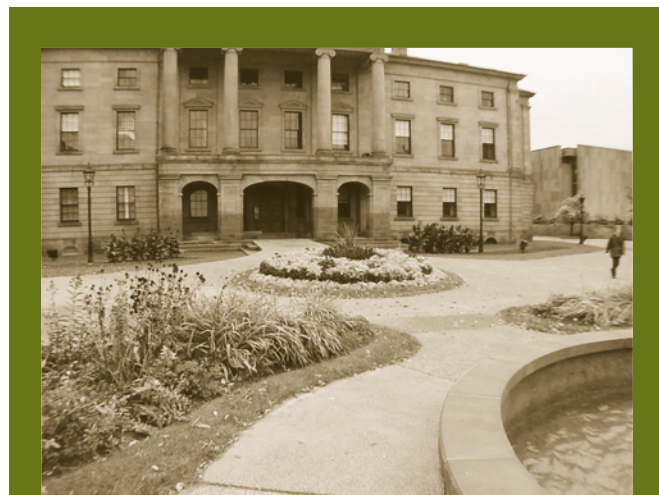
Alterations or new construction designed to meet requirements such as accessibility need to be carefully thought out in order to respect the character-defining elements of a historic place. Accessibility requirements at Province House in Charlottetown, Prince Edward Island were met by changing the slope in the grounds as part of the rehabilitation of the landscape in front of the main entrance. The change in grade is limited to the middle section of the building in order to preserve the view of the base course and the use of sections of the original steps.

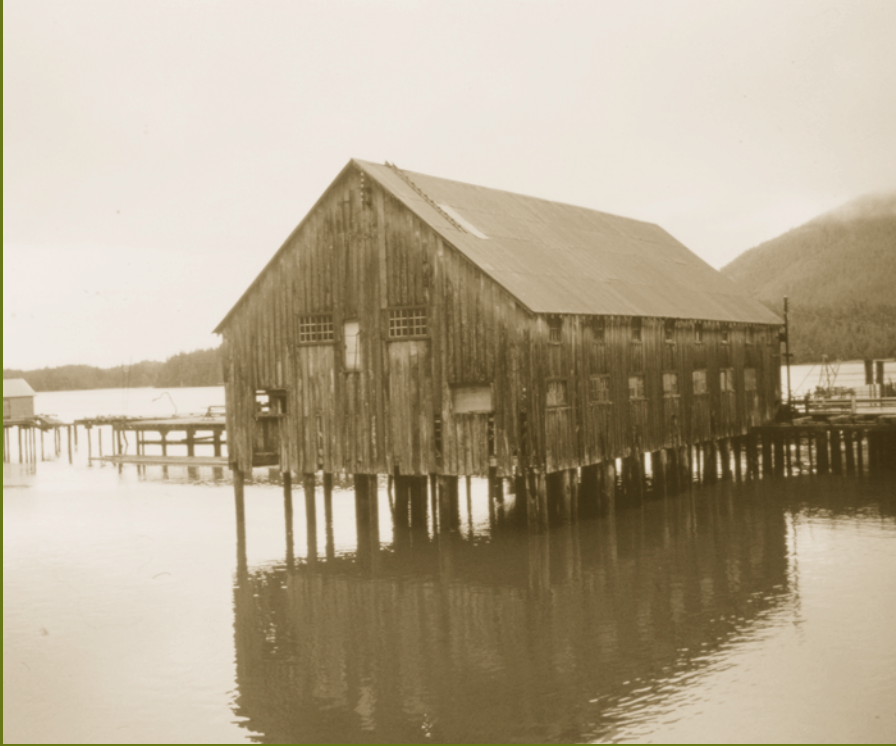
It is important to identify the cause of any damage to a wooden building element before beginning a *Preservation* treatment. In the case of the former machine shop of the North Pacific Cannery, exposure to marine conditions led to deterioration of the exterior wood cladding.

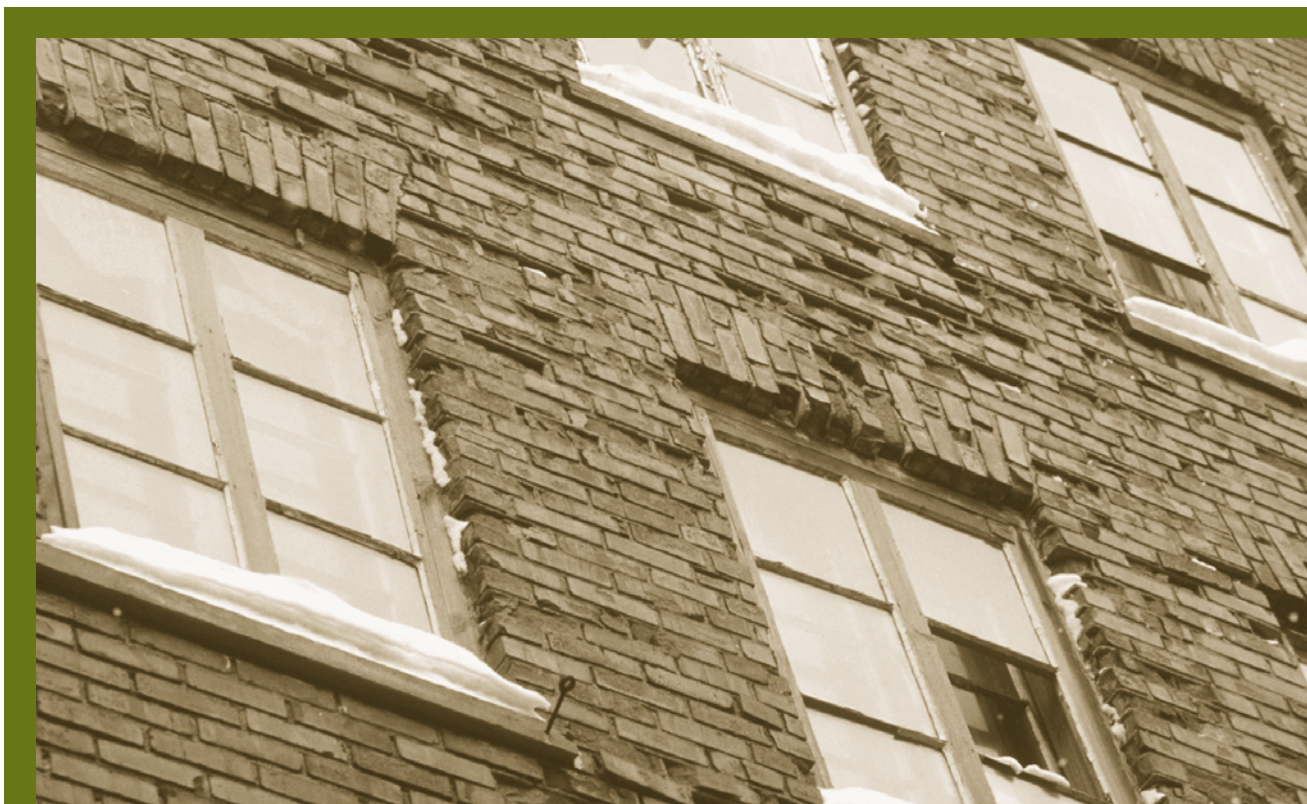
The harsh climate in many parts of Canada can seriously damage masonry elements. This wall in Quebec City has suffered irreversible damage from water penetrating the brick façade and freezing, causing the faces of many bricks to pop off. To avoid damage such as this, it is recommended that moisture penetration be stopped by repairing failed flashings, deteriorated mortar joints or other mechanical defects, not by applying water-repellent coatings, which can trap moisture inside the masonry.

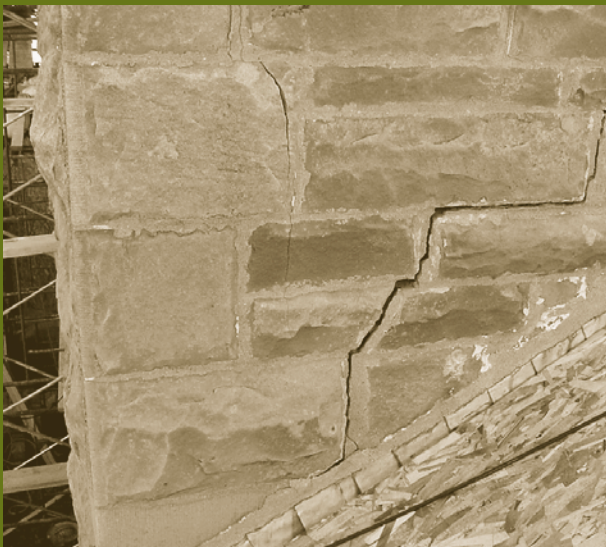
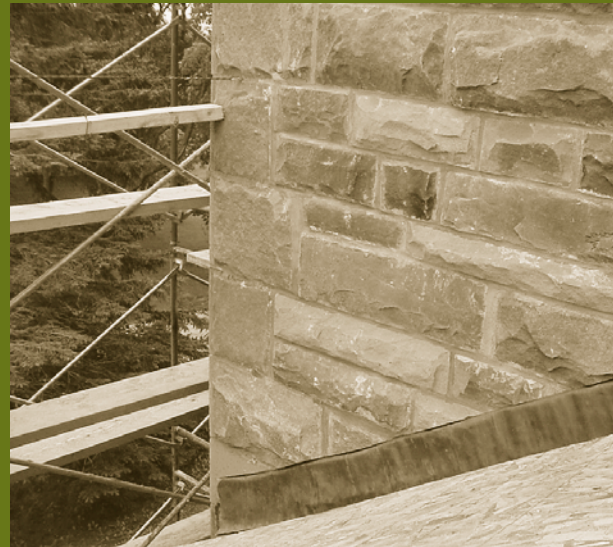
Deteriorated mortar joints in masonry walls should be repaired by repointing. The deteriorated mortar should be removed by carefully hand-raking the joints to avoid damaging the masonry, and the new mortar should duplicate the period mortar in strength, composition, colour, texture, width and joint profile. Repointing with mortar of high Portland cement content is not recommended, unless this was the historic mortar.

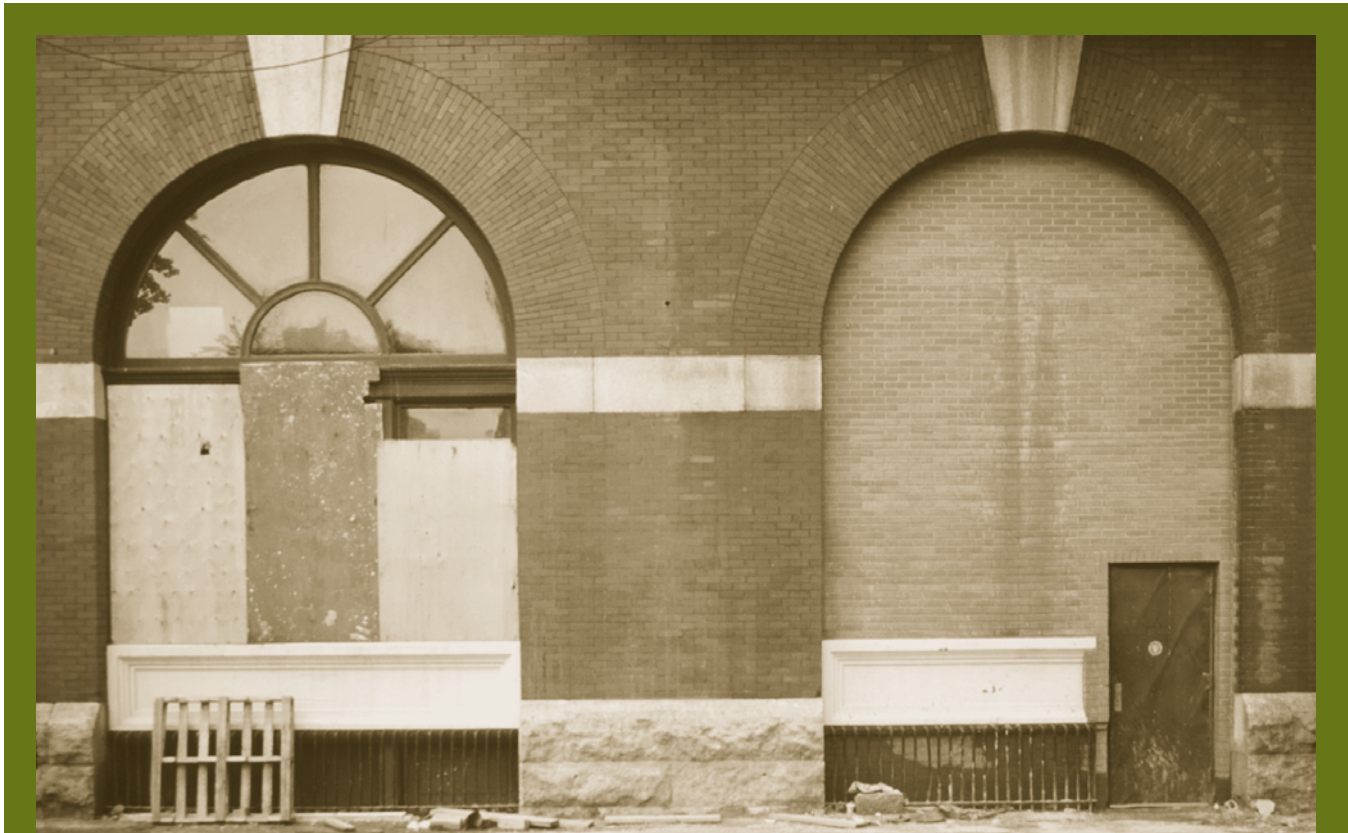
Cleaning masonry should be undertaken only when necessary to halt deterioration or remove heavy soiling. If surface cleaning is appropriate, tests using recognized preservation methods should be first be made in order to select the gentlest cleaning method possible, and be observed over time to determine the immediate and the long-term effects. The test-cleaning of the left portion of this brick and stone wall (using low pressure water and detergents, when there was no chance of freezing) created an acceptably clean wall.

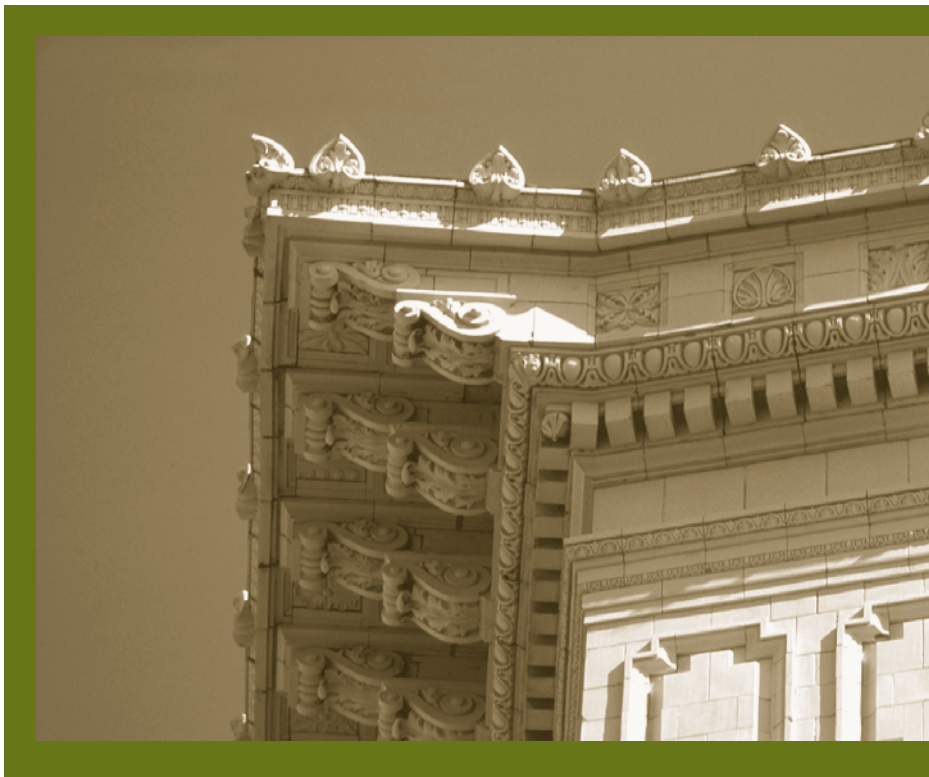
One of the primary causes of deterioration of glazed architectural terra cotta is water. Water-related damage to the glazed units, mortar, metal anchors or masonry backfill can be repaired only when the sources of that water have been eliminated. This typically means repairing flashing, repointing deteriorated mortar with a mortar that has a compressive strength lower than the adjacent masonry unit, and coating or sealing blistered spots to prevent further entry of water. Repointing with waterproof caulking compounds or the wholesale coating of the wall with waterproof materials will impede the normal outward migration of moisture through the masonry joints and likely cause spalling of the glaze or mortar.

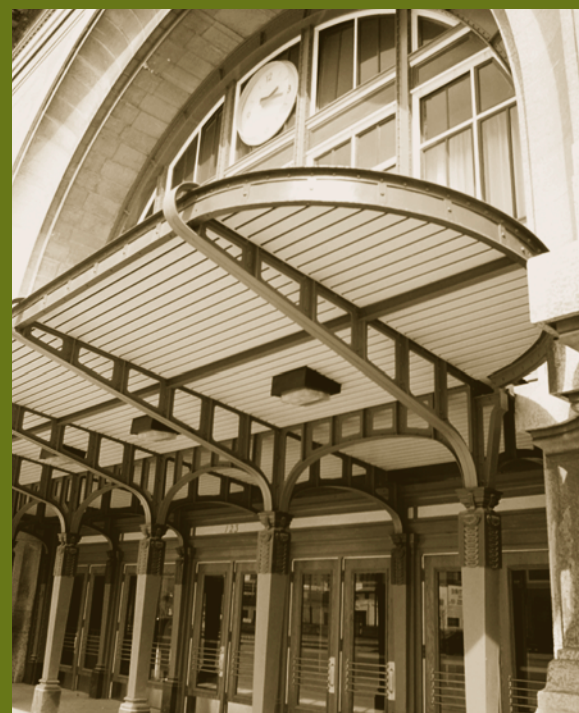
A regular programme of cleaning and re-applying appropriate paint has preserved to a remarkable degree the metal entrance canopy of Winnipeg's Union Station, which was completed in 1911. Protection from corrosion should be considered the first line of defence in preserving architectural metals.

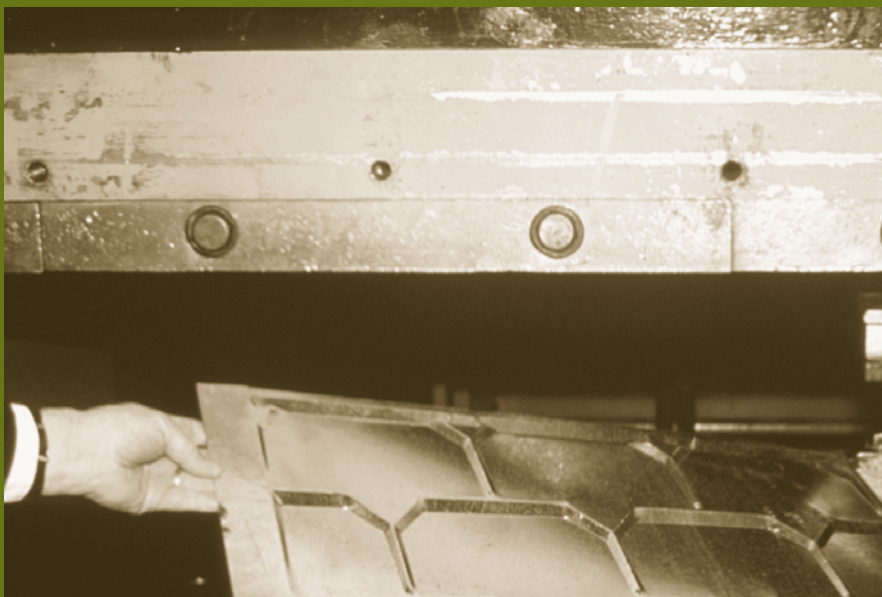
A surviving pressed metal shingle was used as a prototype for manufacturing replacement shingles for the *Restoration* of the main house at the Motherwell Homestead near Abernathy, Saskatchewan. As a rule, in *Restoration*, repairs or replacements of extensively deteriorated or missing parts of features are done in kind, and are based on physical, documentary and oral evidence.

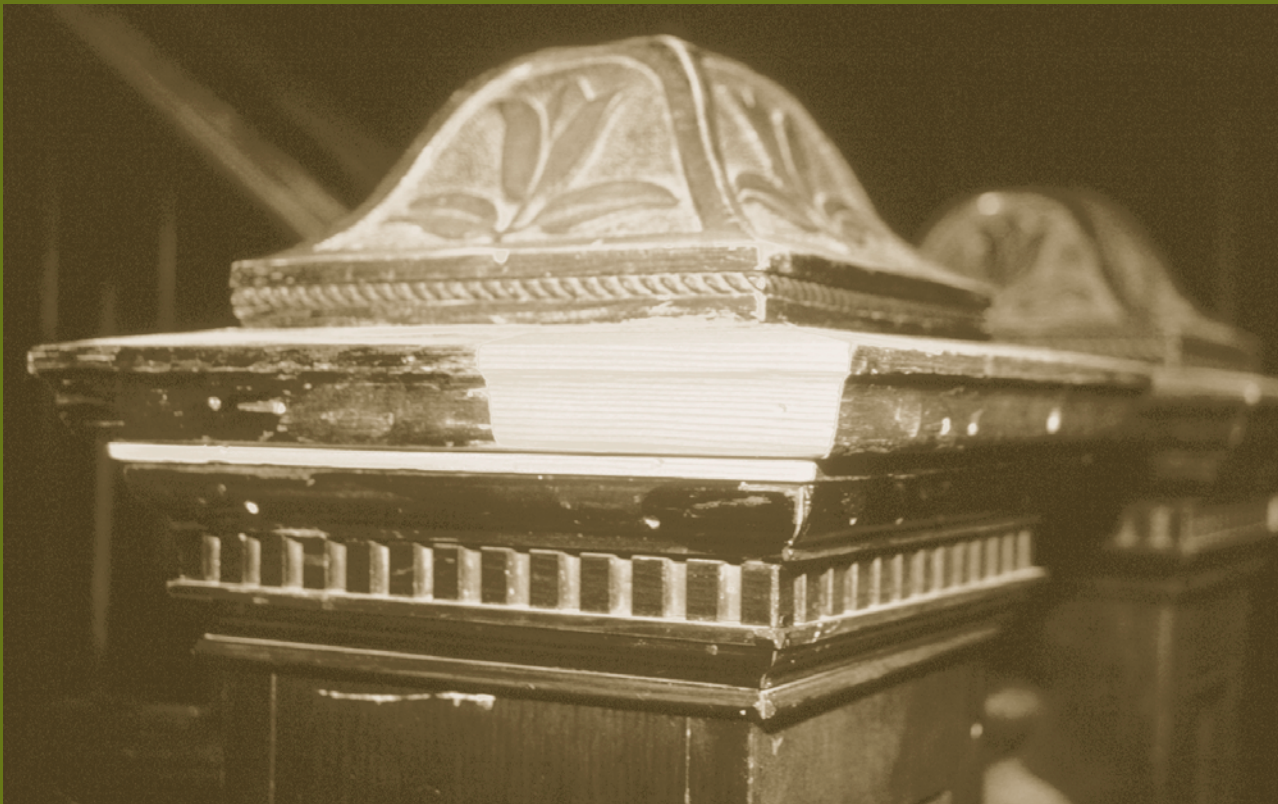
An example of “limited replacement in kind” points out an appropriate scope of work within the treatment *Preservation*. Only the damaged corner of a stair’s newel post has been replaced- (it will be stained to match). Targeting repairs to the deteriorated elements meant that most of the character-defining elements were retained.

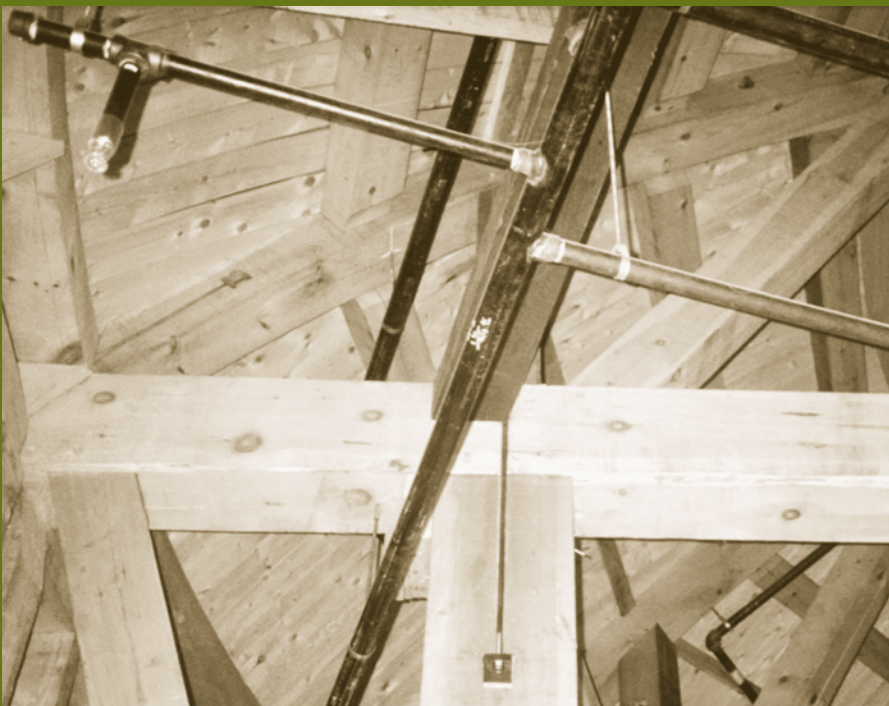
New mechanical systems should be installed in a way that results in the least alteration possible to the building. In the *Restoration* of St. George's Anglican Church, Halifax after a devastating fire, care was taken to ensure that the character-defining structural system and interior features from the restoration period were not altered or obscured when a new fire-suppression sprinkler system was installed in the attic.

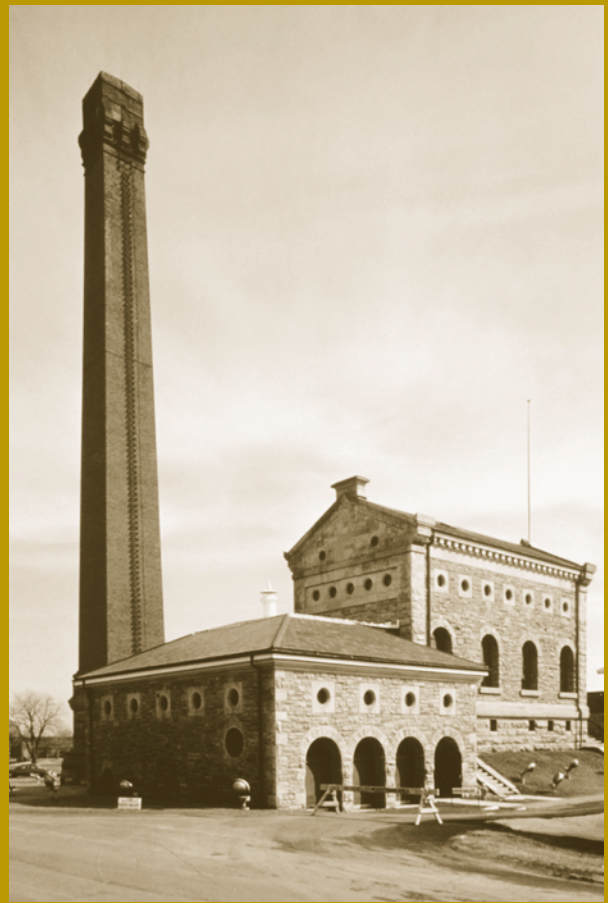
The Hamilton Waterworks, built in 1857-59, is the only intact mid-19th century waterworks in North America. The character-defining compound-beam steam pumping engines were restored to working condition in 1998.

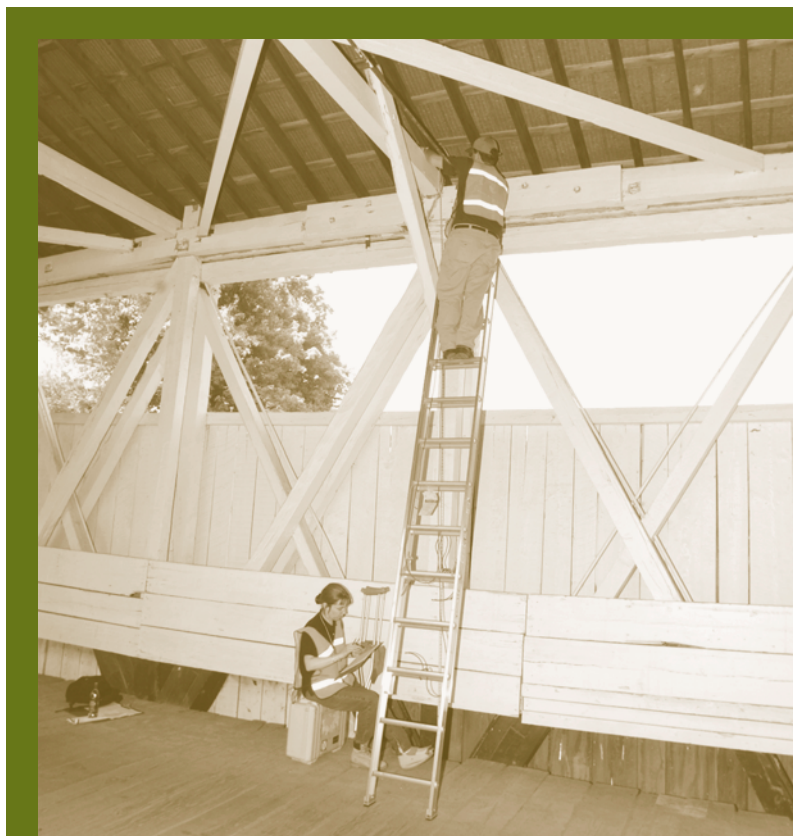
Prior to beginning project work, the form, materials and condition of engineering works should be documented. Heritage recording of the Percy covered bridge, National Historic Site of Canada in Powerscourt, Quebec, the only surviving bridge that uses the McCallum inflexible arch construction, included detailed measurements and a photographic record.
